Advisory Visit

Rivers Meden and Maun, Thoresby Estate, Nottinghamshire

January 2018

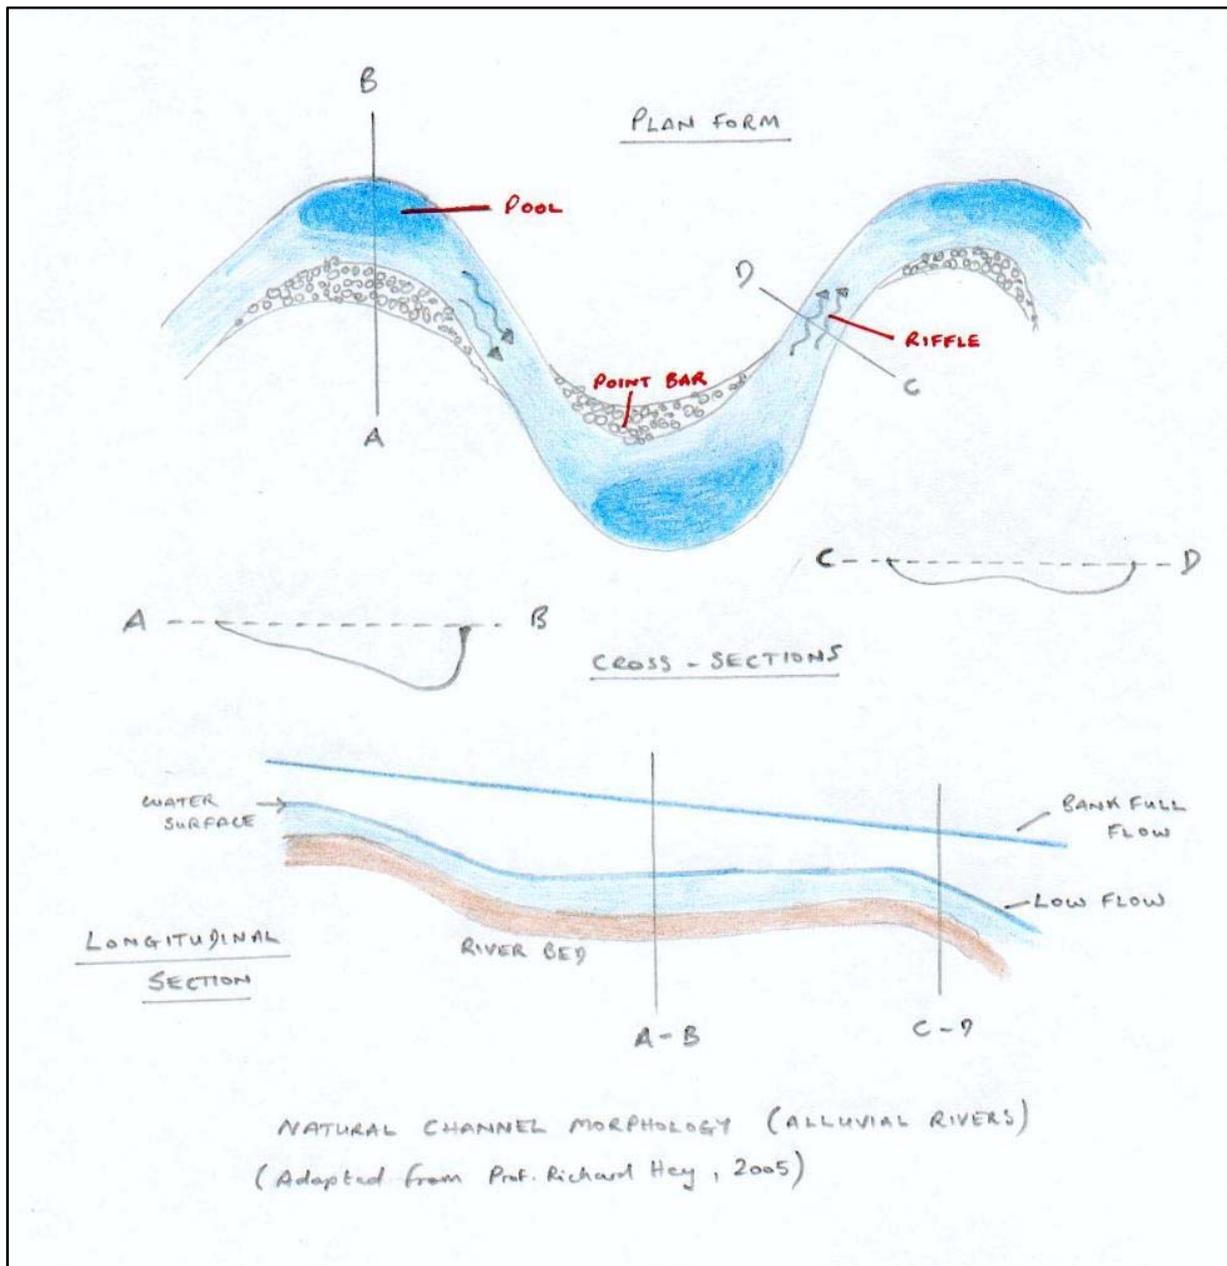
distance, and is lacking a natural pool-and-riffle sequence (Figure 2). This means the reach is comprised of mainly long, shallow, riffle-like habitat (Photo 7), with a short section of deeper glide (Photo 8). This type of habitat has some value for the juvenile stages of trout, but lacks deeper areas and areas of cover which fish beyond c. 6" (15 cm) could inhabit.

Figure 2 Natural river channel shape, showing how pools occur on the outside of meanders, with riffles in-between, providing natural variation in depths and bed substrate, which in turn provides the habitat variety necessary to support healthy populations of trout and other aquatic wildlife.

Ideally, the planform of the river here should be changed to introduce some meanders and re-establish a pool-riffle sequence, providing depth variation and habitat niches for all trout life stages. This would require design input from a professional fluvial geomorphologist and earthworks to excavate new sections of channel and backfill some existing sections. An example of this type of project can be seen in Figure 3 (with more details at www.wildtrout.org/content/river-glaven). Early consultation with Historic England over heritage considerations and with the Estate over the land-take required is essential. The natural flood management aspects of such a project may be advantageous in the current climate of changing agri-environment subsidies.

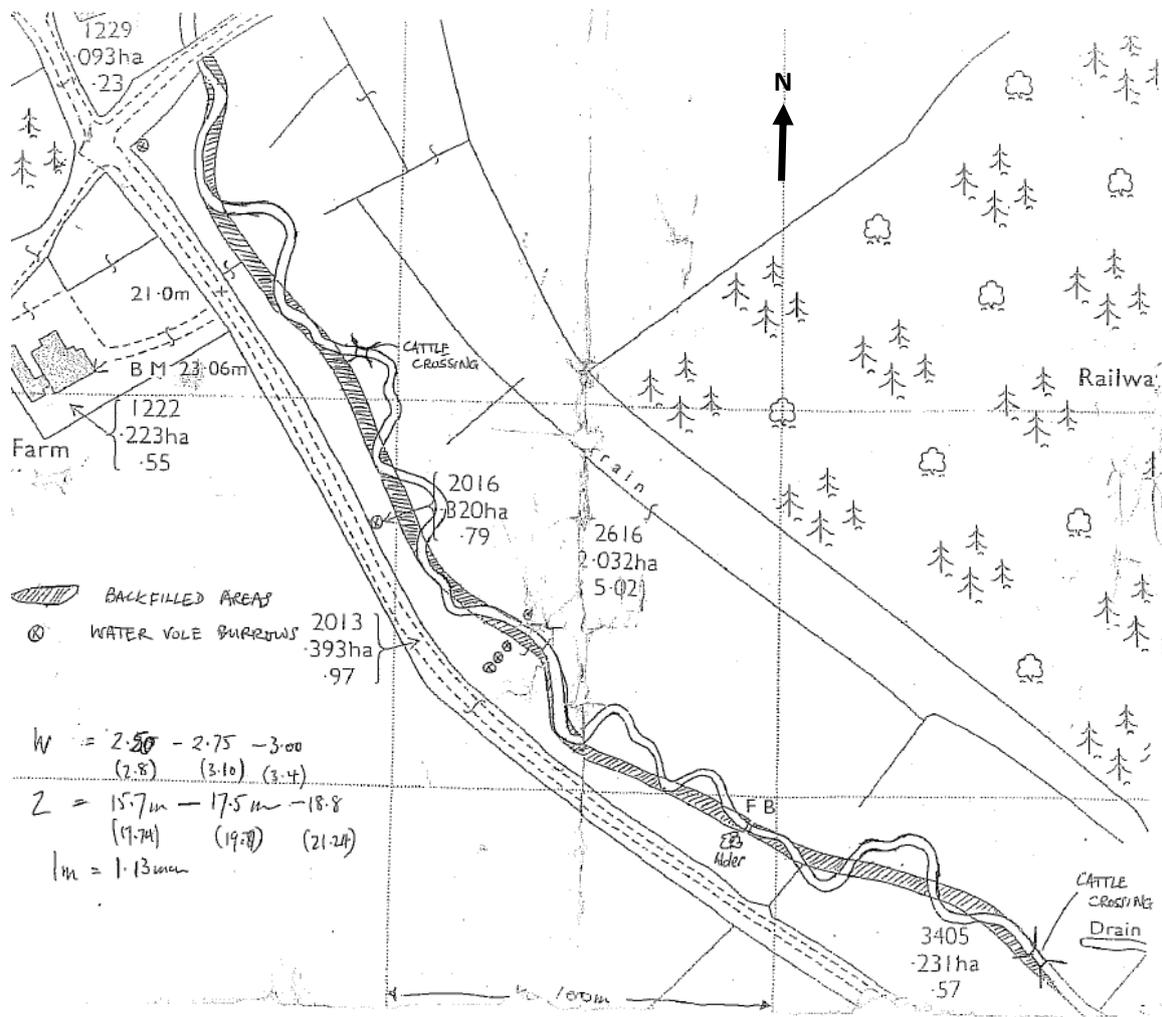
Figure 3 Plan of river re-naturalisation project carried out on River Glaven, Hunworth, Norfolk. Shaded line is the original engineered channel, open line is the new, restored course. The engineered channel was back-filled with spoil excavated from the new channel. (River flowing SE to NW).

A re-meandering project would have a timescale of 2–3 years for delivery. In the meantime, or if such a project were not possible, more immediate (but less permanent and effective) improvements could be made within the existing channel by introducing log flow deflectors and large woody material to create bed scour and depth variation. Some examples are given in Section 4, Recommendations.

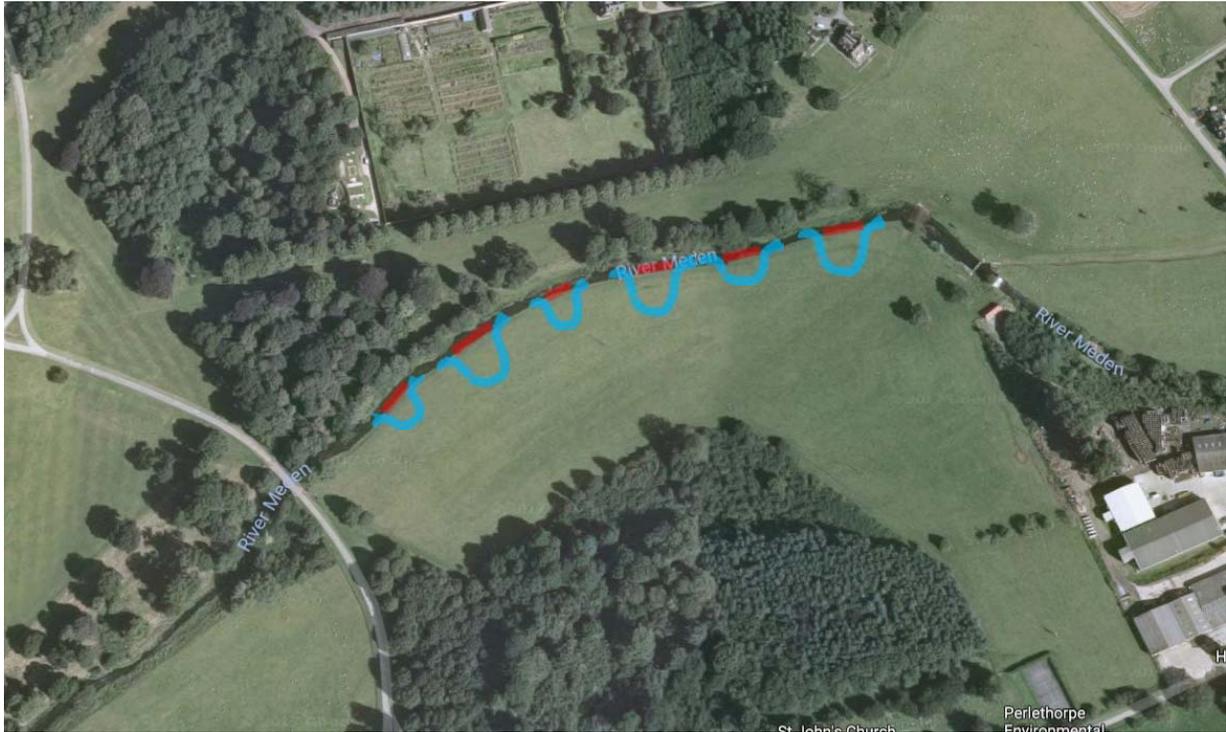
Figure 4 Conceptual diagram of river re-naturalisation project, where meanders are restored to the river planform by cut (blue lines) and backfill of sections of existing channel (red lines). Lowering of the land level adjacent to the river (within the meander loops) to restore the floodplain would also be required. There would therefore be excess spoil that would require removing or landscaping.

- Change the planform of the river downstream between the footbridge and the weir at Thoresby Home Farm to make it more sinuous and restore a natural pool-riffle sequence (Figure 4). Consultation with Historic England on heritage aspects would be required, followed by a levels survey and input to the design from a professional fluvial geomorphologist.

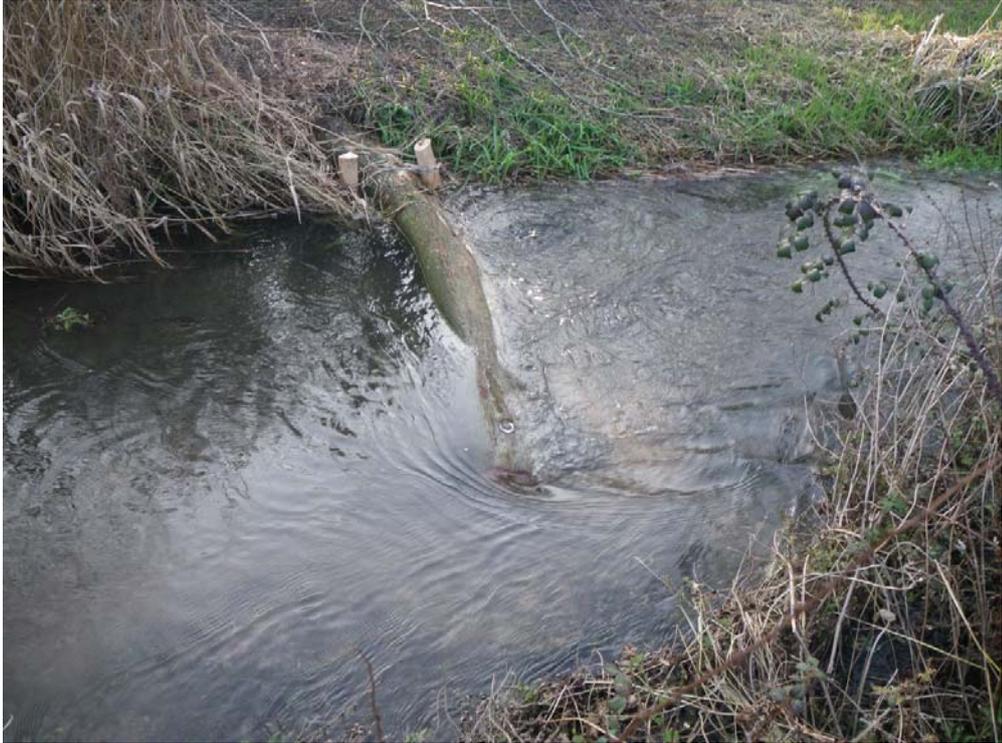
Photo 15 Example of a log flow deflector.

A re-meandering project would have a timescale of 2–3 years for delivery. In the meantime, or if such a project were not possible, more immediate improvements can be made within the existing channel by introducing log flow deflectors and large woody material to create bed scour and depth variation (Photos 15 and 16).

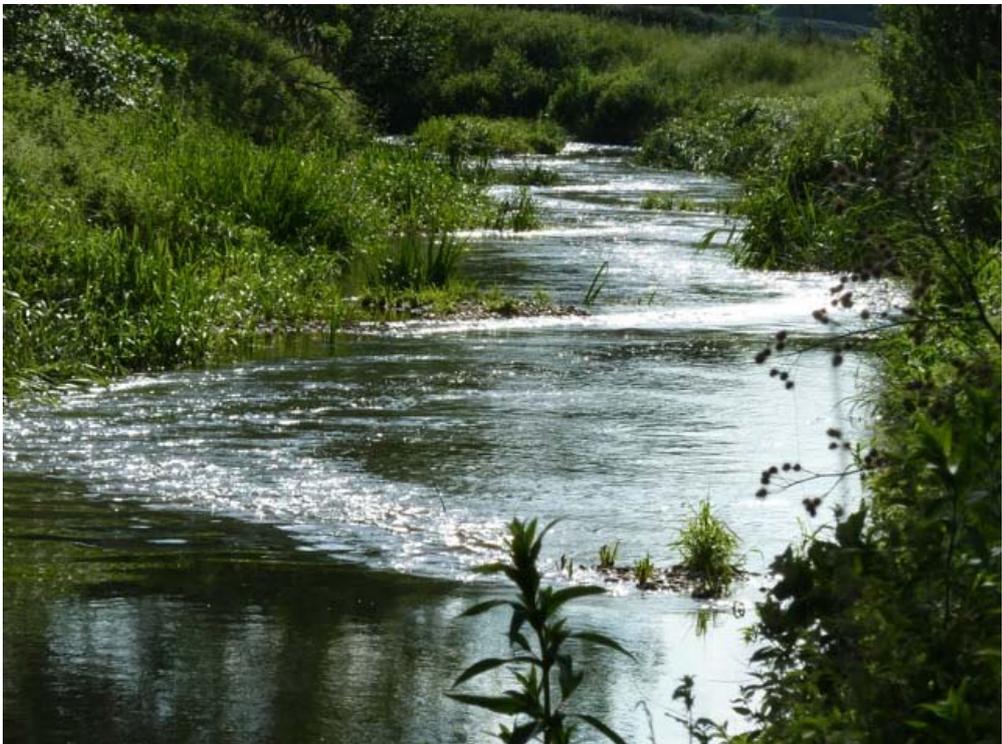
Photo 16 A sinuous flow pattern achieved by positioning flow deflectors on alternate banks (Photo: Ian Hawkins).

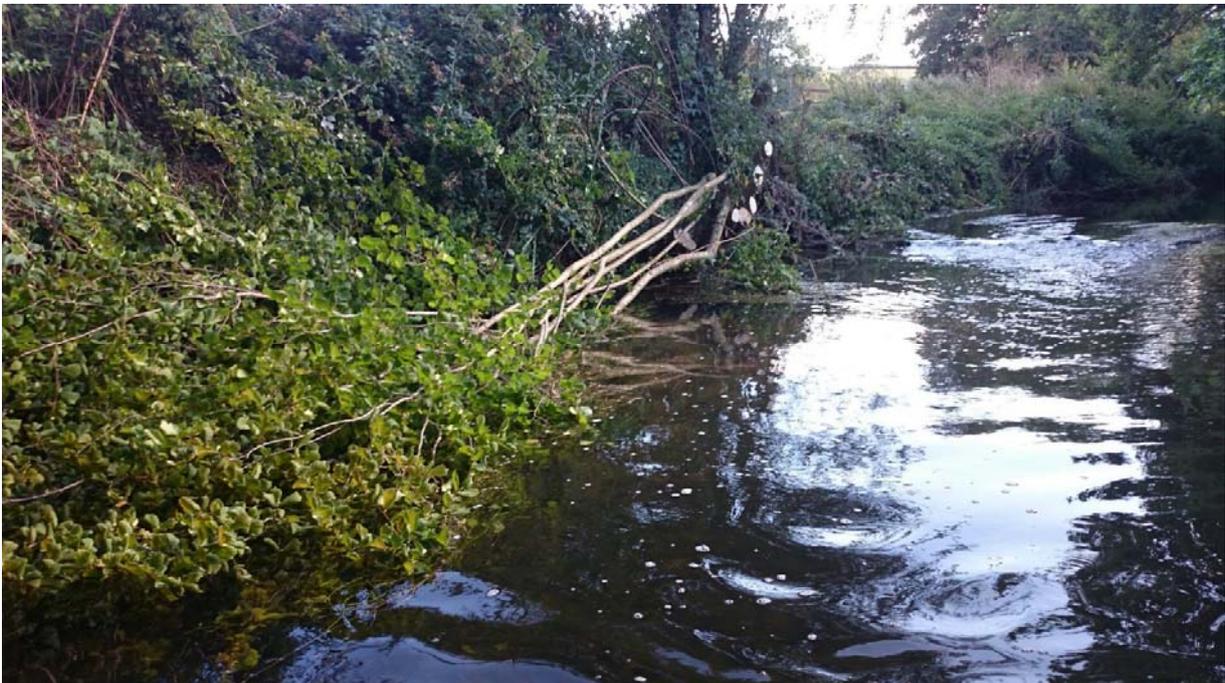
Photo 17 Small trees laid into the river margins to provide improved cover for fish.

- Create a bypass channel around the weir/sluiice near Thoresby Home Farm to improve fish passage, by modifying the existing channel on the left bank feeding the former water meadow. Further investigation into the feasibility of this is recommended, including consideration of the heritage aspects, existing ground and water levels, and the quantity of flow that could be diverted without compromising the existing abstraction. An example of a bypass channel is shown in Appendix 1.
- Re-visit the Budby section and wade the river, making habitat and angling access improvements, such as 'hinging' small trees (Photo 17) and introducing flow deflectors.

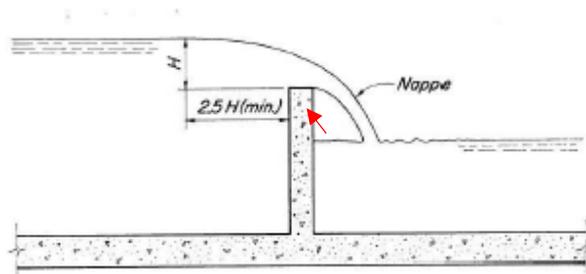
The weir in Photo 2 has a level invert (crest) across the entire width of the brook, with a sharp downstream edge which causes two problems for fish passage:

- A shallow, even spread of water across the weir crest
- Water plumes to leave the face of the structure creating an air gap between the plume and the structure (Figure 1). This prevents fish from swimming up and through the plume, and causes them to have to jump. Fish are essentially designed to swim, and while they can clearly jump, especially salmonids, jumping fish is a sign that they are in difficulty.

Figure 5 Long section of a weir with a level crest and sharp downstream edge creating an air gap (red arrow). Known as an aerated or ventilated nappe.

- The weir crest could be made more varied with free gaps, notches, and lateral variations of the structure included in the works to ensure that a wide variety of flow and velocity conditions occur across the structure at any one flow condition. These heterogeneous conditions offer fish of different species, sizes, and abilities a better prospect of surmounting obstructions.

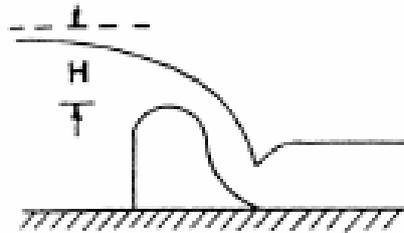
Figure A6 Long section showing radiused profile, excluding air gaps and allowing fish to swim over the weir.

In `streaming flow` situations the gaps, notches must be at least 0.20m wide for trout & large coarse fish. In `plunging` flow situations (more likely) they should be wider and a minimum of 0.3m for trout and coarse fish.

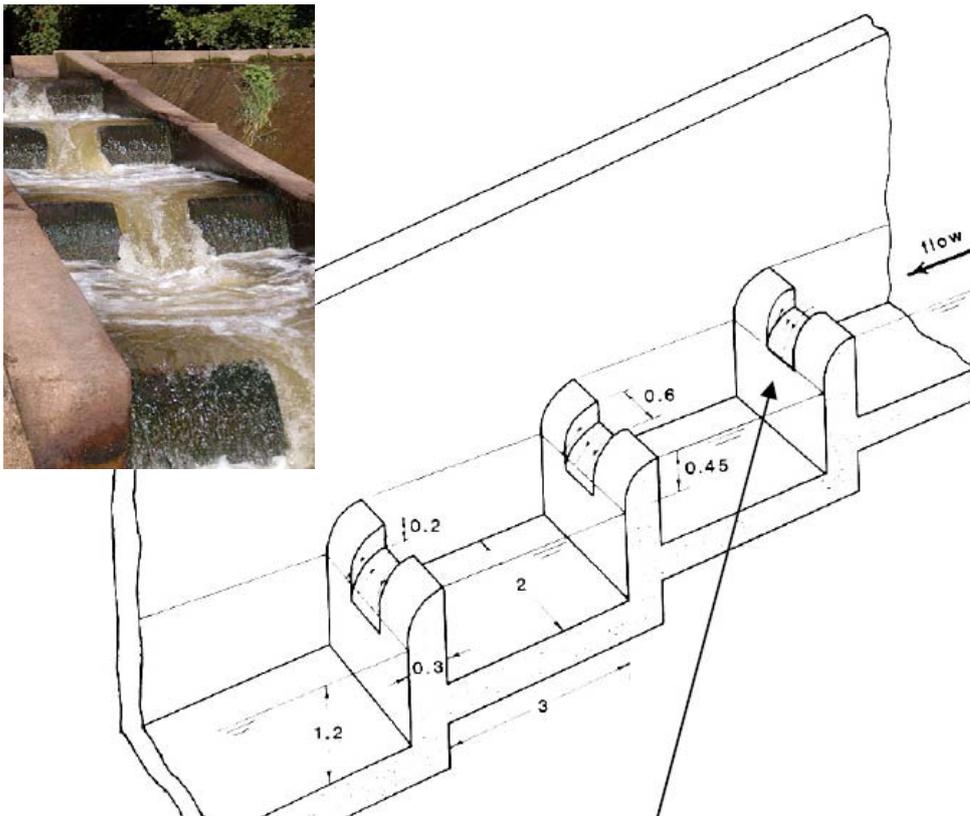
Figure A7 Schematic diagram of a pool-traverse fish pass showing the radiused profile of the weir walls and notches, minimising turbulence. The same principle applies to notches in small weirs.

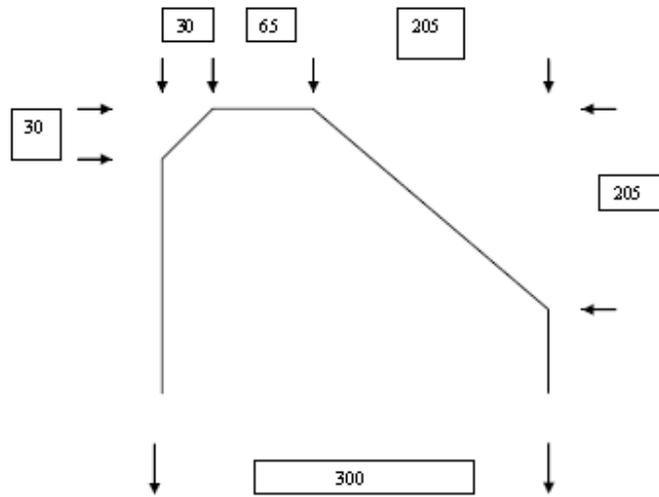
Figure A8 Measurements (scalable) for a chamfered profile to a 300-mm thick wall which would create an adherent nappe. In some cases, such as when constructing blockstone weirs or using natural materials, it may be difficult to achieve satisfactory profiles. However, the same effect can often be achieved by ensuring that the stones put in the notches are sloped.

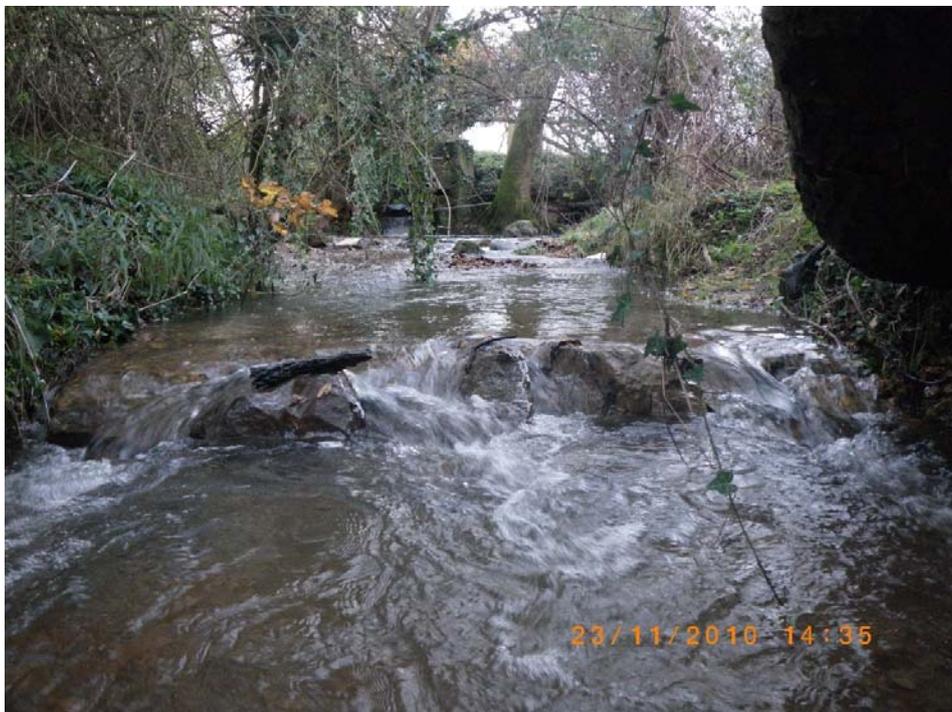
Figure A5 Two rough-crested weirs in series.

>0.5m (0.3m for trout and coarse fish), two or more weirs in series (with notches) can be used (Figures A5 and A6).

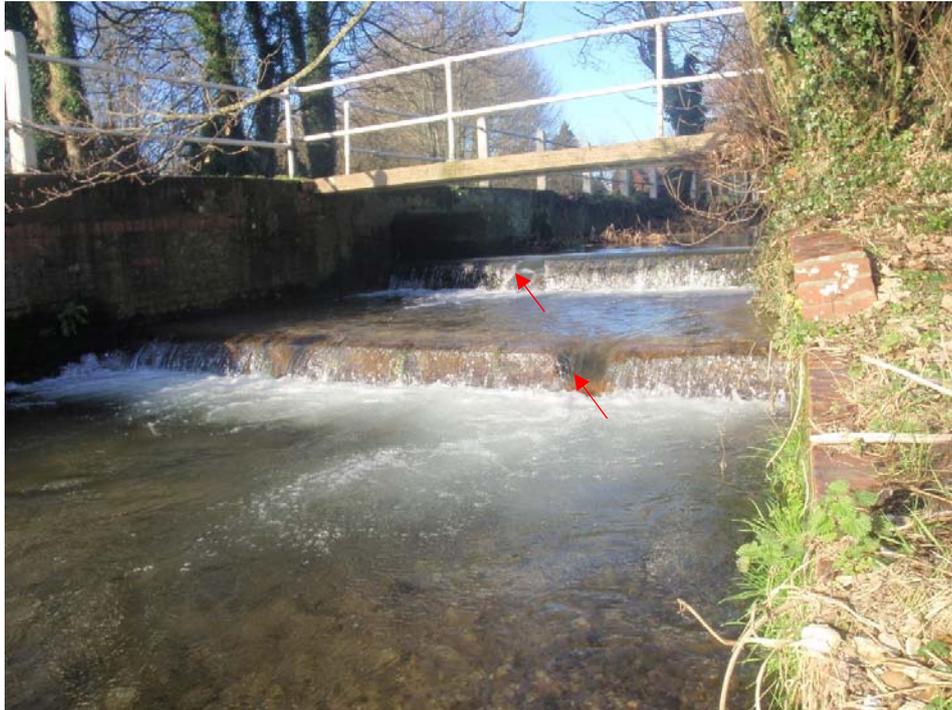
Figure A6 Retrofitted fish passage improvement: new pre-weir (foreground), raising water levels at the existing weir (background) with a radiussed notch in each (arrows).

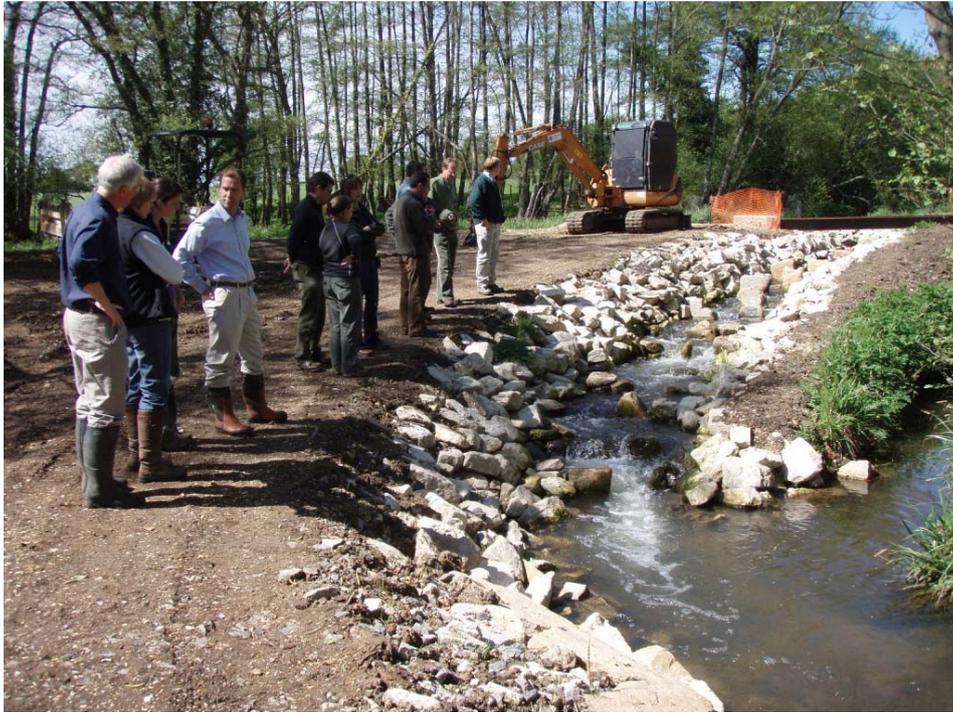
Figure A9 A rock-ramp fish pass illustrating the concept of a heterogeneous surface providing varied flow patterns conducive to fish passage at most river discharges.
