Advisory Visit

Merritt's Brook, Birmingham

23/01/12

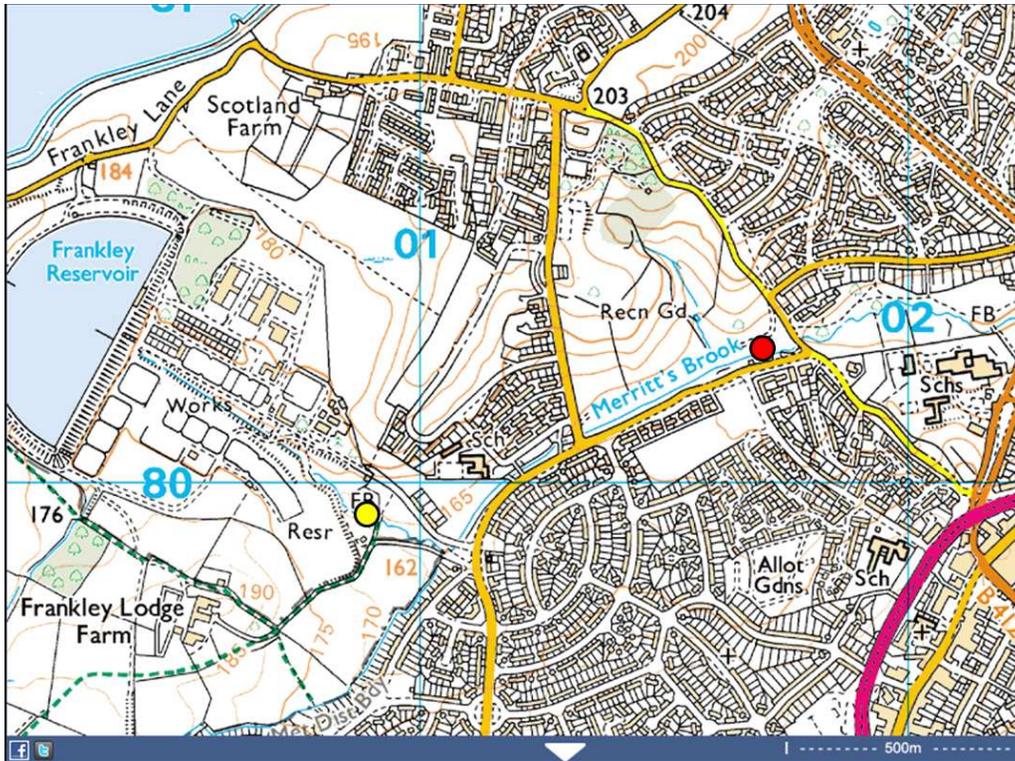
Figure 1: Map of inspected reaches from upstream limit at SP 00889 79931 (yellow circle) to downstream limit at SP02143 80317 (red circle)

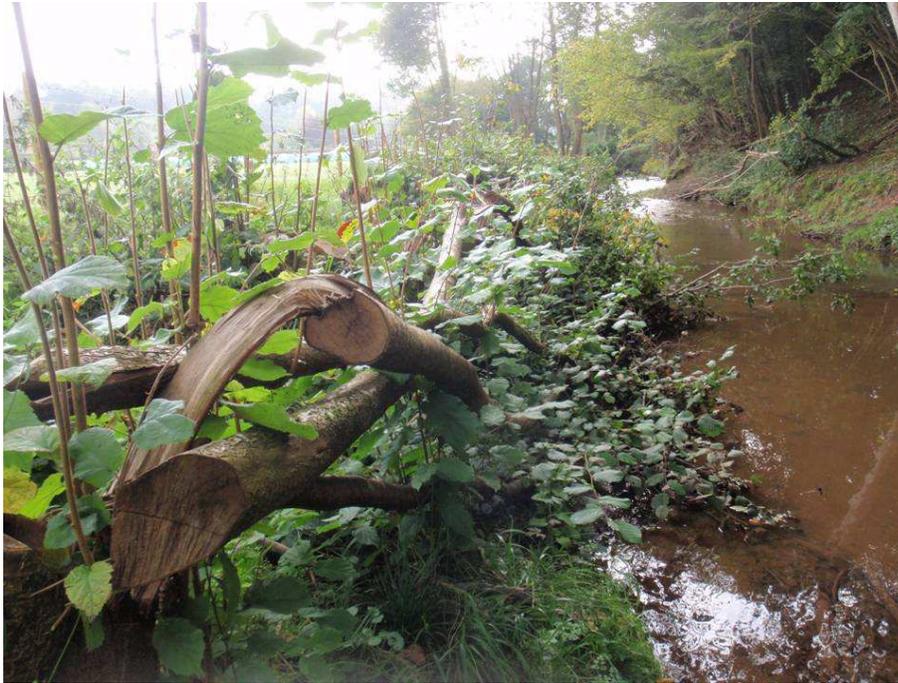
Figure 15: Hinged (or pleached) saplings used to generate marginal cover

- Combine the sensitive canopy opening at Merritt's Brook Lane section with "hingeing" or "pleaching" of saplings (or cabling of suitable-sized limbs of trees obtained during canopy work) to provide marginal cover and generate flow velocity and depth variety. Figure 15 gives an example.

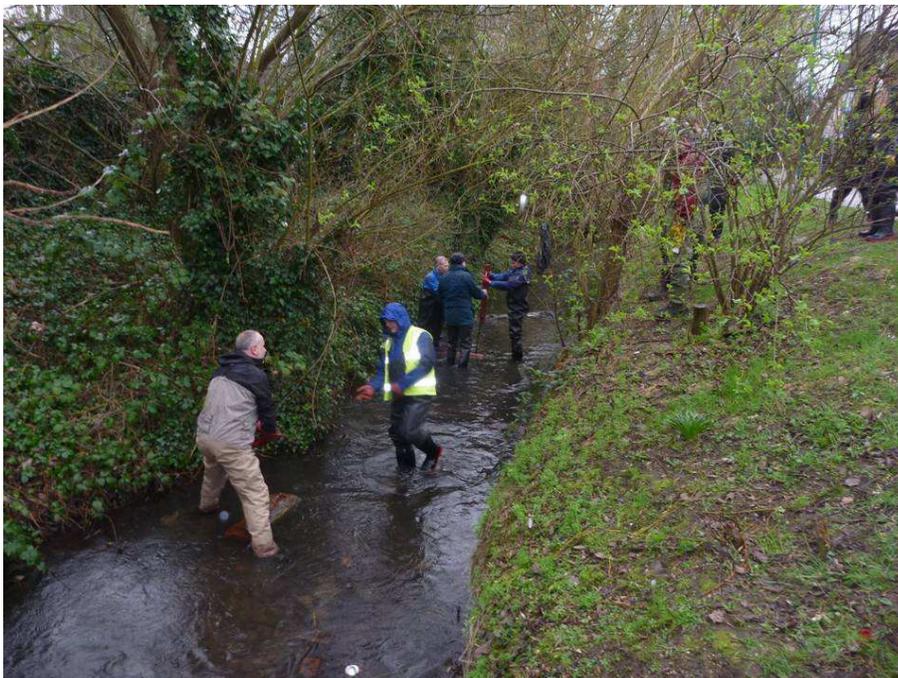
Figure 16: Mini logs being pinned into the urban river Wandle to generate greater spatial heterogeneity within the channel

- Some small in-stream log pinning could also be used to generate greater structural diversity in the channel alongside Merritt's Brook Lane (e.g. Figs. 16 and 17) – **N.B. it is imperative to collate information on underground services where any stakes or pins are proposed to be driven into the stream bed or surrounding banks**

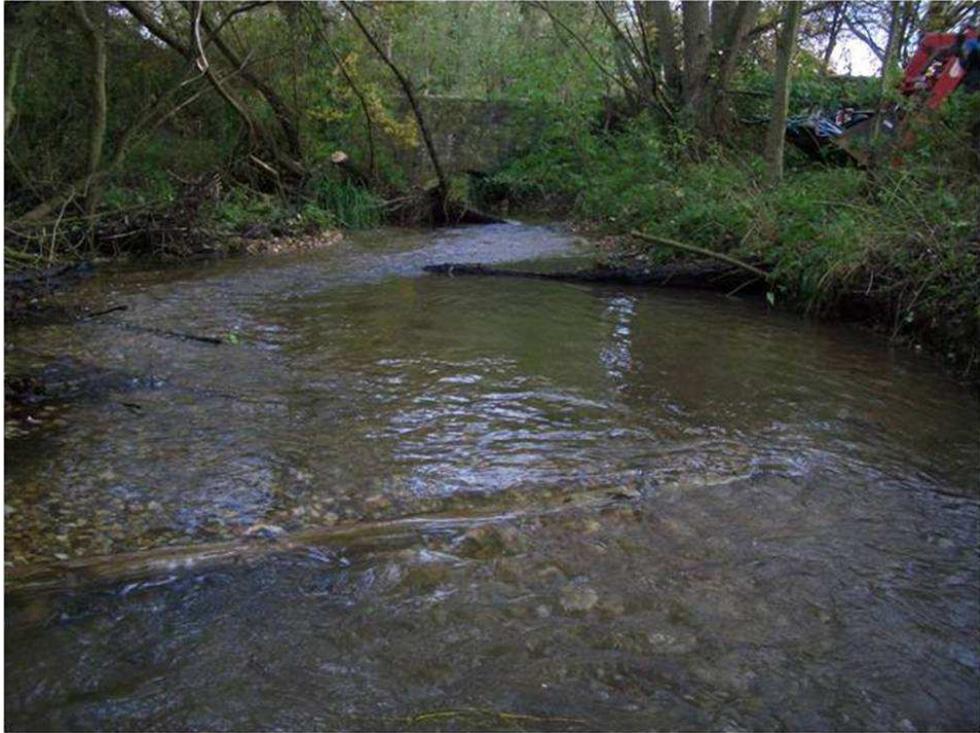
Figure 17: Tree limbs pinned to retain and "grade" spawning gravels in the River Len as well as promote meandering flow in a straightened channel

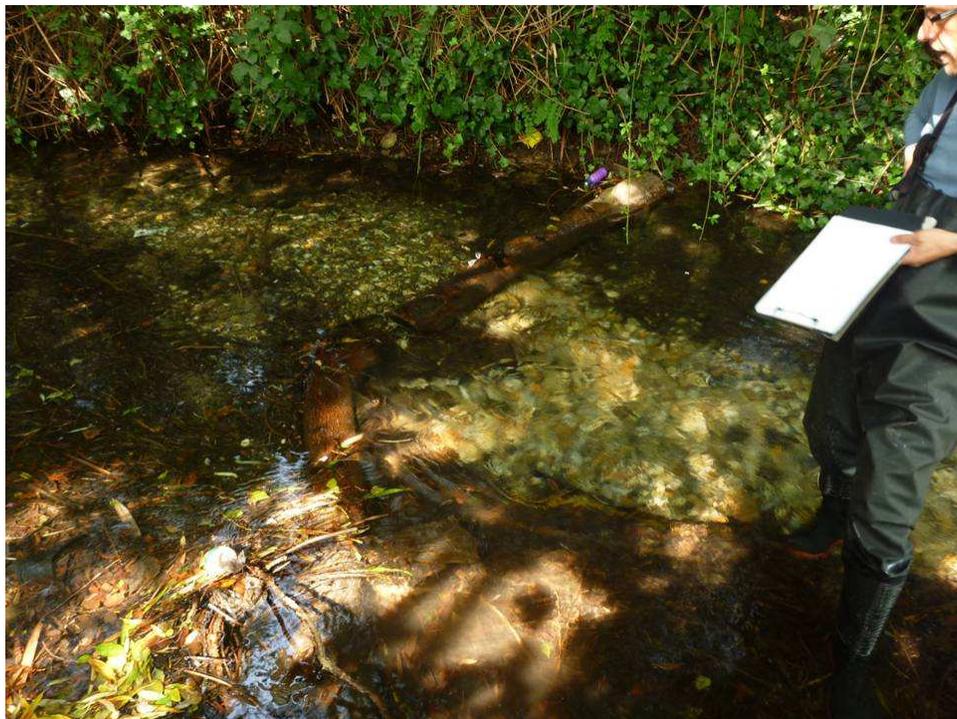
Figure 18: Upstream "V" installed on the urban river Wandle in Carshalton to clean and sort spawning gravels

- An upstream V (e.g. Fig. 18) could be considered at suitable locations within the lower visited reaches downstream of Merritt's Hill to promote pool formation and spawning gravel improvement
