**River Mimram, Tewin, near Welwyn Garden City,  
Hertfordshire**

**An Advisory Visit by the Wild Trout Trust October 2015**

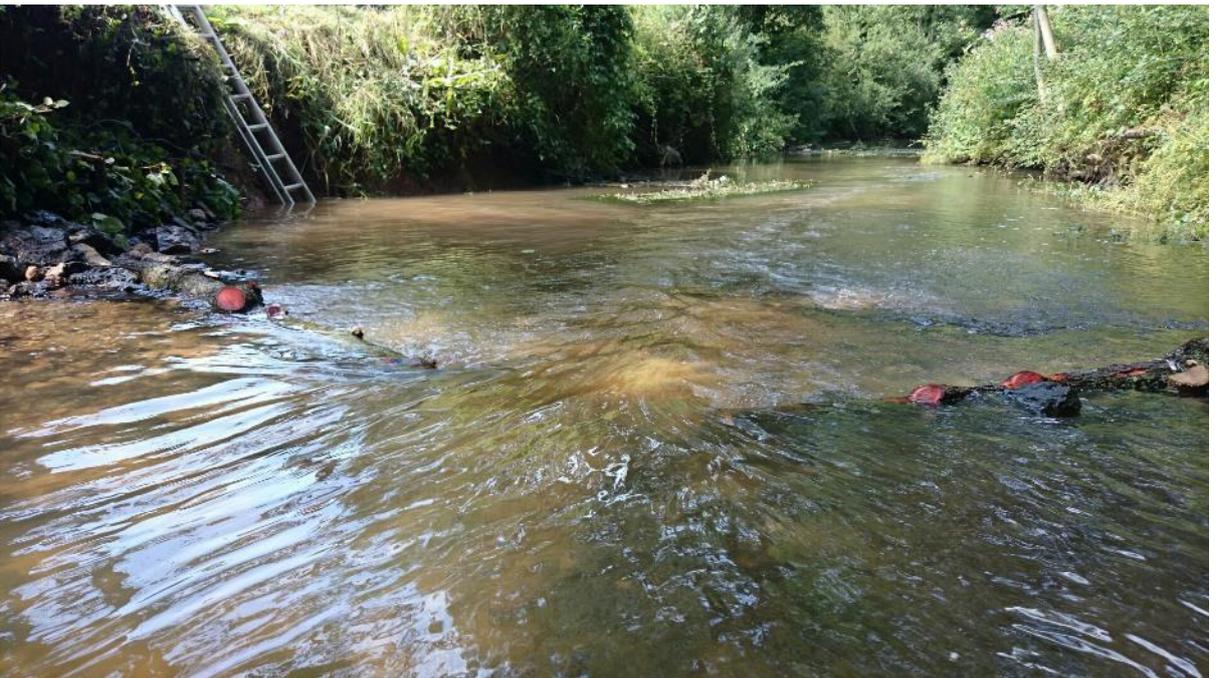
Figure 6: An example of a pair of log deflectors installed in an 'upstream V' formation (with an approximately 1m gap between them) to replace a blockstone summer weir. This arrangement has helped to scour down the bed and retain depth during low flows without impounding the river.

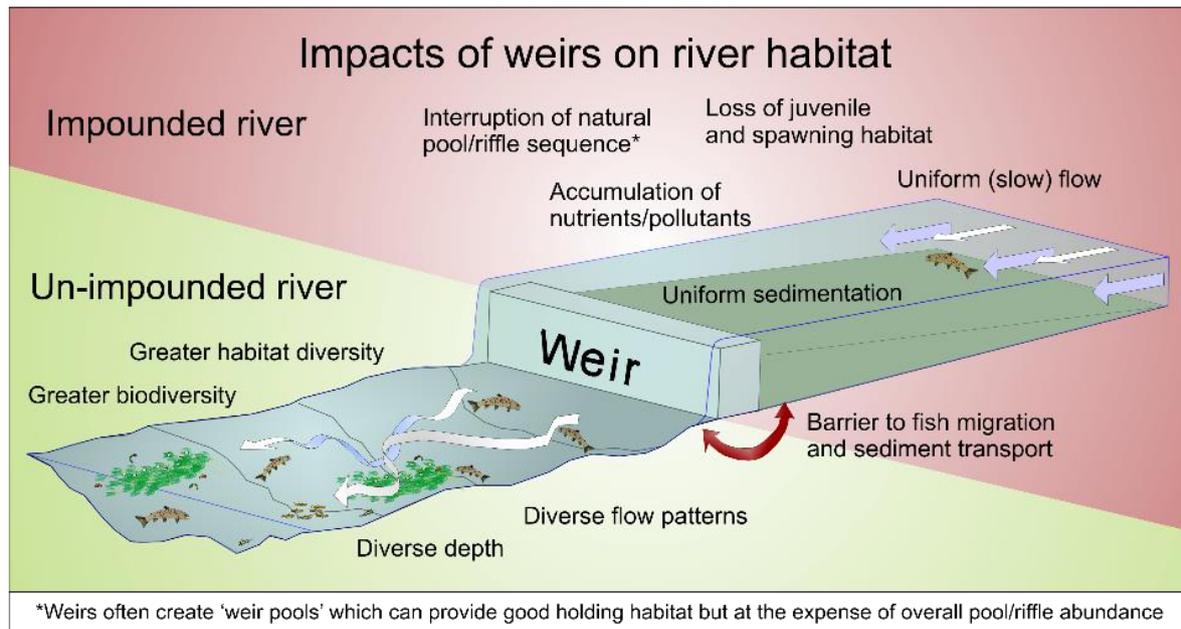
Although the weir is not necessarily a barrier to trout migration, it remains a significant obstacle for juvenile trout and smaller fish species. Whilst it is commonly believed such structures help to protect fish during low flow events by retaining sufficient depth, it is often during low flow events that weirs are at their most damaging. During low flows, obstacles that may be perfectly passable under other flow conditions can become barriers to fish passage. This can prevent fish from easily moving out of low flow environments and accessing deeper pool habitat. The slowing of flow during such events can also lead to spikes in temperature, putting undue stress on fish and other temperature-sensitive

Figure 18: An illustration highlighting the impacts of weirs on river habitat

The weir is a key limiting factor presently preventing this reach from reaching its full potential as a healthy chalk stream ecosystem capable of supporting a vibrant wild trout population. Therefore, removing the weir or at least lowering a significant portion of it to bed level should be considered a priority action for the

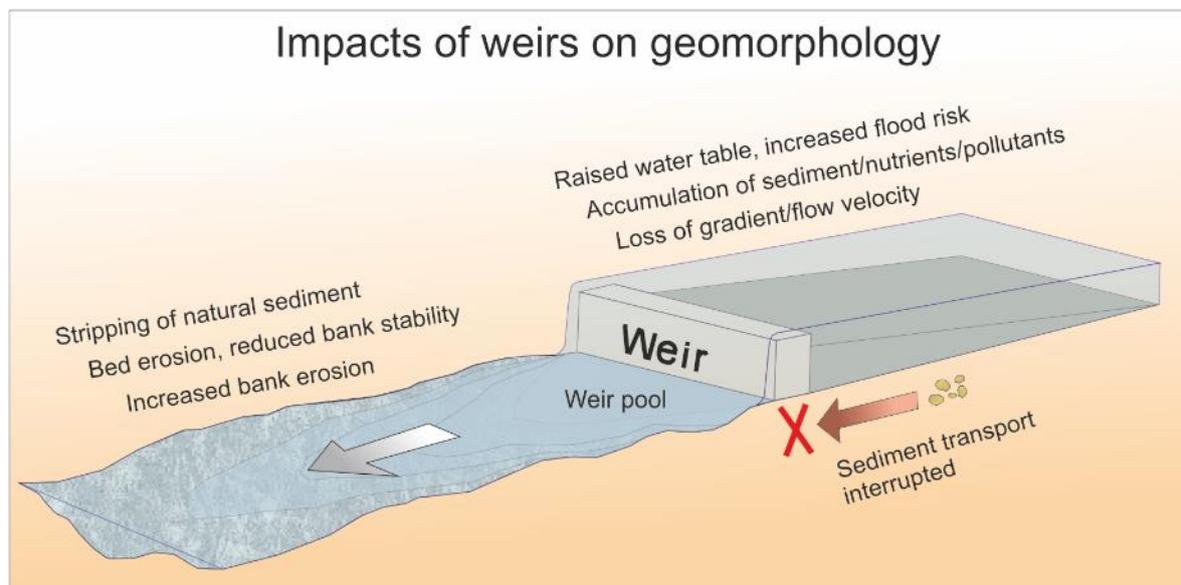
organisms. During higher flows, when the river should be at its most morphologically active, weirs can inhibit natural processes, preventing new pool habitats from forming and inhibiting the development of a natural two-stage channel. A WTT information paper, referencing scientific literature relating to impoundments and barriers to fish passage, is available on the WTT website: <http://www.wildtrout.org/sites/default/files/library/Obstructions%20information%20paper%2020082013.pdf>

Figure 19: An illustration highlighting the impacts of weirs on river morphology

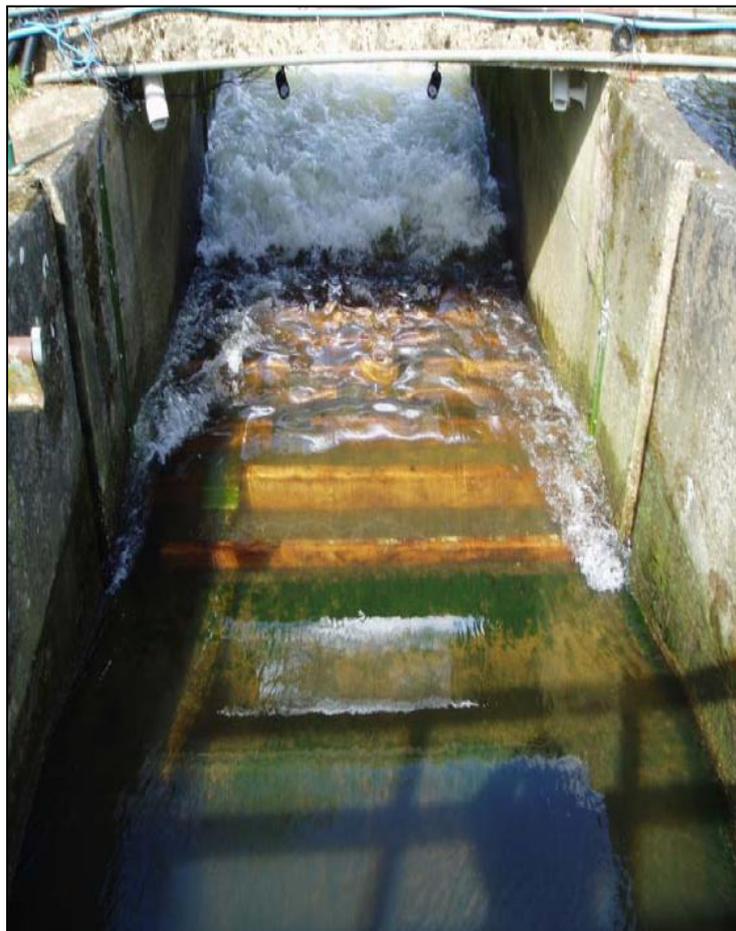
A short distance below the B1000 road bridge is a crump style EA flow gauging weir which was not observed during the advisory visit. This structure is reportedly not a complete barrier to fish passage but could nonetheless be a significant obstacle under certain flow conditions (Pers. Comm. George Horne). Ensuring that fish are able to migrate up into the TFFC waters from downstream will be of the utmost importance for safeguarding the wild trout population for the future. Some EA gauging weirs have been successfully altered with low cost baffles to make them more passable for fish and exploring the feasibility of such a modification on this weir is recommended.

Figure 25: An example timber baulk easement fixed to a crump weir

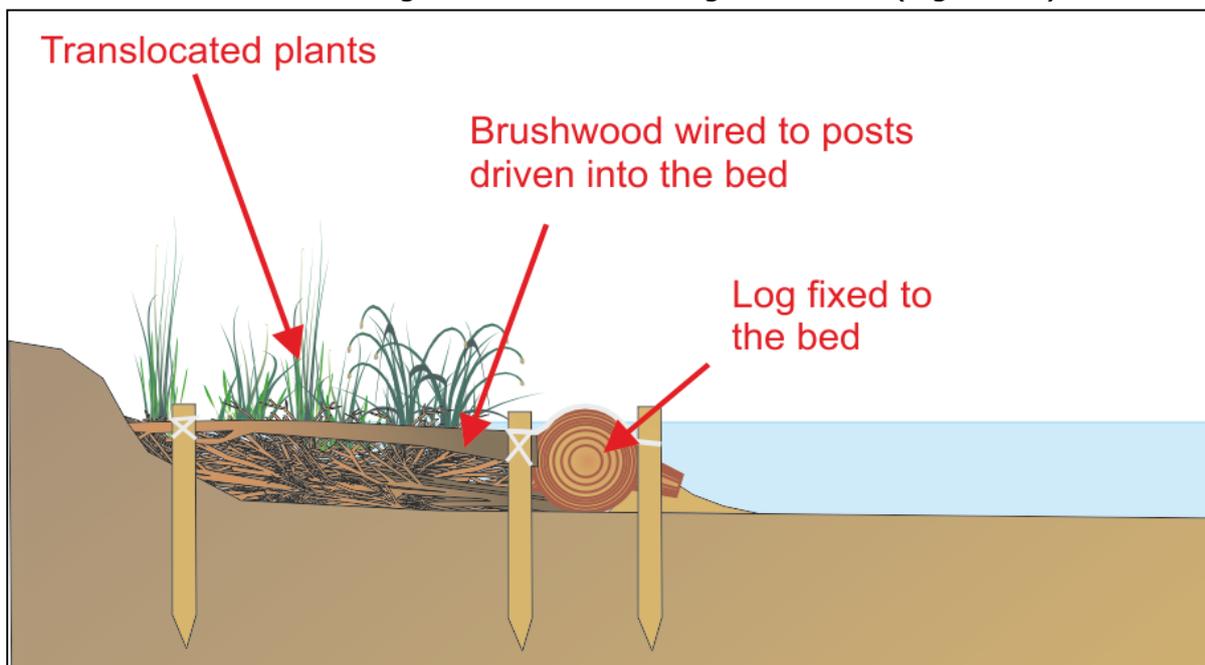
Figure 32: A drawing showing a cross section of a log and brushwood marginal berm. If densely filled and covered with local marginal turfs, such a structure makes for good angler access once fully established.

5. The recycled car tyre revetment should be removed and replaced by a more appropriate structure. For example, logs secured to the bed and back-filled with flint gravel rejects. If the cost and/or logistics of importing gravel make this option unfeasible, another option could be to backfill with brushwood until dense-enough to walk on and secure with cross-braces cut from straight branches. Translocated marginal turfs could be planted over the structure and within a season it should be established enough to withstand being walked on (Figure 32).
