River Monnow, Walterstone, Herefordshire

An Advisory Visit by the Wild Trout Trust, May 2014

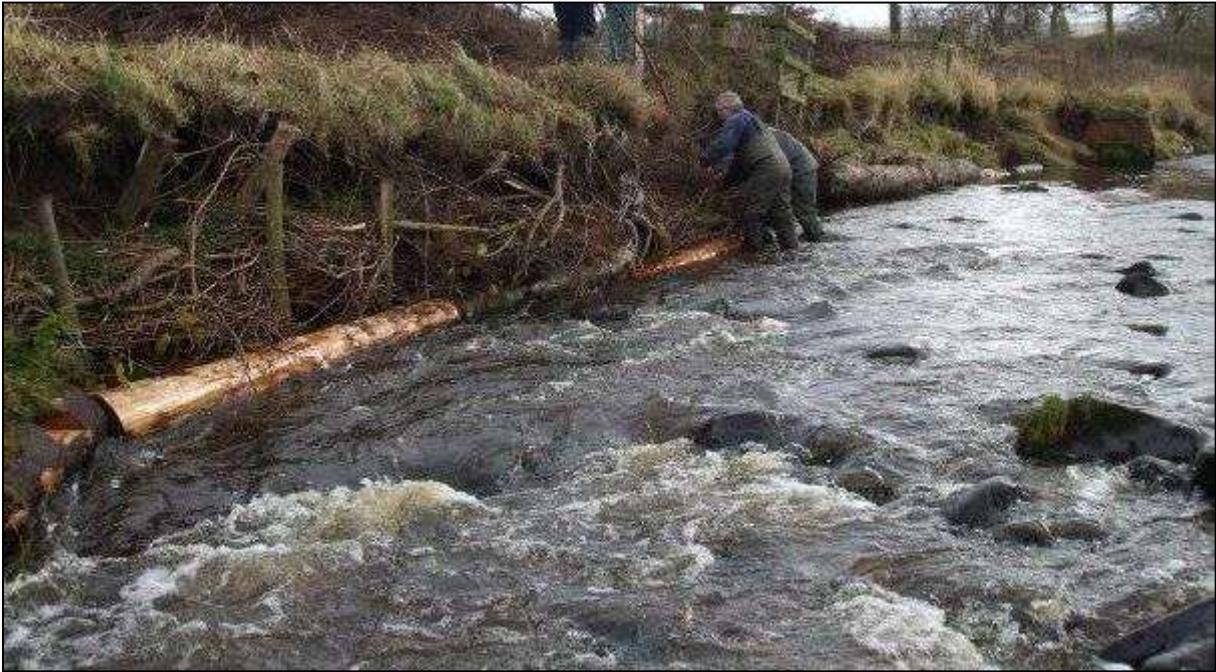
Figure 23: A brushwood bank protection revetment being installed on a spate-prone river

3. In areas where excessive erosion is deemed to be a problem, brushwood won from on-site tree works could be used in combination with live willow to stabilise the bank (see example Figures 19 and 20). Densely-packed brushwood is very effective at absorbing energy from the flow and locally slowing water velocity, this in turn encourages deposition of sediment. Live willow 'whips' (thin, straight sections) and live willow stakes driven into the bank will, if successfully planted, continue to grow and strengthen with time. Willow whips and stakes can probably be won from existing bankside willows.

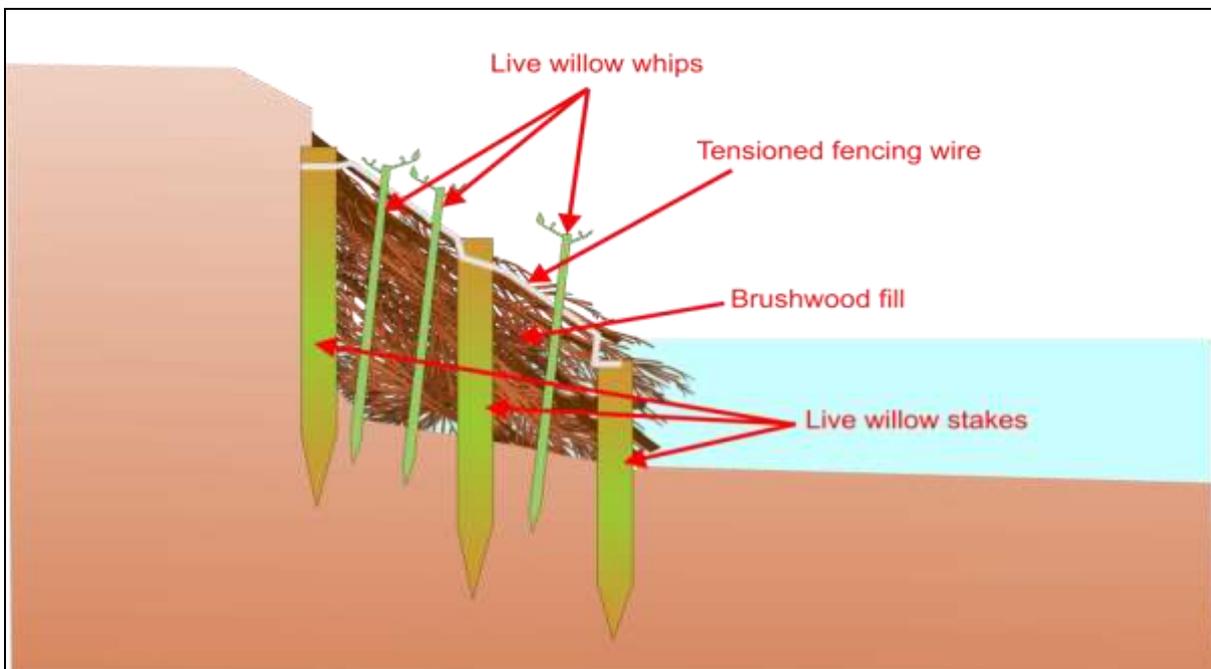
Figure 24: A cross section illustration of a brushwood erosion protection installation with live willow

Willow can be cut and planted at any time of year but the technique is most successful if undertaken in winter or early spring when the willow is still dormant.
