**Walkover Habitat Survey**  
**Nettleham Beck, Lincolnshire**  
**November 2016**

This report is the output of a site visit undertaken by Tim Jacklin of the Wild Trout Trust to the Nettleham Beck, approximately 5km north east of Lincoln, on 28<sup>th</sup> and 29<sup>th</sup> November, 2016. Comments in this report are based on observations on the day of the site visit and discussions with Marie Taylor (Lincolnshire Rivers Trust) and David Hutchinson (Environment Agency).

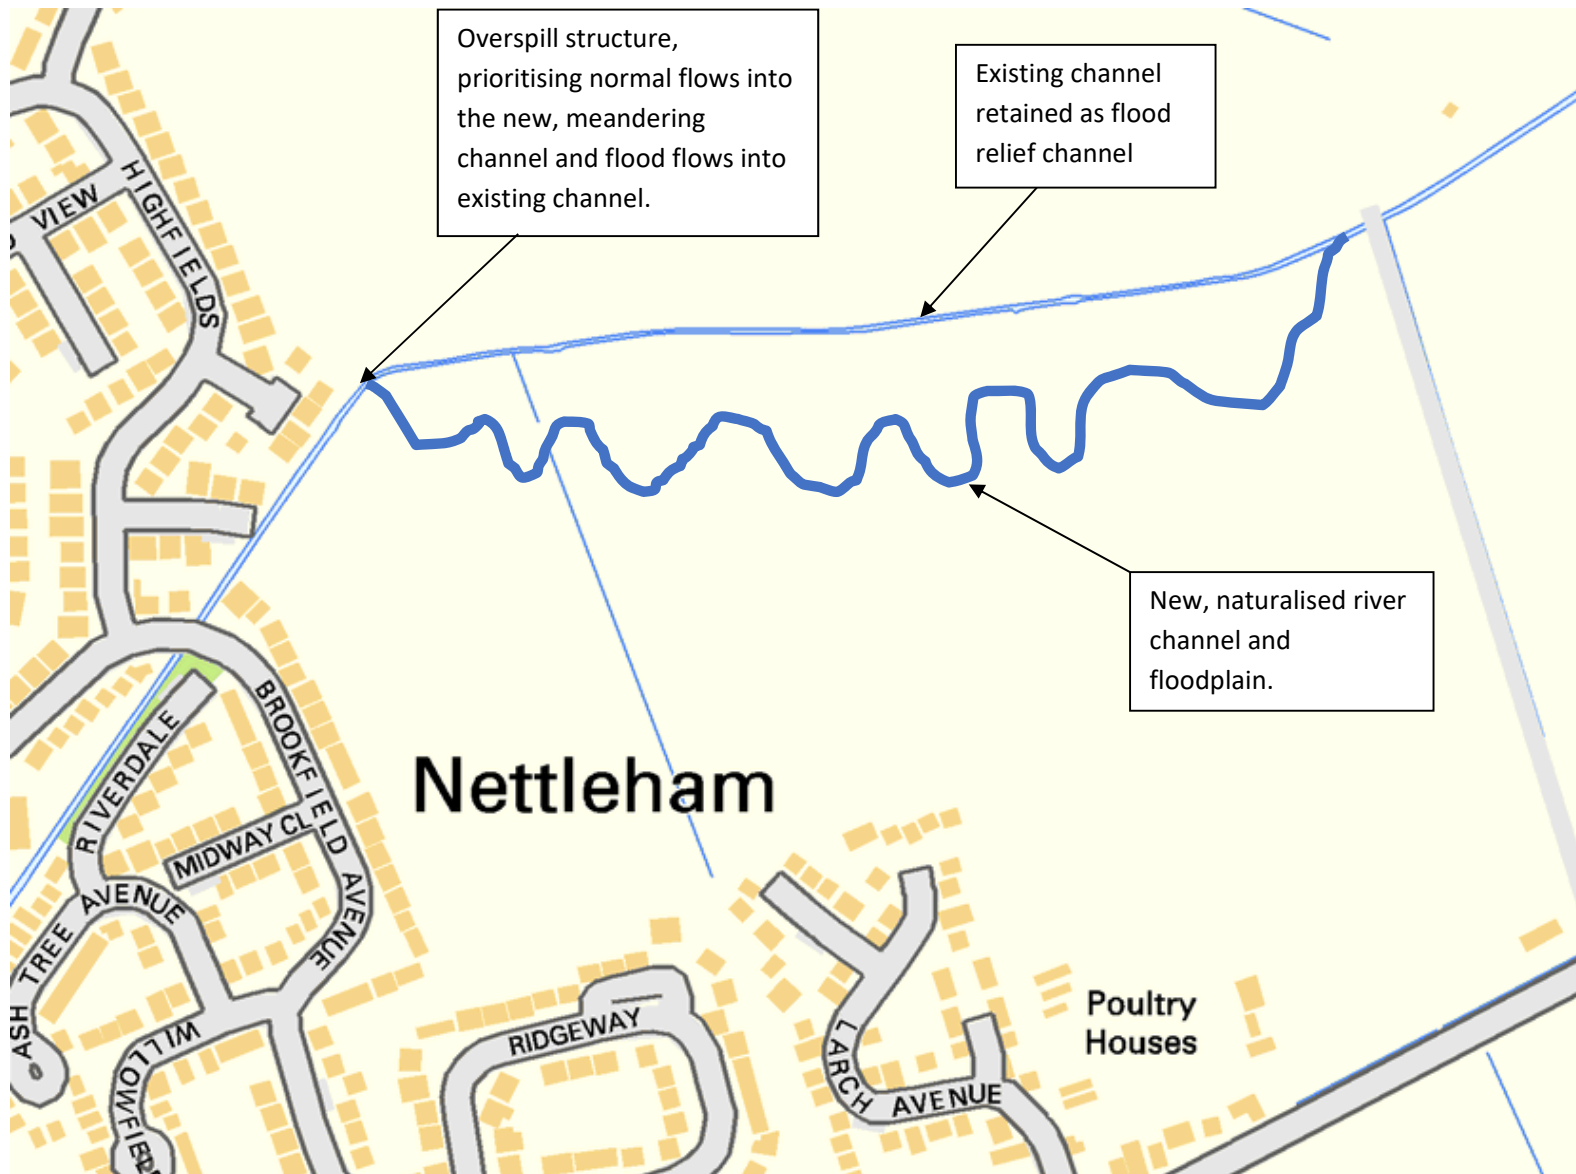
Figure 1 Concept for naturalised beck channel downstream of Nettleham, providing gains for biodiversity, flood risk reduction and public amenity. For illustrative purposes only, not to scale.

There is good potential in this area for a river re-naturalisation project, creating a new channel approximately along its historic course using the principles of natural river geomorphology; this concept is illustrated in Figure 1. A number of similar projects have been carried out elsewhere and further examples are provided in Appendix 1. The advantages of such a project in this location include:

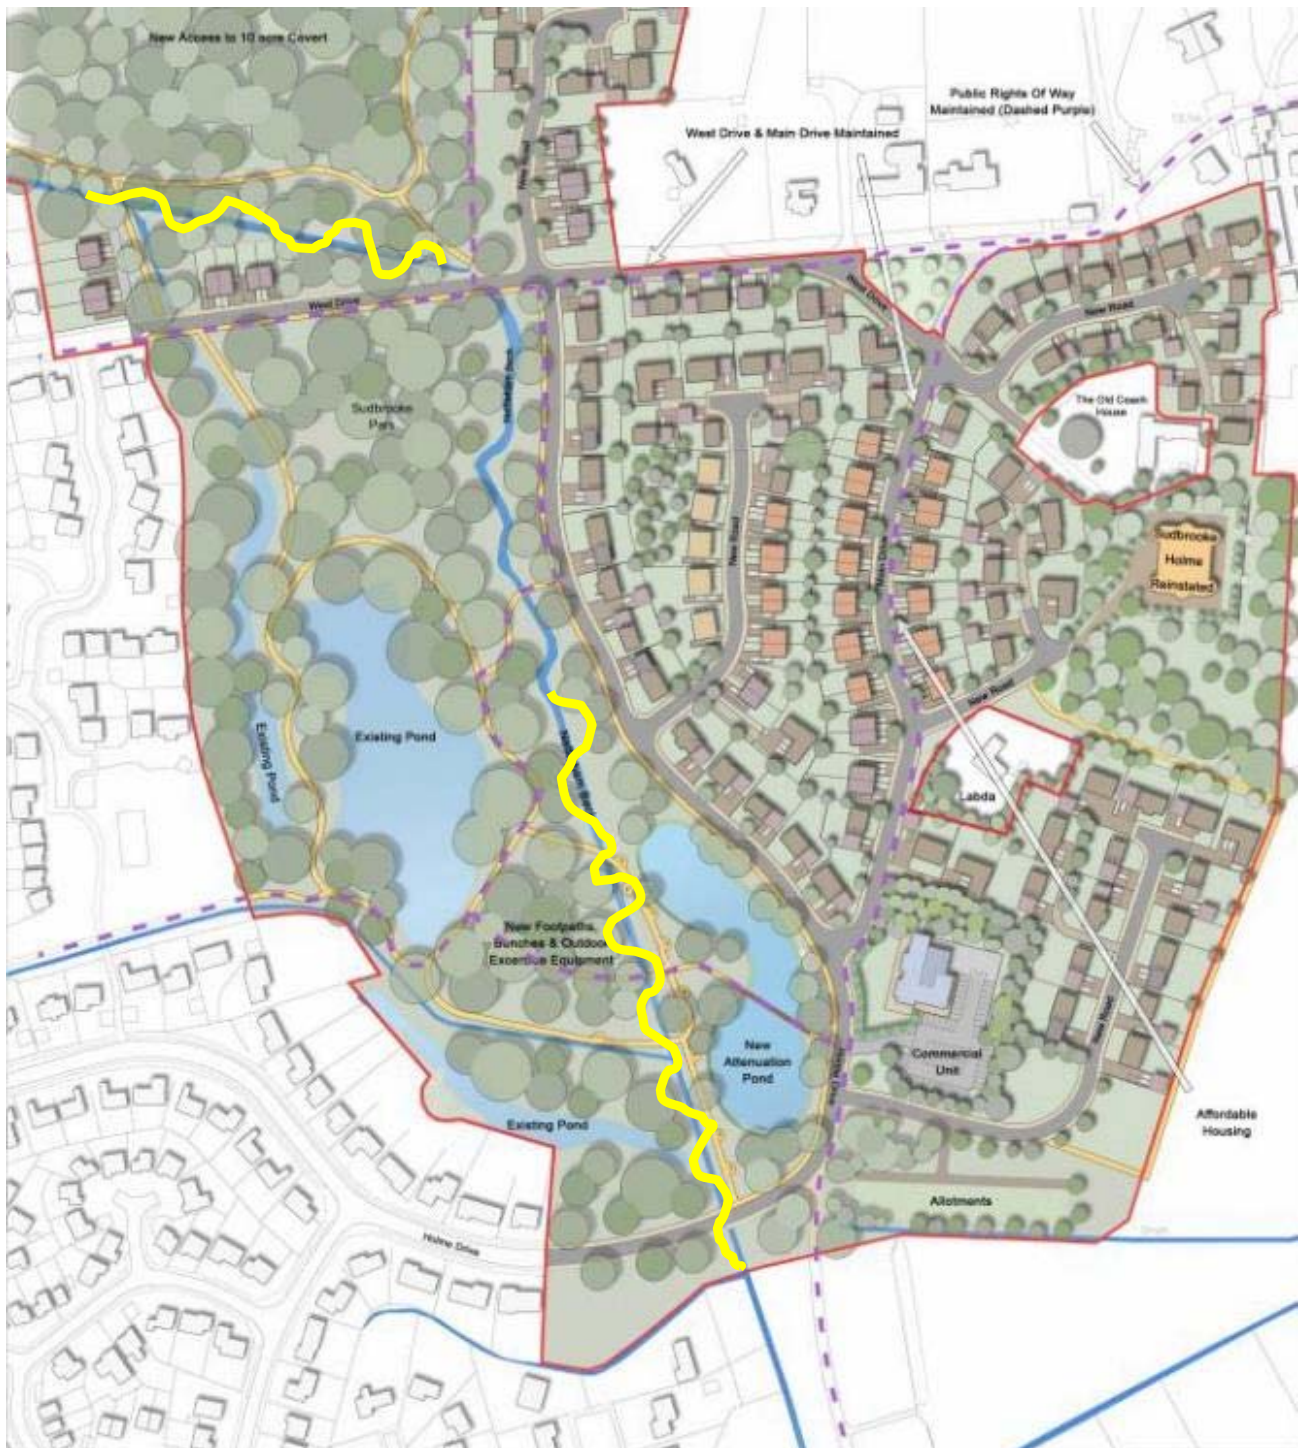
Figure 2 Plan of proposed development in Sudbrooke Park from <http://parklands-sudbrooke.co.uk/>. The superimposed yellow lines indicate the concept of re-meandering the beck through this reach, enhancing biodiversity, potentially reducing flood risk and providing sustainable drainage benefits (for example, integrating the proposed attenuation pond into the floodplain of the beck). For illustrative purposes only, not to scale.

The area within Ten Acre Covert and Sudbrooke Park has good potential for a river re-naturalisation project, restoring meanders and floodplain connectivity using the principles of natural river geomorphology; the concept is illustrated in Figure 2. A number of similar projects have been carried out elsewhere and examples are provided in Appendix 1. The advantages of such a project in this location include:

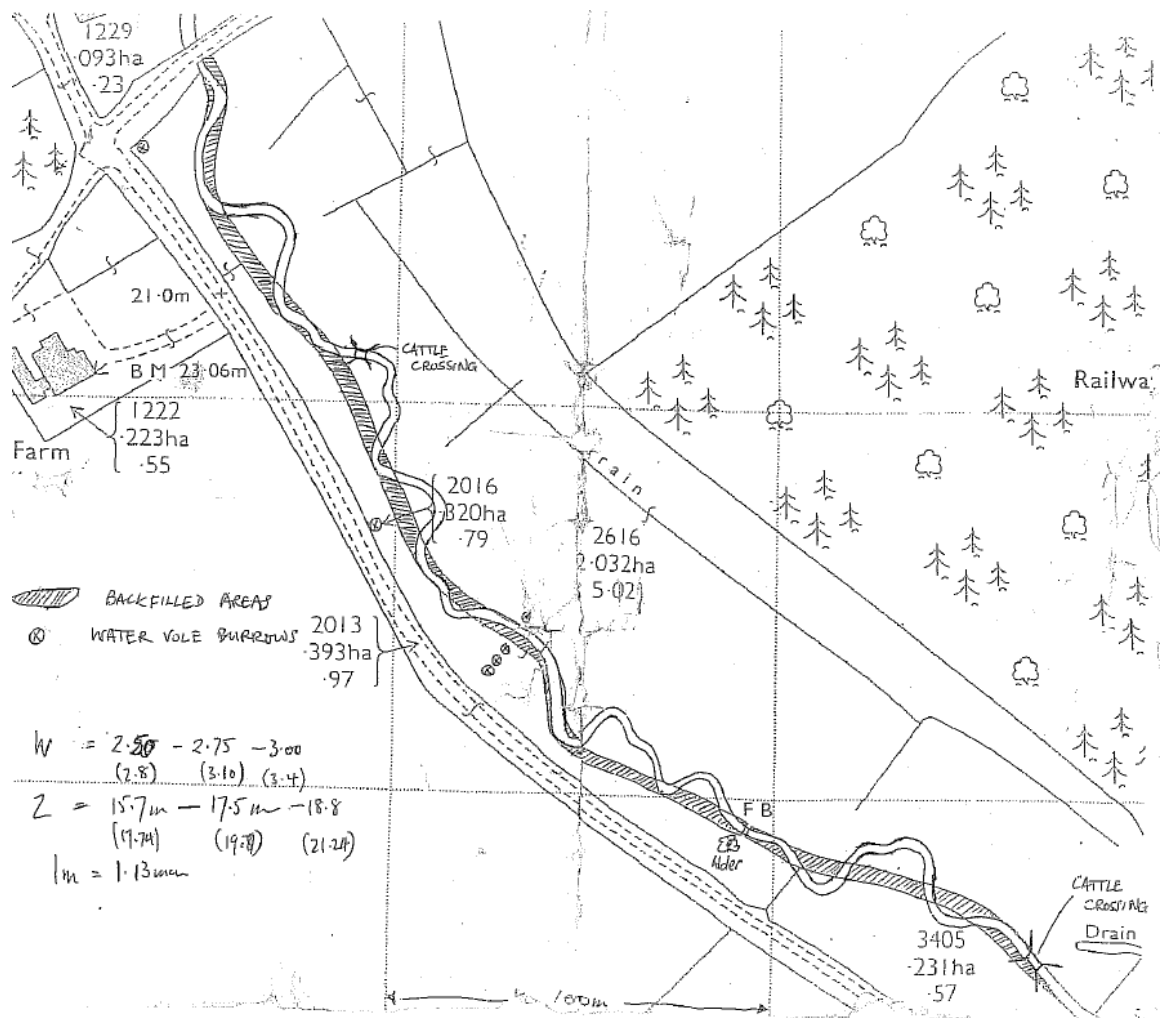
Figure 3 Plan of river re-naturalisation project carried out on River Glaven, Hunworth, Norfolk. Shaded line is the original engineered channel, open line is the new, restored course. The engineered channel was back-filled with spoil excavated from the new channel. (River flowing SE to NW).

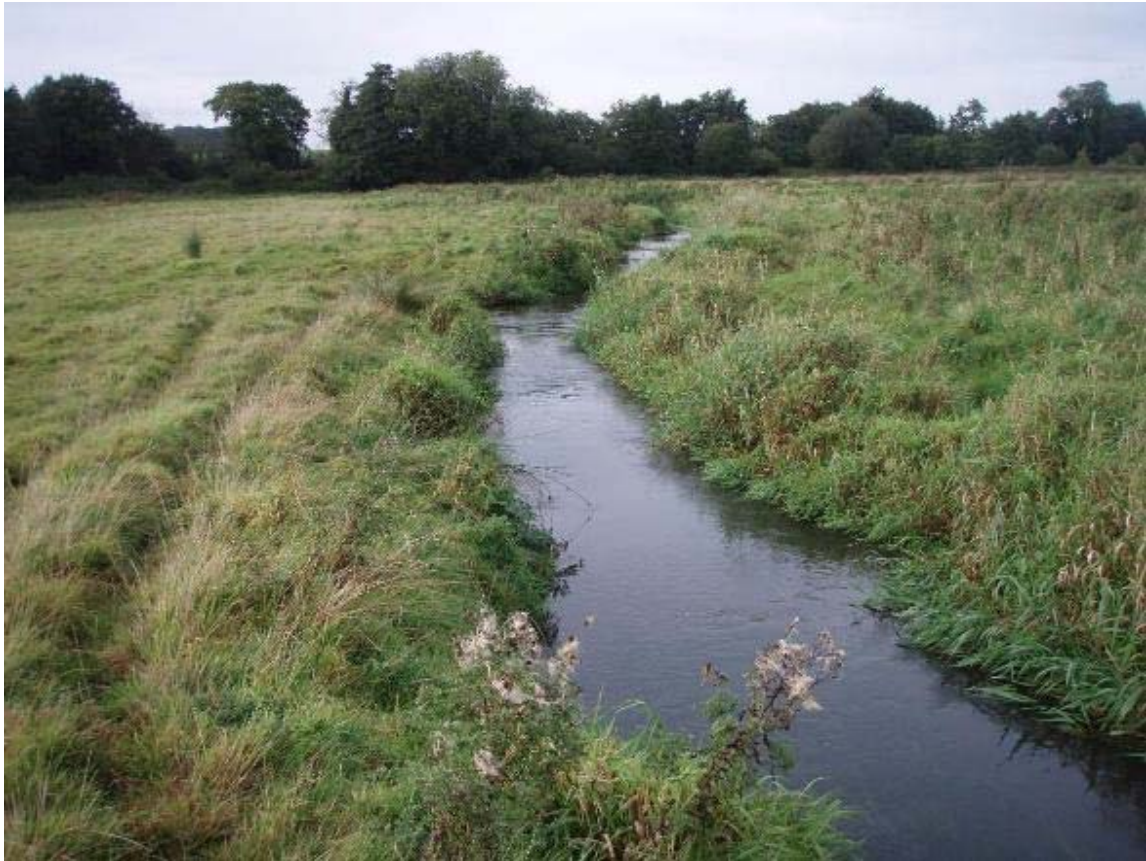
**Photo 39 Typical condition of River Glaven pre-restoration – straightened, incised channel disconnected from the floodplain and lacking a pool-riffle sequence.**

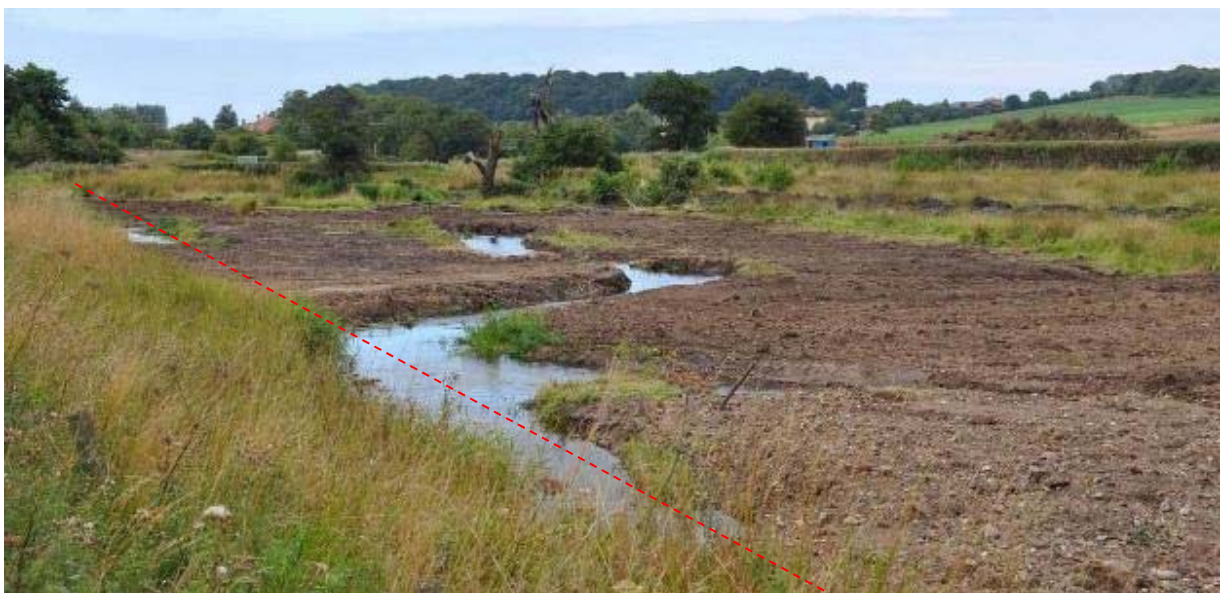
**Photo 40 River Glaven at Hunworth immediately post-restoration. Original channel course indicated by dashed line. (Picture: Ross Hadow)**

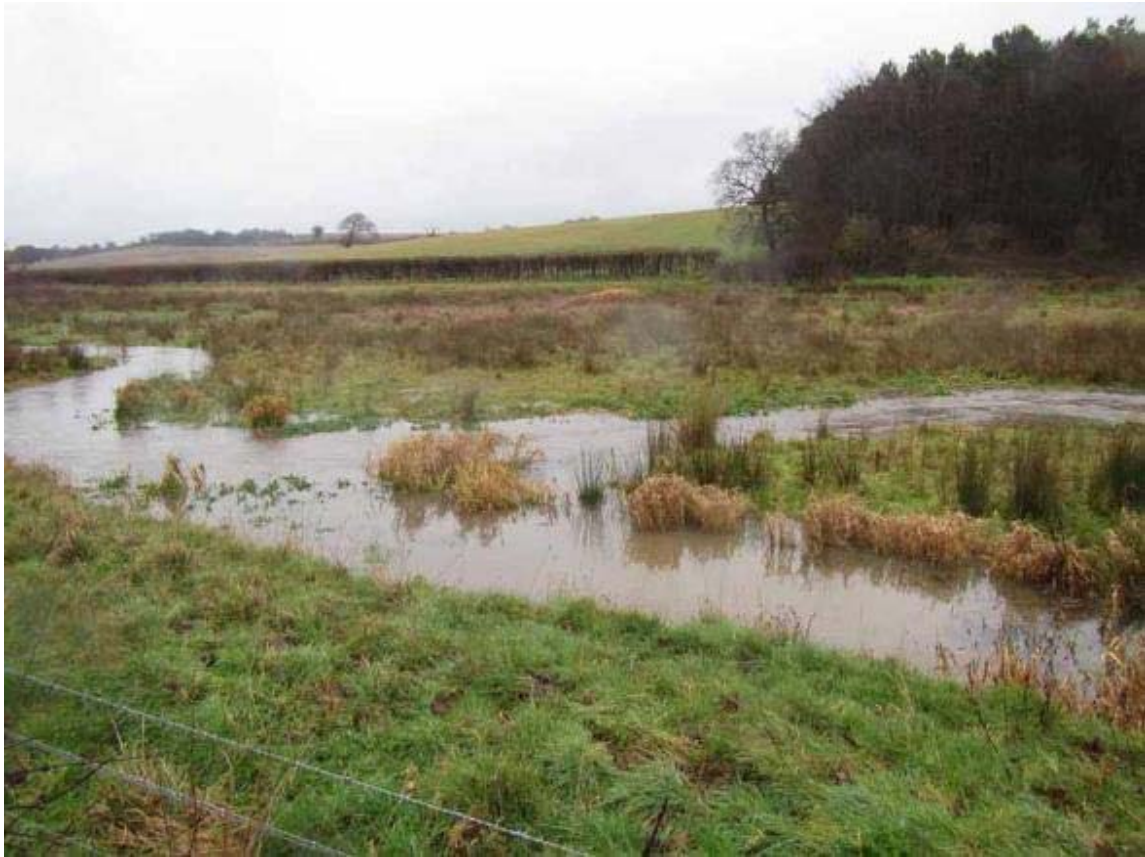
**Photo 41 River Glaven at Hunworth four years post-restoration, in flood conditions, illustrating flood storage function of the reconnected floodplain (Picture Ross Haddow).**

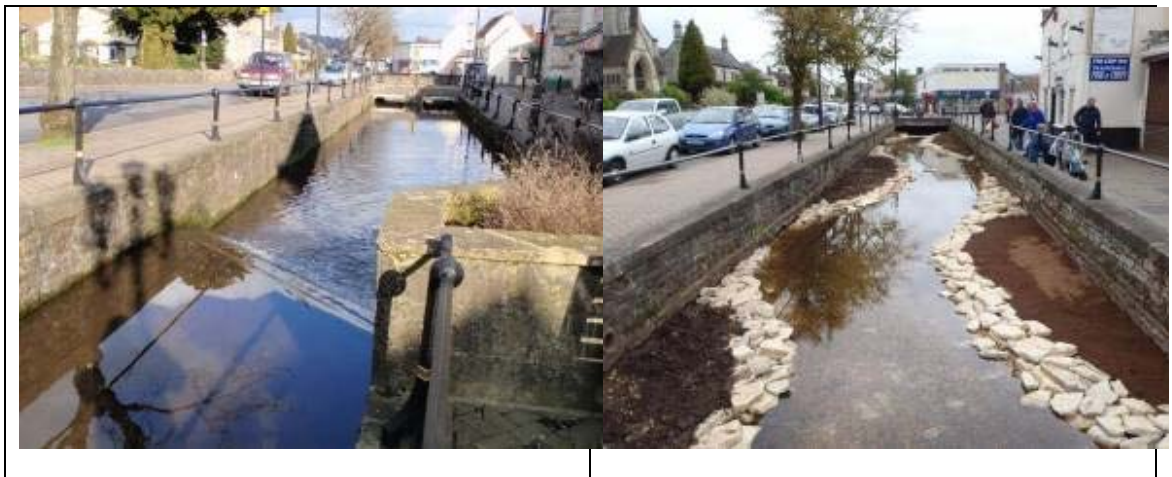
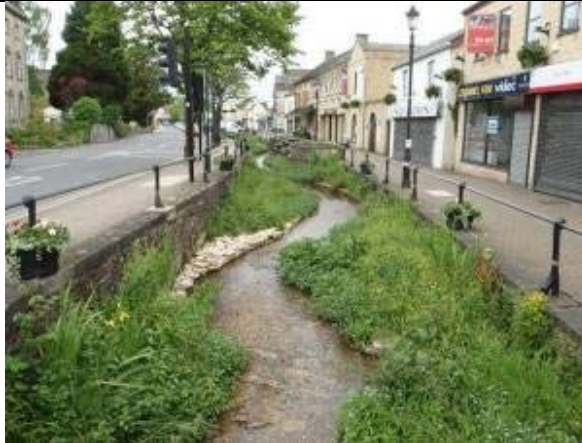
River restoration carried out in Midsomer Norton illustrating the principles of narrowing the channel with low, vegetated shelves. Top left (before), top right (during) and left (after 1 year).

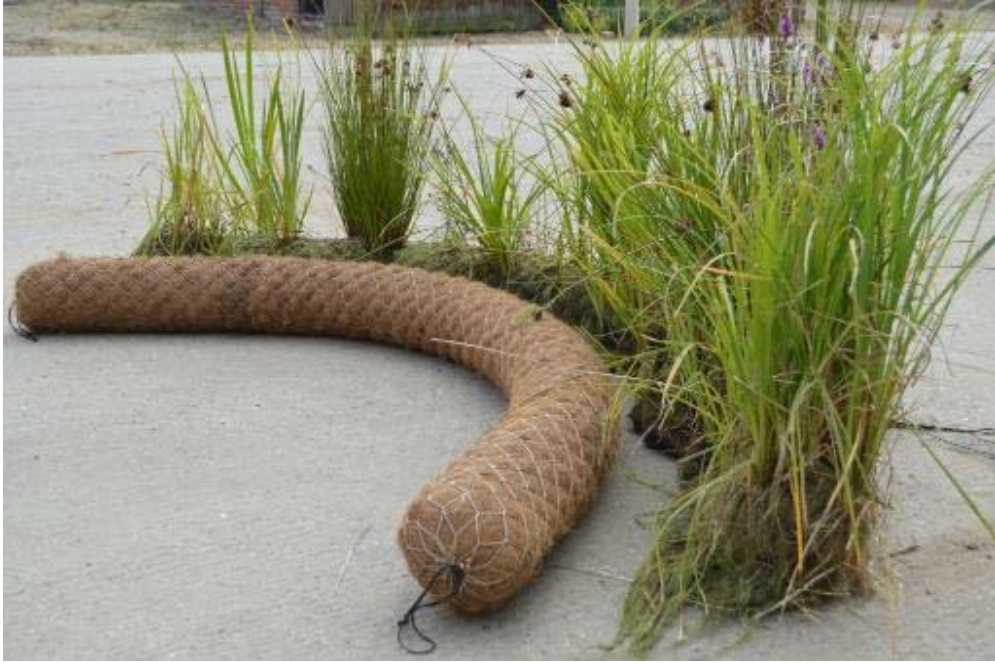
**Photo 42 Coir logs can be used to soften the margins of engineered channels. Picture: Salix Products.**

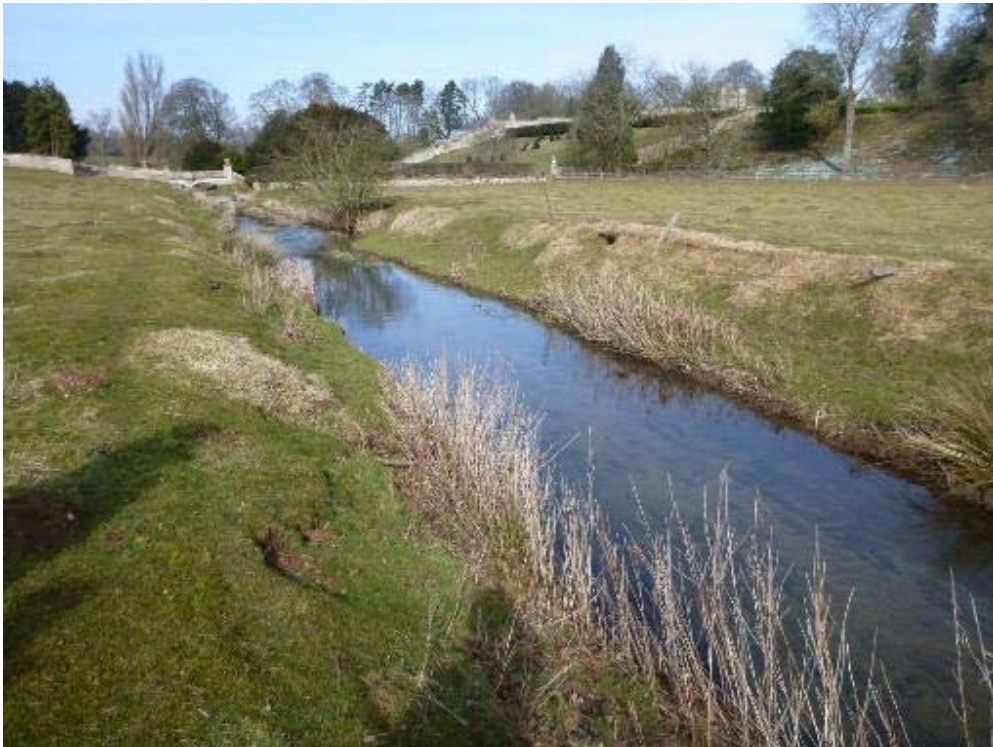
**Photo 43 River Witham, Easton (before works).**

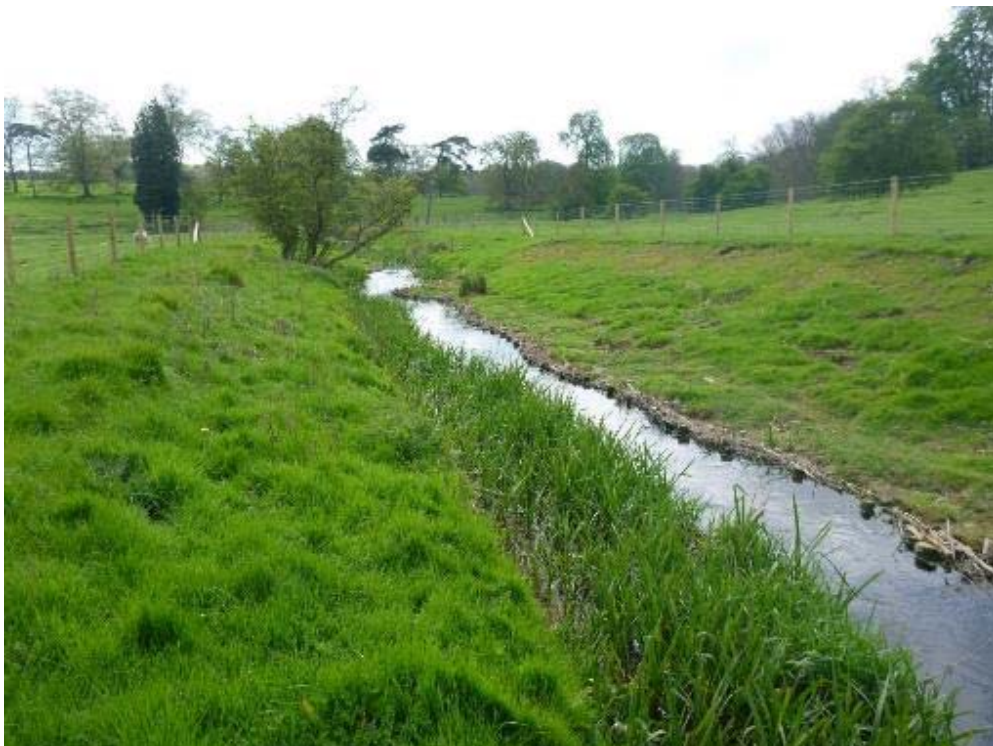
**Photo 44 River Witham, Easton (after channel narrowing works). Note that the embankment has been graded to create an inset flood plain retaining high flow capacity.**

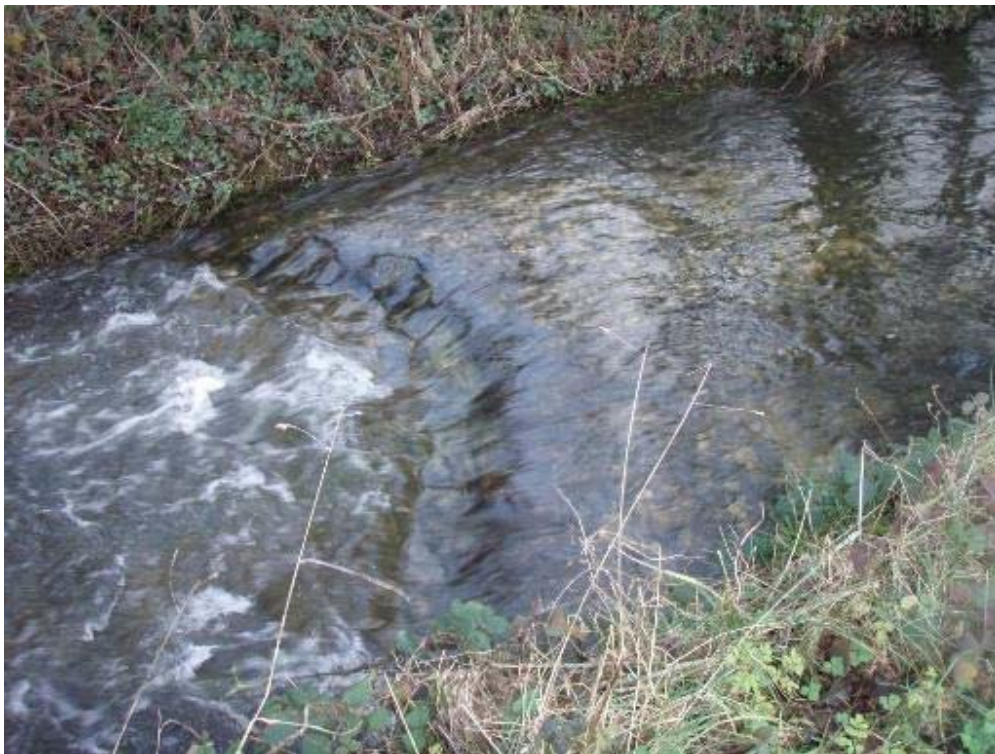
**Photo 45** Low, stone crescent weir in a previously drained, lowland limestone stream in Ireland. Note the focus of stream energy to scour the bed downstream.

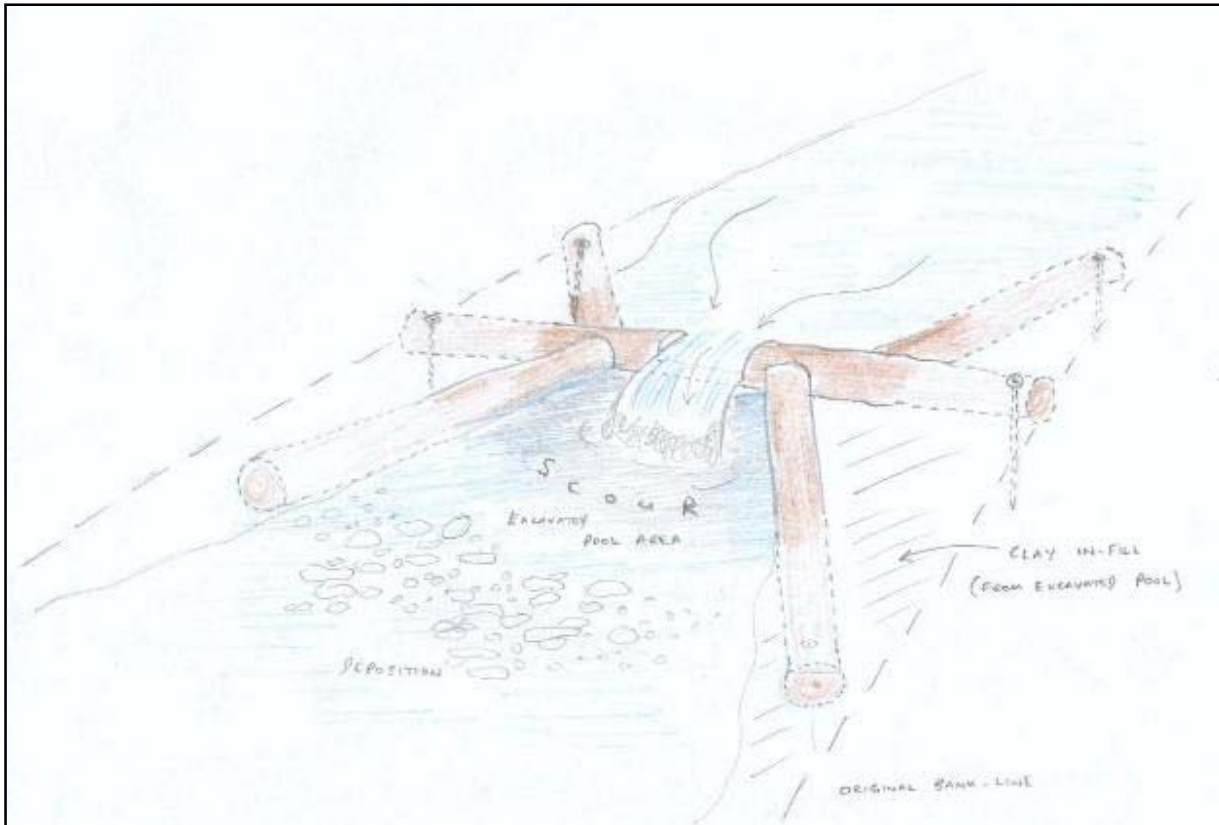
**Figure 4 Schematic of a K-dam, a log built structure to create pool habitat in straightened reaches.**

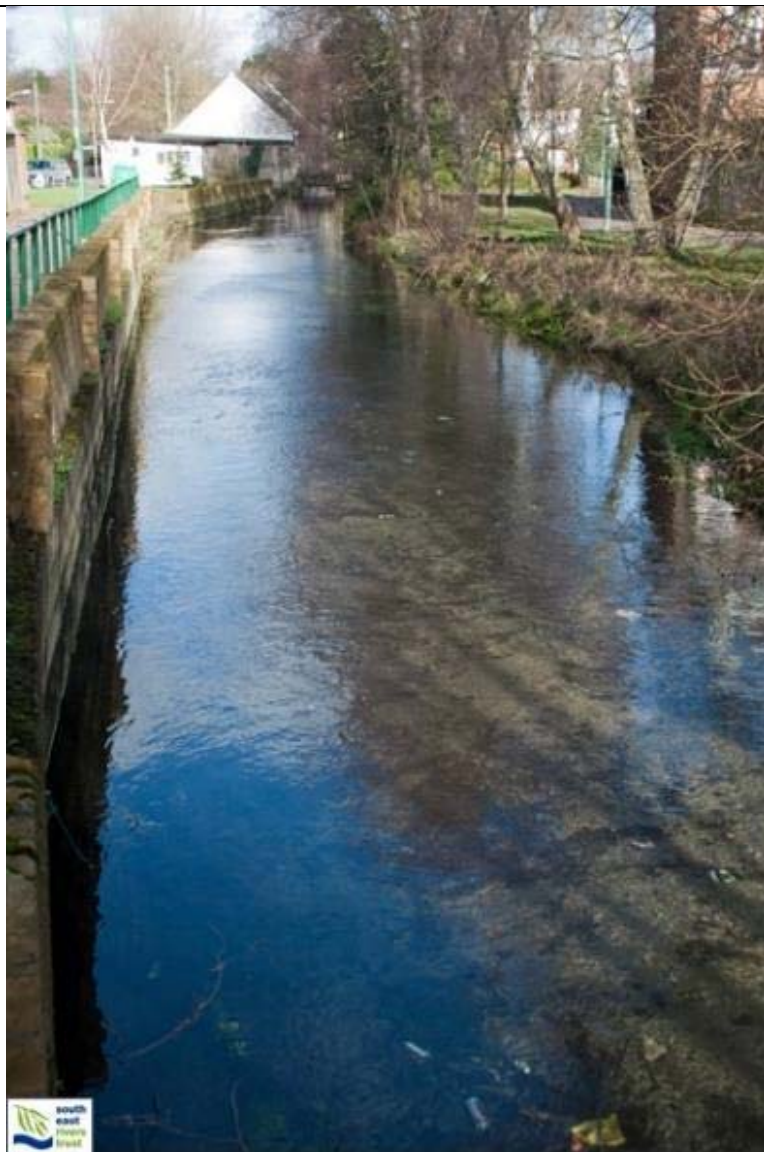
Photo 46 River Wandle, south London, upstream of weir, before weir removal  
(Picture: South East Rivers Trust)

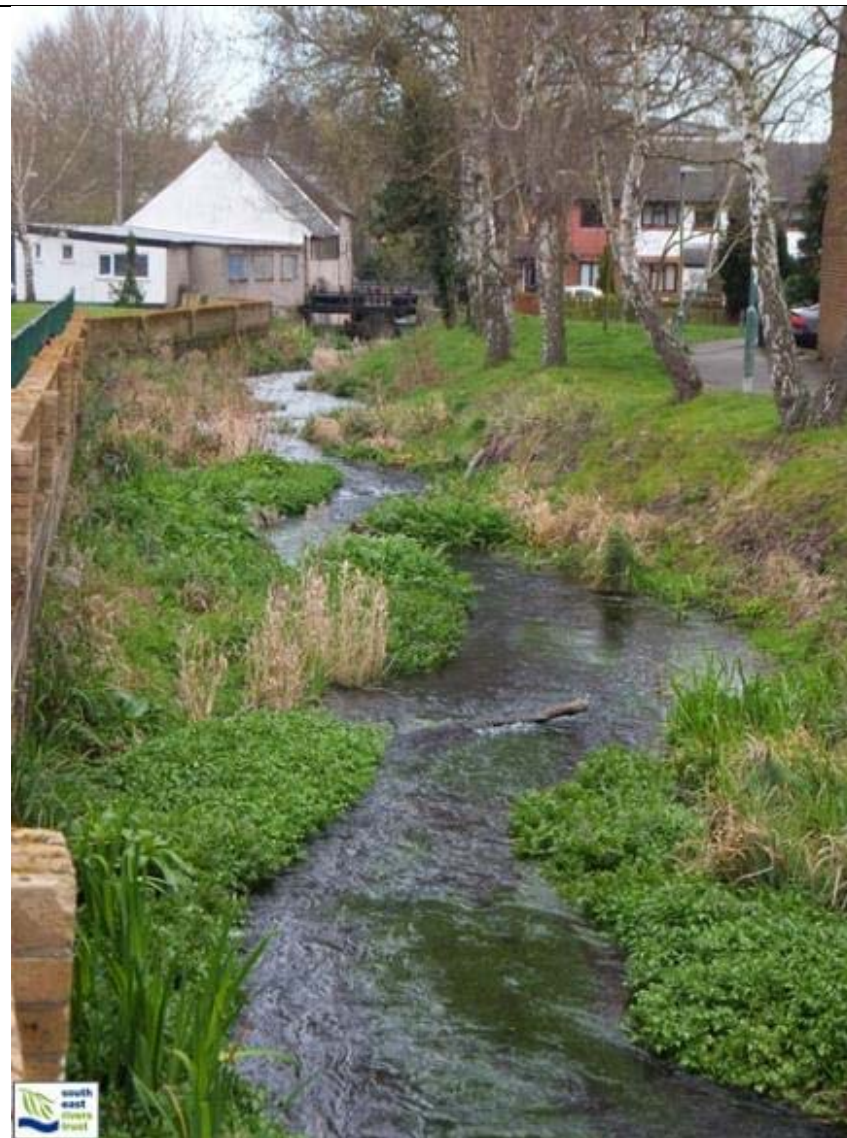
Photo 47 River Wandle, upstream of weir, some months after weir removal  
(Picture: South East Rivers Trust).
