**Advisory Visit**

**River Onny, Shropshire**

**November 2017**

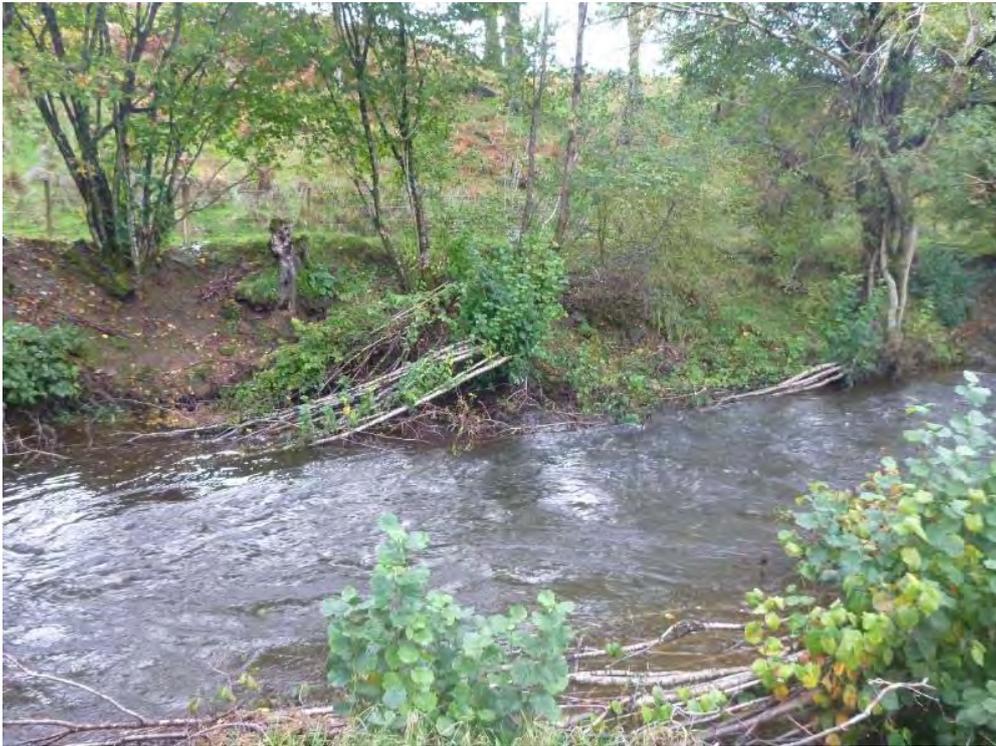
*Photo 17 Hinged trees providing excellent fish cover.*

- Assess the trees on the left bank for risk of toppling and damaging the bank alongside the road. Make a plan for staggered coppicing over a few years to reduce this risk and the need for invasive bank repairs. Likewise, repair presently small areas of damage to bank revetments to prevent more extensive problems and interventions.
- Hinge smaller trees into the river margins to create cover for fish (Photos 17 and 18).

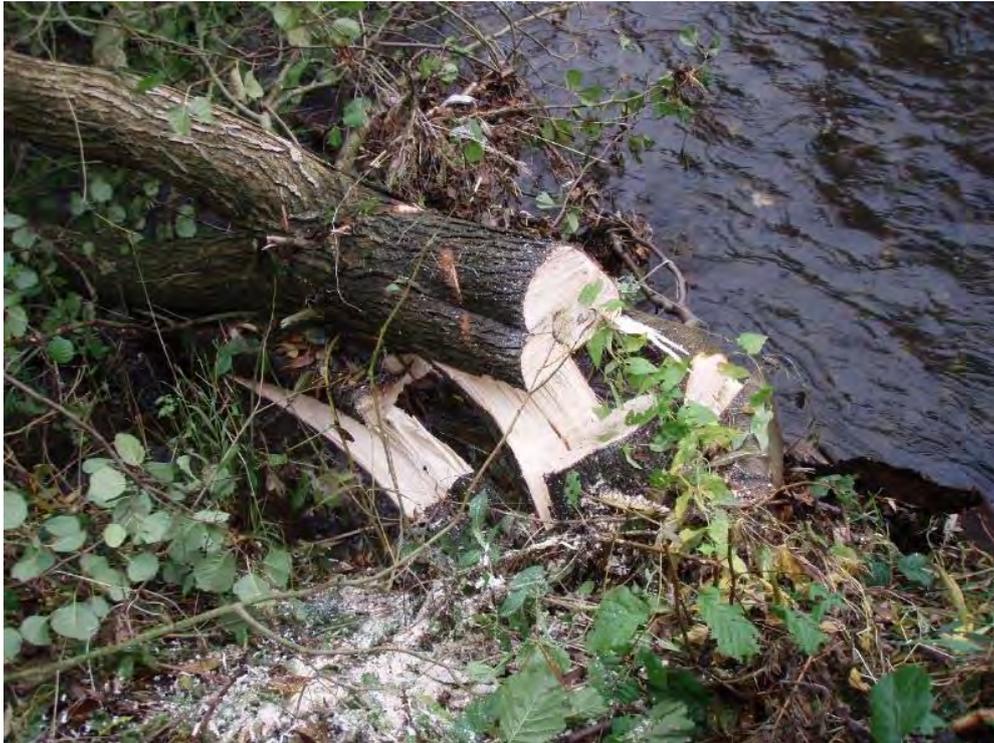
*Photo 18 Partial cut to allow tree to be laid into the river.*
