Advisory Visit

Oxfolds and Costa Beck, North Yorkshire

June 10th 2010

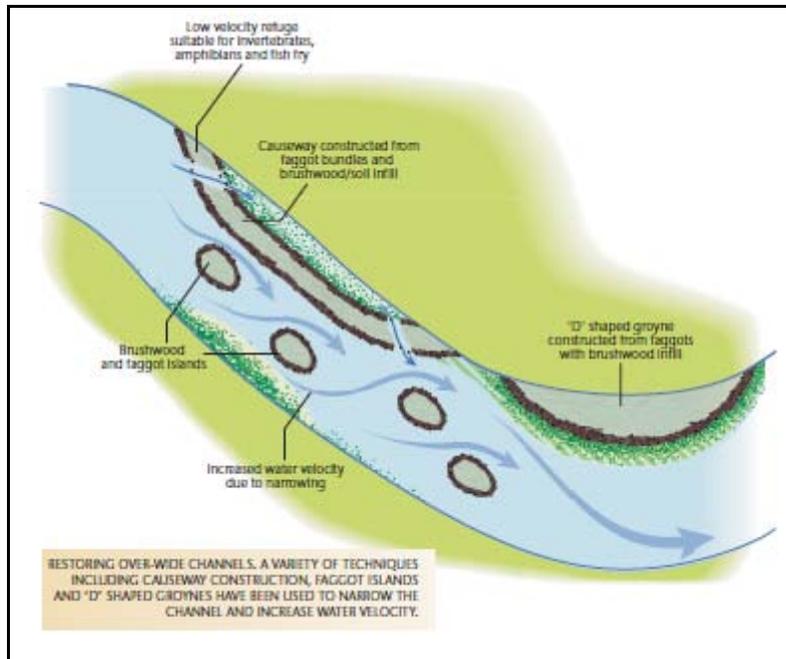
Figure 3 Channel narrowing options – see Chalkstream Manual for full details

- Channel narrowing to speed up the flow rates. This can be achieved using the methods described in the Chalkstream Habitat Manual (e.g. cut-and-fill to create a two-stage channel). River widths upstream of the gauging station can be used as a guide. (Figures 2,3; Photo 14)

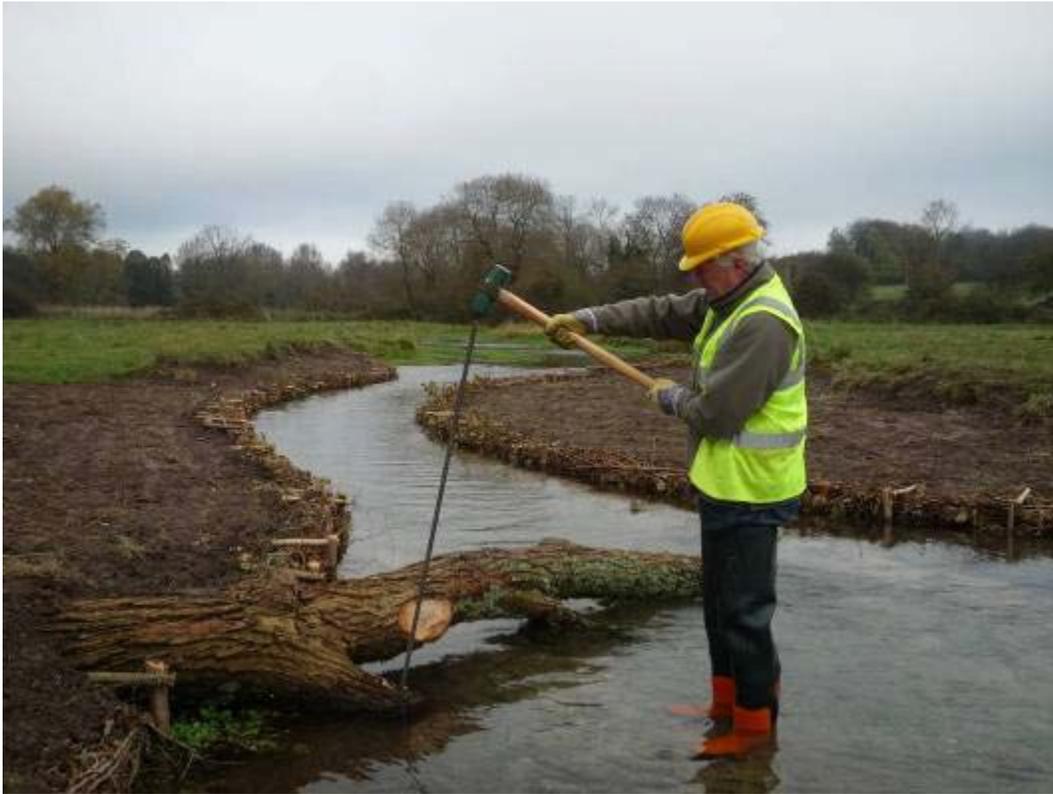
Photo 14 Recently narrowed channel and woody debris installation, River Meon, Hants.

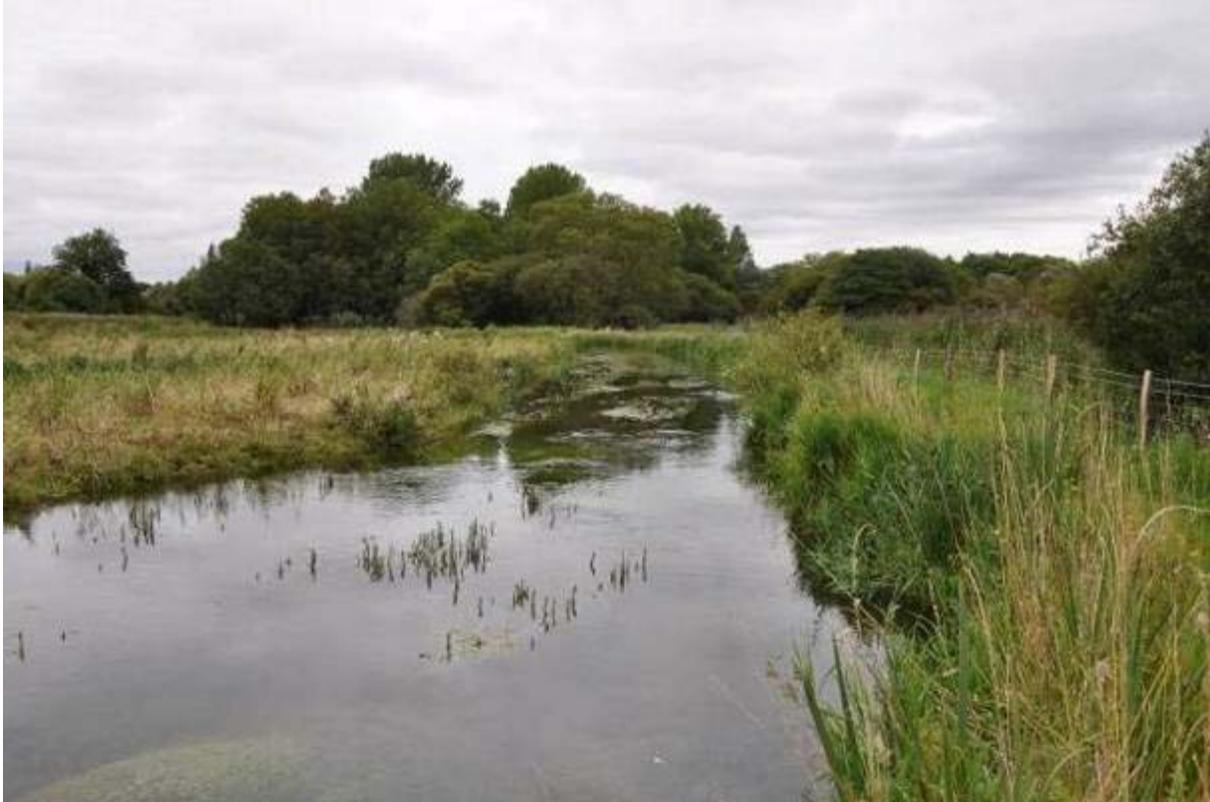
Photo 15 (Before) Channel narrowing upstream and deep pool dug to energise river and create diverse habitat for conservation and fishery – Slight gradient and mixed substrates: main channel Itchen – Winnal. (Picture Dr. Nigel Holmes)

Another method of rapidly remodelling a river channel is simply using an excavator to create pools and then use the spoil to make 'shoulders' upstream of the pools to maintain scouring flows. This technique was pioneered by Dr. Nigel Holmes and is suitable for rivers with very stable flows such as Costa Beck. It has the advantages of being quick, cheap and having no net import of materials (hence maintaining overall channel capacity). (Photos 15, 16).

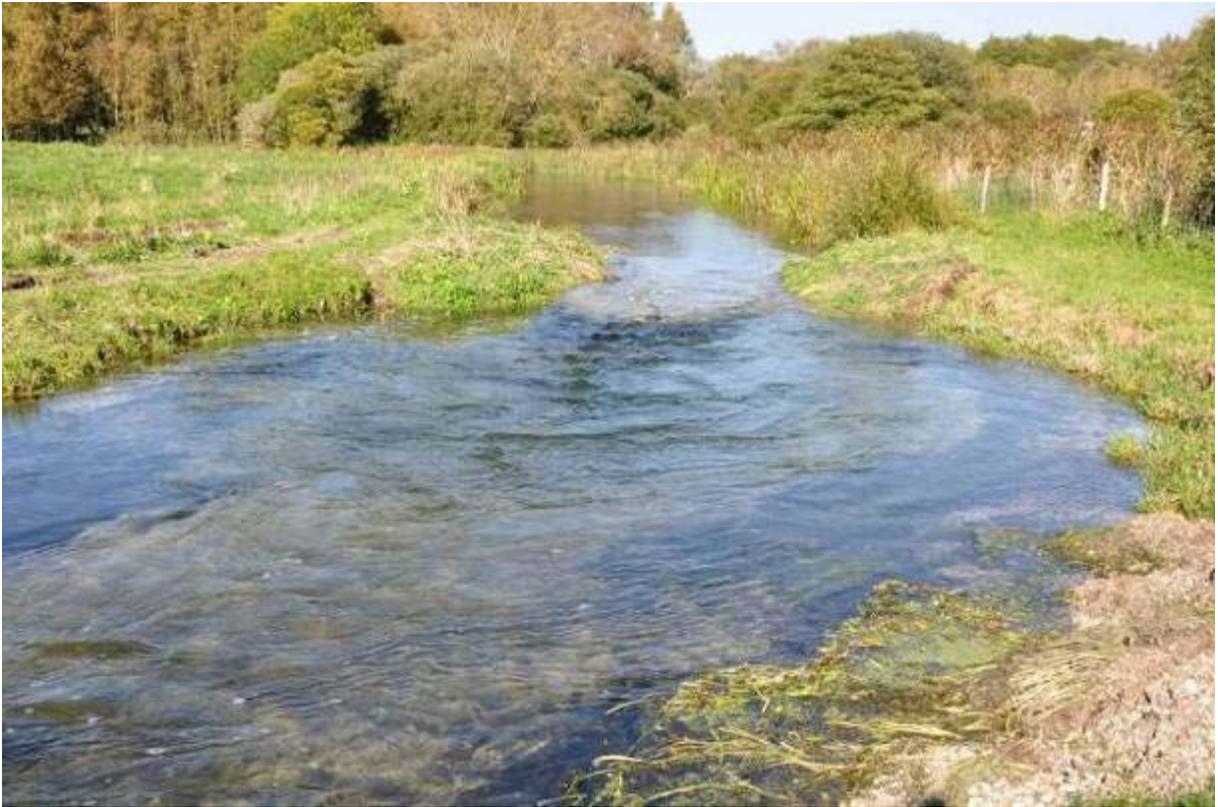
Photo 16 (After) Channel narrowing upstream and deep pool dug to energise river and create diverse habitat for conservation and fishery – Slight gradient and mixed substrates: main channel Itchen – Winnal. (Picture Dr. Nigel Holmes)
