Project Proposal
River Peffrey, Ross and Cromarty
March 2011

This report is the output of a site visit undertaken by Tim Jacklin of the Wild Trout Trust to the River Peffrey on 24-25th March, 2011. Comments in this report are based on observations on the days of the site visit and discussions with Simon McKelvey (Director, Cromarty Firth Fisheries Trust and Conon District Salmon Fisheries Board), Marcus Walters (Moray Firth Sea Trout Project Officer) and Merryl Norris (British Trust for Conservation Volunteers).

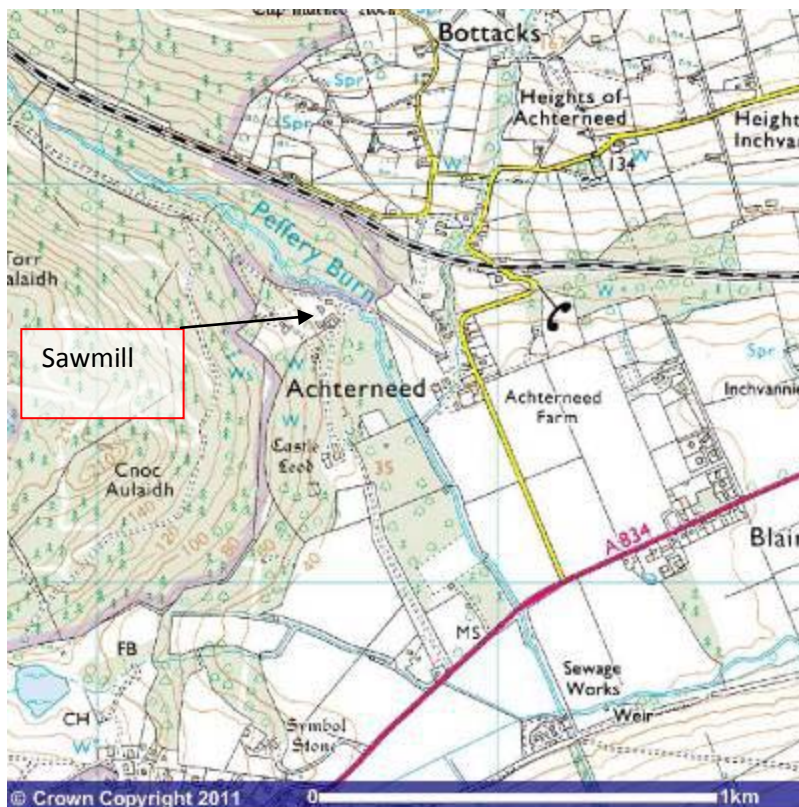
3.1 Sawmill to River Gauging station (Section B – RRC report)

The river channel gradient here reduces from approximately 1 in 50 (2%) on the section upstream of the sawmill, down to 1 in 160 (0.62%). From the sawmill bridge (NH 48661 59671) downstream, this section has clearly been straightened and probably moved from its original course (RRC, 2010). Stone revetment is present in places as are stone embankments or levees, particularly along the LHB adjacent to arable fields.

The RHB upstream of the A834 road is wooded and provides some scope for re-alignment of the river channel and re-modelling of the plan-form (to introduce some sinuosity) over approximately 400 m, without affecting the arable land on the LHB (Photo 1). A project to achieve this would require a survey of levels and design by a fluvial geomorphologist, plus landowner consent. The table below gives an approximate indication of costs of such an option:

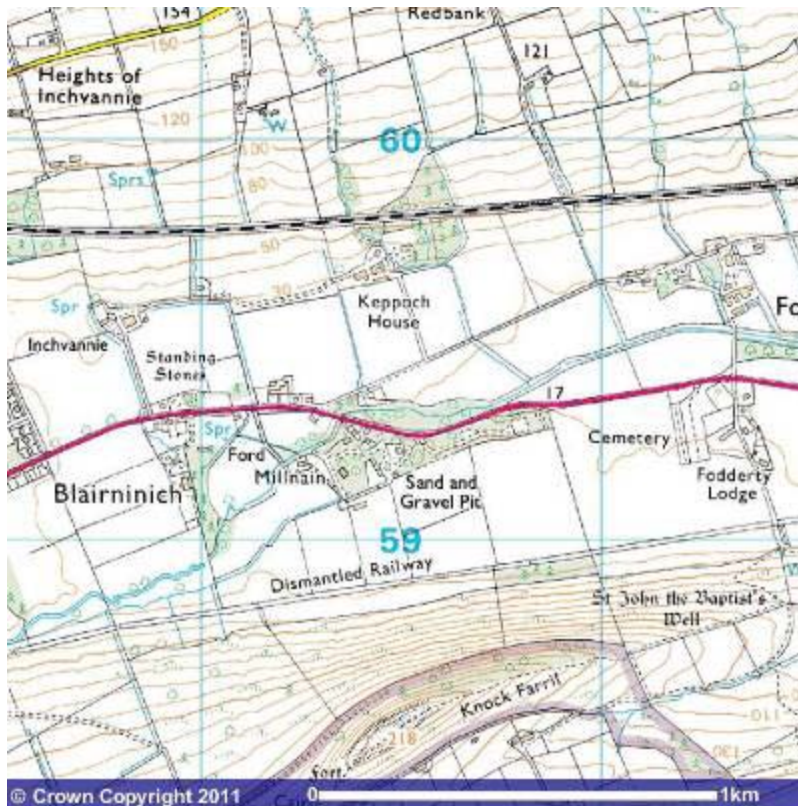
3.3 *Watergate to A834 bridge Millnain (Section D – RRC report)*

Apart from the upper 200-m section affected by unlicensed channel straightening works, the habitat on this section of river is very good, as highlighted in previous reports (RRC, 2010; WTT, 2009). The dimensions of the river here (river corridor width – flood prone area; height of channel in relation to floodplain; meander frequency and amplitude; etc.) should be used as a template for the design of full river restoration options in other sections.

Restoration of the 200-m section noted above would have costs in the order of magnitude similar to the Achterneed section (3.1 above) – maybe 30% less because it is a shorter, more accessible section.

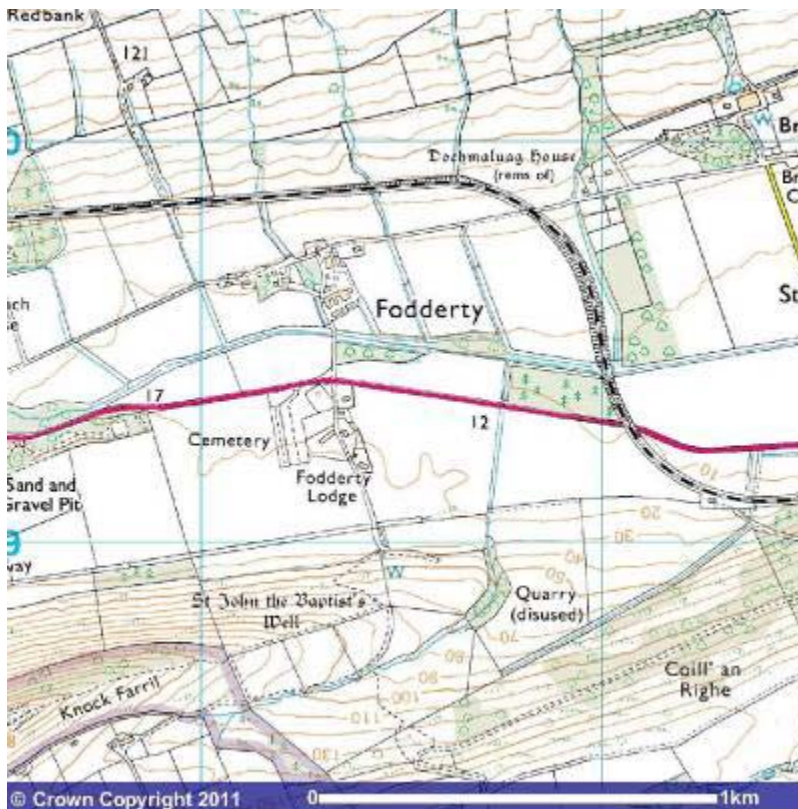
3.4 Millnain (A834) to Docherty Road (Section E RRC report)

The wooded section immediately downstream of the A834 road bridge has good in-stream habitat with meanders, gravel side bars and shoals, floodplain connectivity and in-channel large woody debris. There is a reasonably broad strip of woodland from the A834 road to the river on the RHB (about 30 m) and from the arable fields on the LHB (about 20 m) – this gives the river room to meander and create natural in-stream features. There are occasional areas within this section where the river has been straightened and in-stream structures could be used (e.g. NH 50711 59317).

With downstream progress the river becomes more constrained between embankments and takes on similar characteristics to the stretch upstream of the sewage works – uniform, straight and shallow (e.g. around NH 51074 59489 down to Fodderty House road). In-stream structures (Appendix 2) are appropriate here, particularly the K-dam, wedge dam and flow deflectors. Photo 6 shows a tree leaning into the channel which has created some rare depth and flow diversity in this reach; it gives a good indication of the dimensions for introduced structures. Site selection should take account of the presence of the naturally occurring

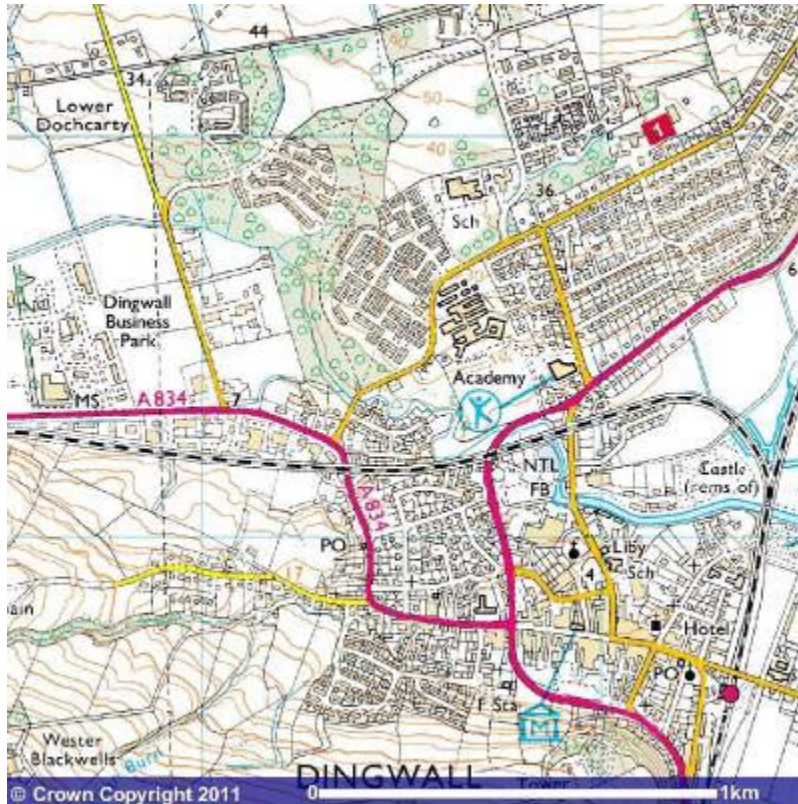
3.5 Docherty Road to tidal limit (Section F – RRC report)

This reach of the river is divided into two sections in the RRC report², F1 (woodland section) and F2 (town section). There are large amounts of fine sediment blanketing the river bed throughout this section and large amounts of litter and discarded trash within the river channel. The accumulation of fine sediment on the river bed is likely to be a combination of the decreasing gradient of the channel and the increased rate of supply of fine sediment from land use upstream (forestry, arable agriculture). There are different opportunities for in-stream habitat improvement within these river sections compared with further upstream; the structures described in Appendix 2 would not work here because of the lower gradient. “Tree sweepers” or brushwood bundles (Figures 2, 3) could be used to promote channel narrowing (in the woodland section) and depth variation. Trash clean-ups are being carried out in this area and should be continued to promote community awareness and responsibility for the watercourse.
