**Advisory Visit**

**Rea Brook, near Shrewsbury**

**November 2015**

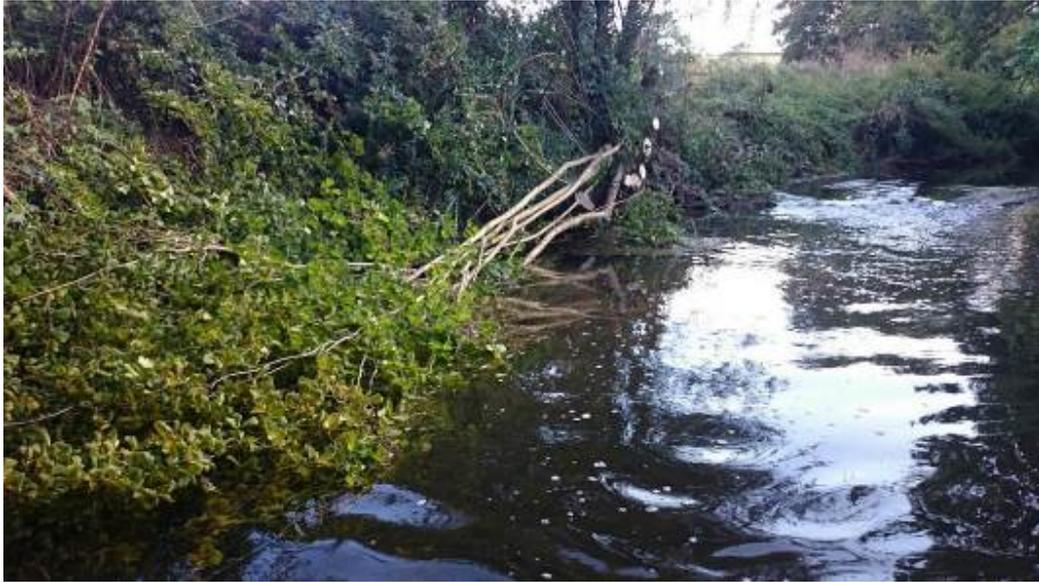
**Photo 24** Example of small trees hinged into the margins (like hedge laying).

- Hinge small trees and branches into the margins of the brook in the areas highlighted (Photo 24).
- Introduce logs and rootwads, keyed into the bank with an excavator (or by hand) to form structures which will promote bed and bank scour, increasing depth variation and promoting meander formation (Photo 26). Figure 1 shows how the angle of introduced structures influences where the scour takes place. The locations of these structures should be on straighter areas of the brook as highlighted above.

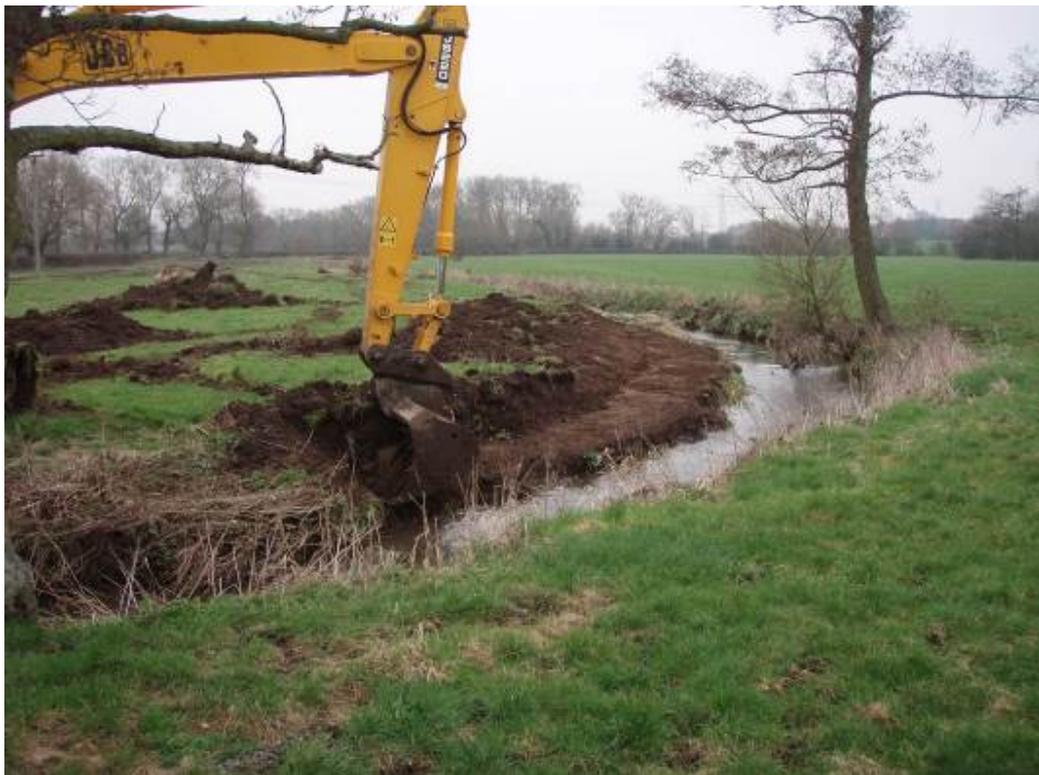
**Photo 25** Bank re-profiling on the inside of a meander. The toe of the bank could be taken even lower than illustrated here, down to normal water level.

creating these features by deliberately re-profiling the banks would improve the in-stream habitat in this reach (Photo 22). Re-profiling should be targeted on the inside of bends to create an asymmetric cross-sectional profile (see Recommendations).

- Re-profile the banks of the brook on the inside of meanders to restore natural flow patterns and promote the formation of gravel point bars and provide slack water marginal refuge areas (Photo 25).

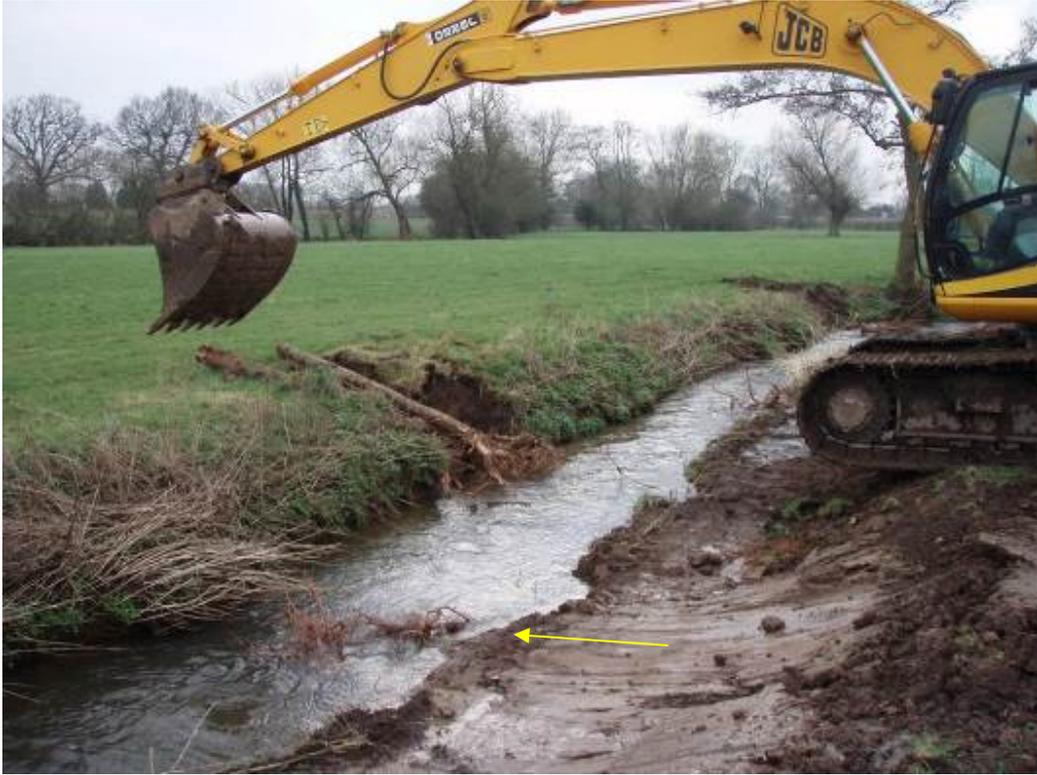
**Photo 26** Rootwads being keyed into the banks of a small brook, with root plates extending into the channel.  
Arrow indicates one already in position.

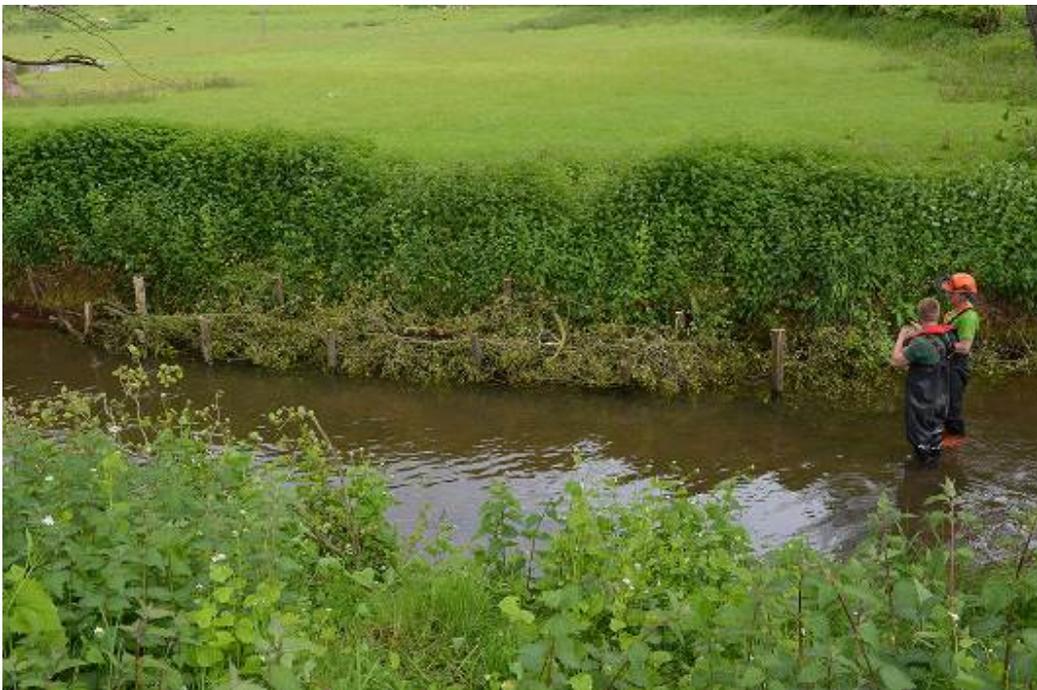
**Photo 27** Example of brushwood revetment, installed against the far bank.

- Install brushwood revetments along the toe of banks in the areas highlighted. Trees such as willows (*Salix cinerea* and *S. caprea*) could be incorporated to improve marginal tree numbers in open areas (Photo 27).

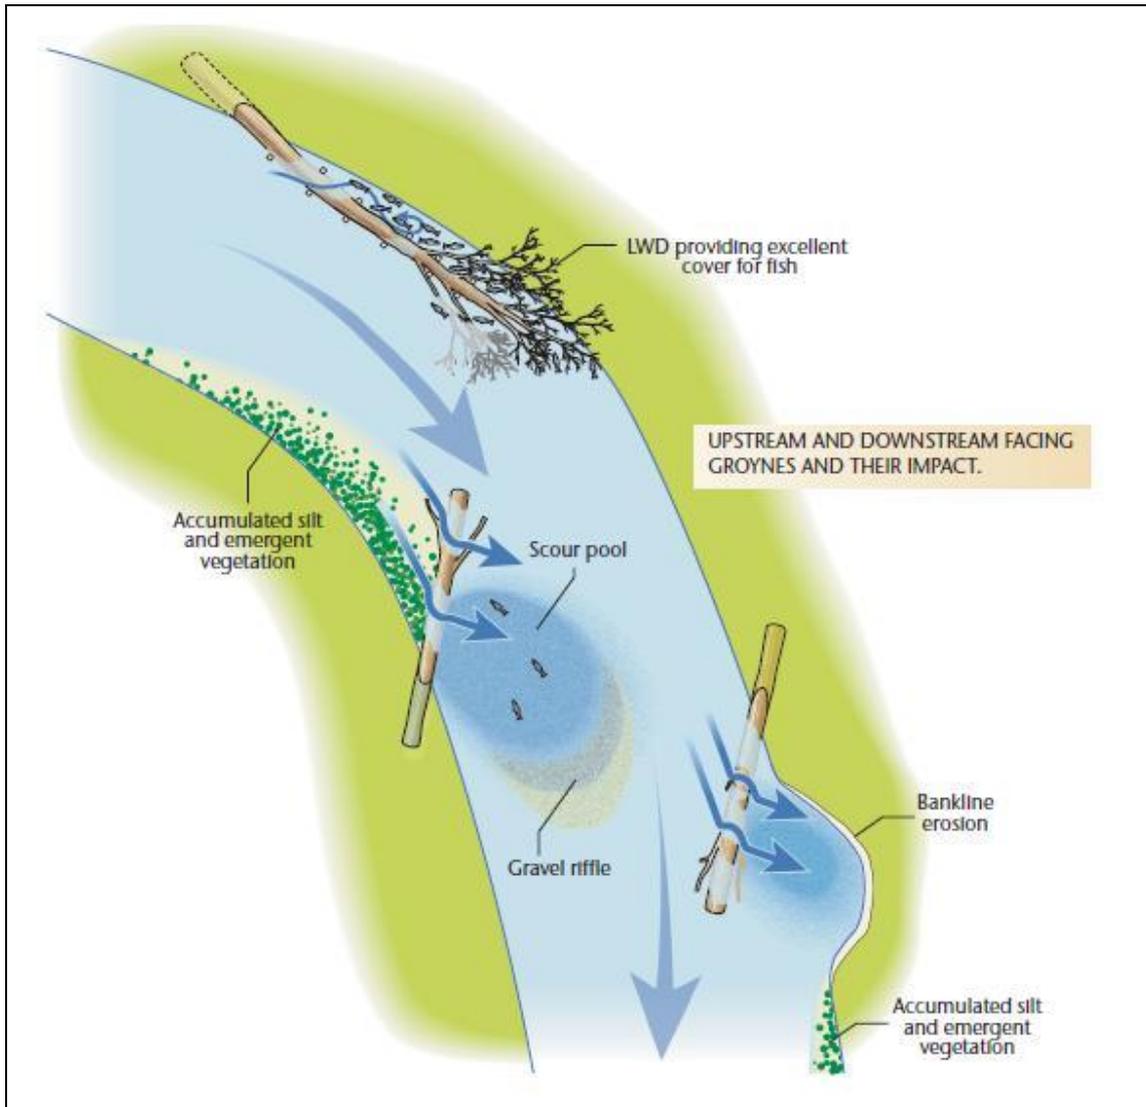
**Figure 1** The effects of positioning woody structures upon where scour takes place. Upstream pointing structures (left) scour the river bed, whereas downstream pointing structures scour the bank and can be used to encourage meandering to occur.
