Advisory Visit

River Rea, Shropshire

13th November, 2013

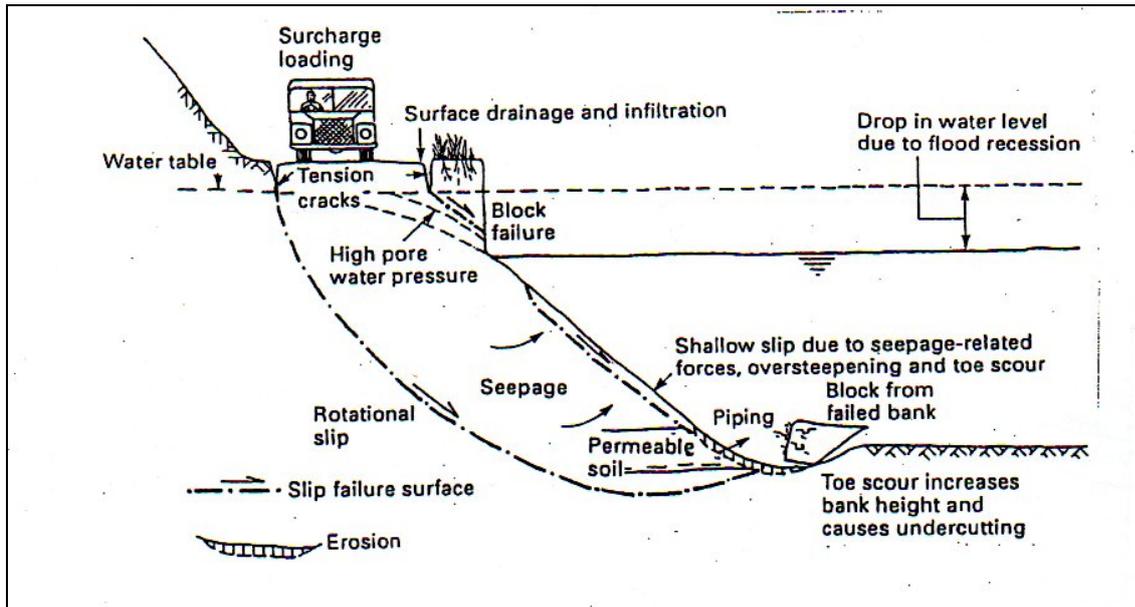
Figure 1 Processes responsible for mass failure of river banks (Hey and Tovey 1989)

- Basal scour increases the height and angle of the bank
- Rapid drawdown of river levels following flood recession or infiltration during rainfall increases pore water pressures, seepage forces and the effective weight of wet soil
- The bank top is loaded (e.g. with heavy livestock)
- Cohesion of bank material is reduced by wetting
- Vegetation, particularly if well-rooted, is destroyed as this reinforces bulk strength of the soil and its increases its tensile strength
- Tension cracks are well- developed and become filled with water.

For a given bank, failure is most likely during or immediately after sustained high flows. This encourages basal scour and associated heightening and steepening of the bank, and the saturated soil reduces any cohesion, increases seepage forces in non-cohesive material (e.g. gravels), and increases the unit weight in soil. Removal of any tree or shrub cover will not only expose the bank to higher shear stresses but also reduce the bulk unit strength of the soil by destroying the root system. The actual type of failure depends upon the bank composition and geometry – see Figure 2 below.

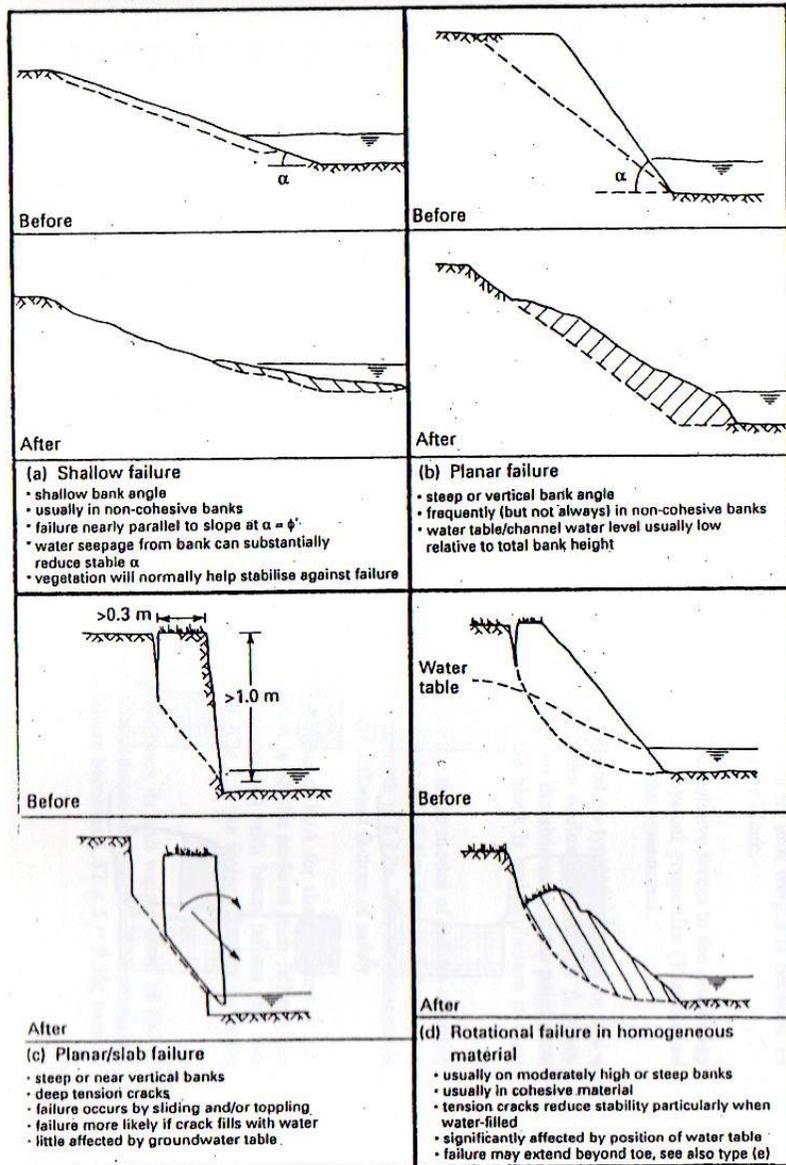
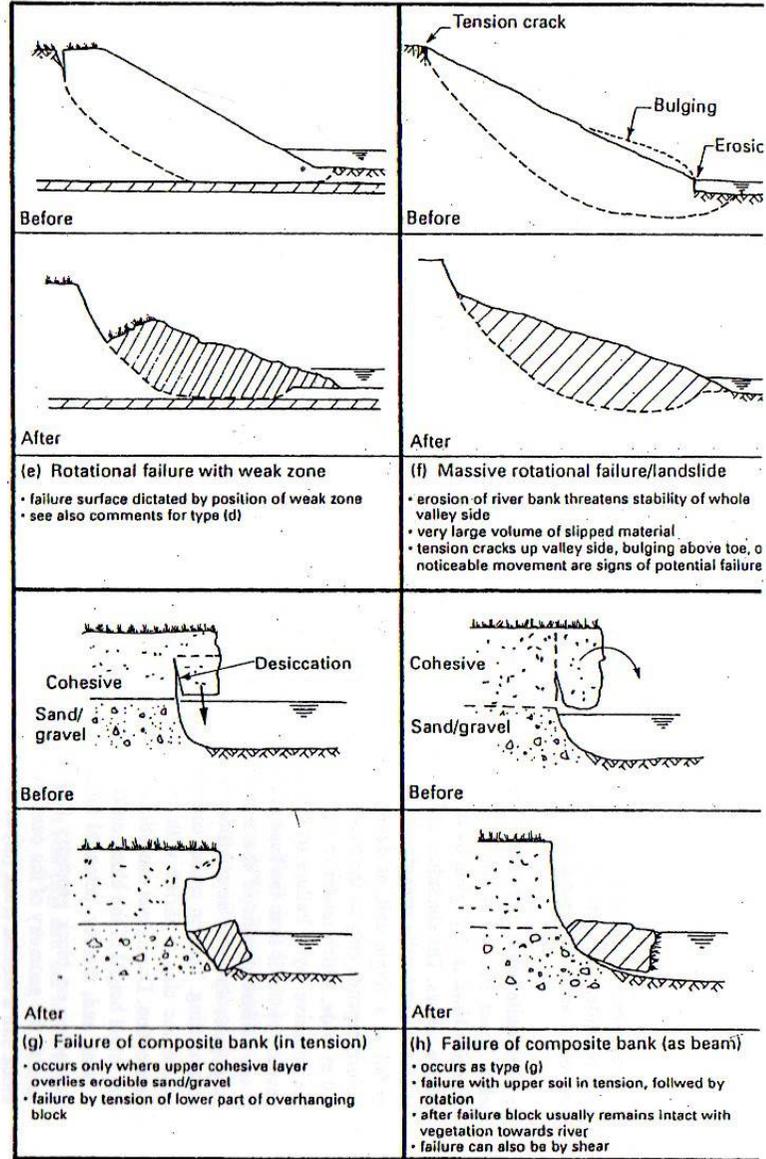
Figure 2 Types of mass failure of river banks (Hey and Tovey 1989)

contributing to accelerated erosion rates. Brushwood revetment is unnecessary here because the banks should become stable once they are fenced and livestock access is prevented; this contrasts with block failure where soft revetment is required to reduce erosion rates whilst fencing and vegetation regenerates. Figure 2 in the appendix shows rotational failure (type d) compared to block failure (types g and h).
