Advisory Visit
Afon Rhiw, Powys
September 2012

Introduction

This report is the output of a site visit undertaken by Tim Jacklin of the Wild Trout Trust to the Afon Rhiw / River Rhiew, at Lower House, near Berriew, Powys on 6th September, 2012. Comments in this report are based on observations on the day of the site visit and discussions with Mr. Woodruff (landowner), Mike Morris (Senior Projects Manager, Severn Rivers Trust) and Jason Jones (Fisheries Officer, Environment Agency Wales).

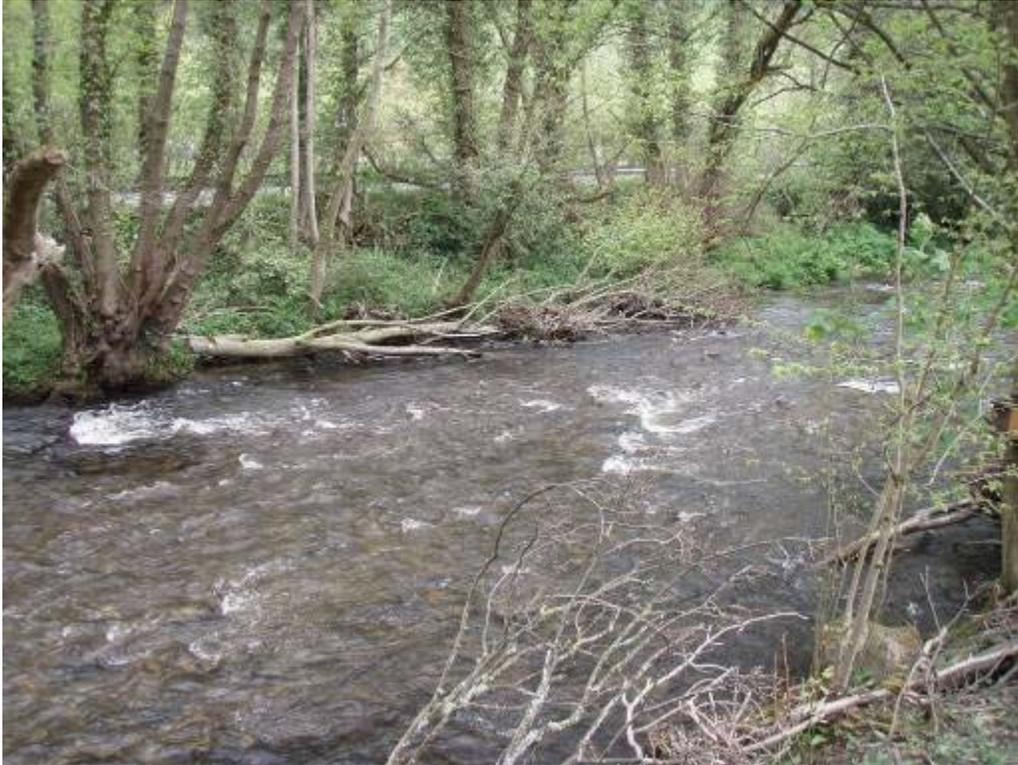
Photo 7 Tree kicker on River Ceiriog near Chirk.

- Tree kickers are whole trees which are anchored to a single secure point on the river bank and pushed parallel to the bank by the flow (Photo 7). The WTT have installed many such features on high energy river such as the Rhiw, by fixing the felled tree either to its own stump, or to the exposed roots of other riparian trees, using cabled steel wire (Photos 8, 9).

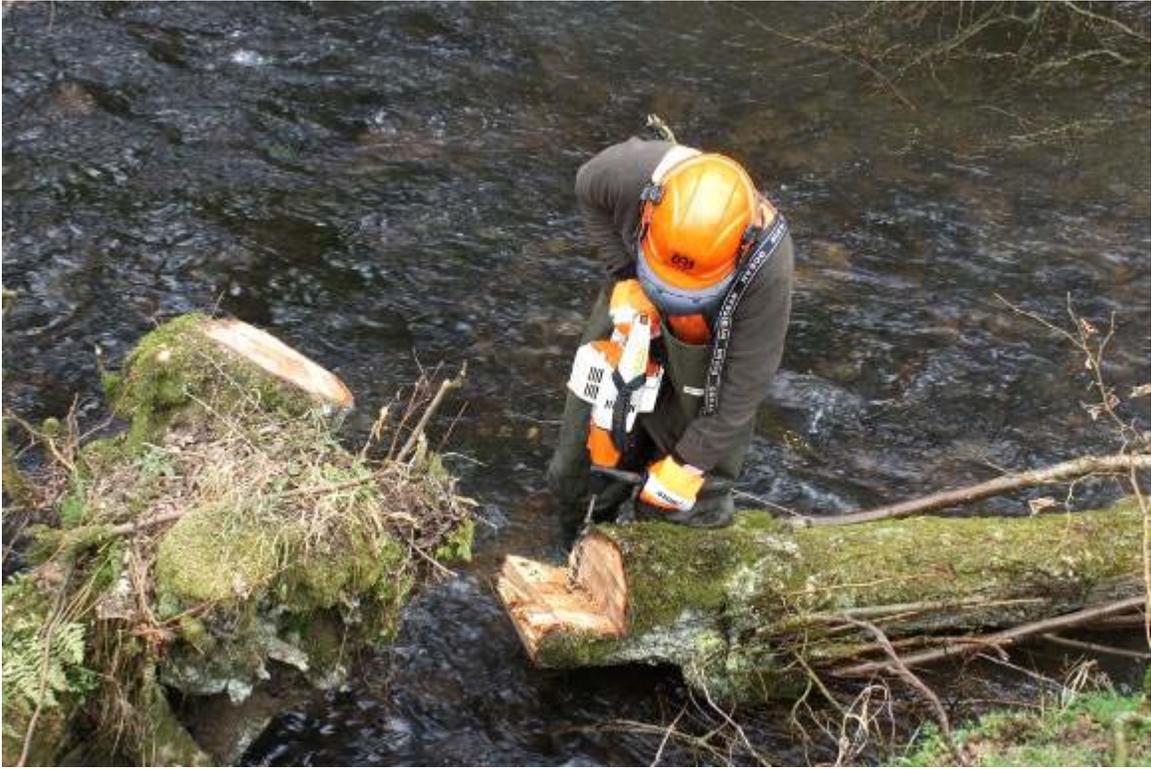
Photo 8 Cutting and drilling

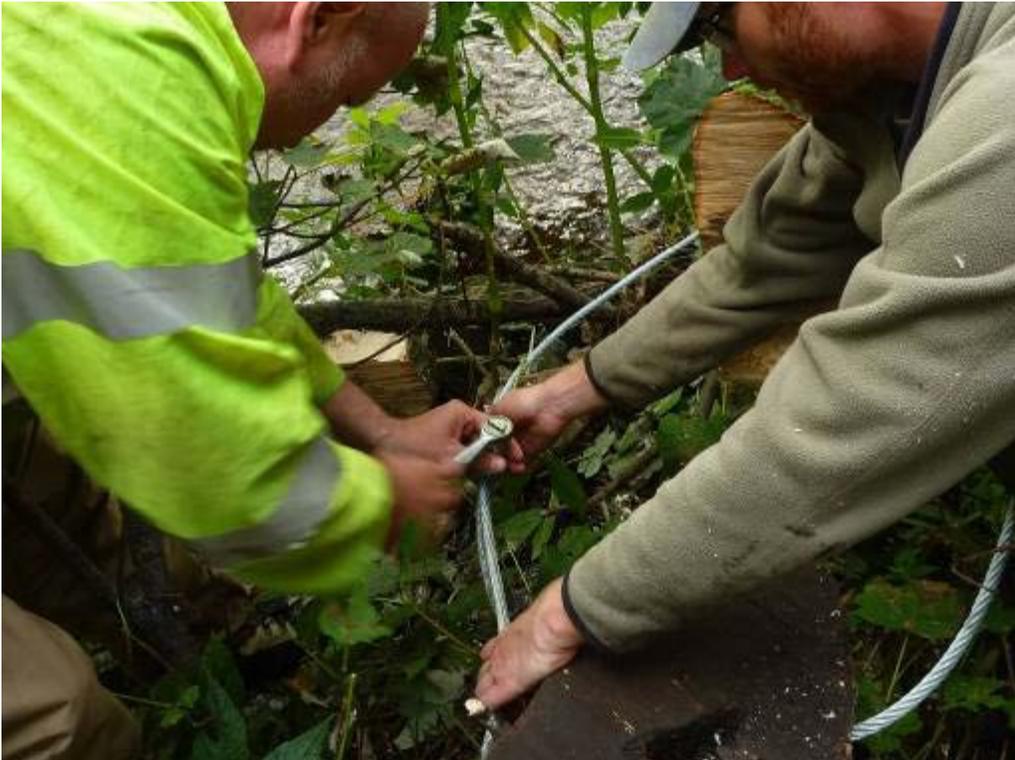
Photo 9 Fixing with cable

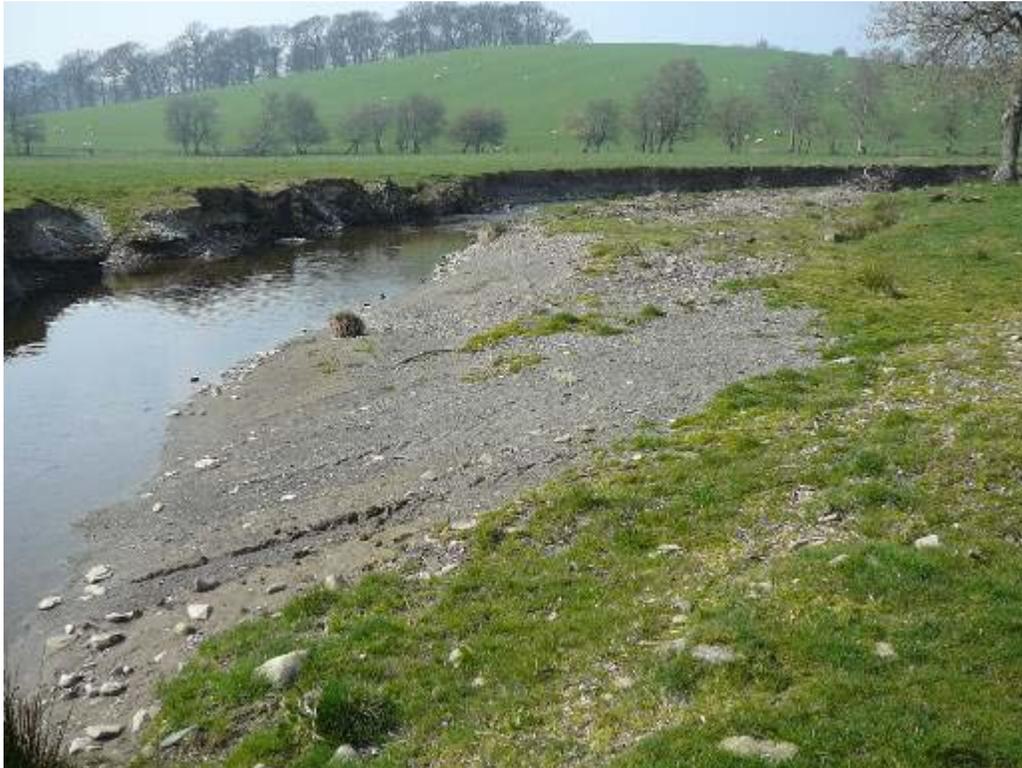
Afon Dulas (before)

- Soft revetment. This technique is not only suitable for reducing excessive erosion rates but provides superb juvenile salmonid habitat. It is vital that treated areas are fenced well back from the bank edge to prevent livestock access and allow trees to establish.

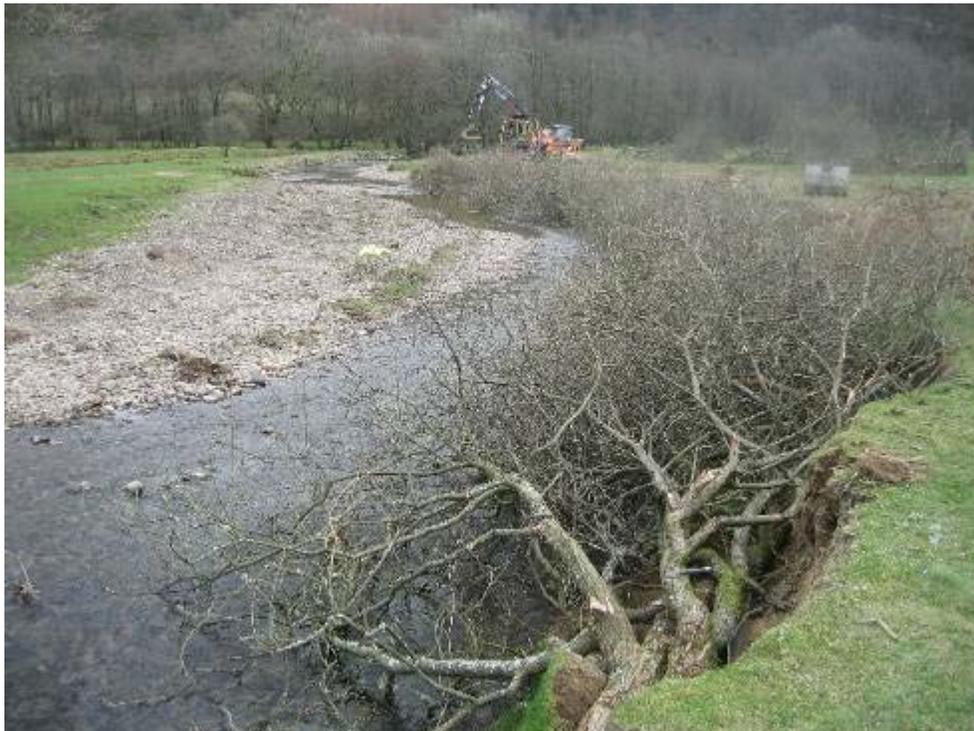
Afon Dulas (during installation). A Wye & Usk Foundation project. (Photos courtesy of Simon Evans)

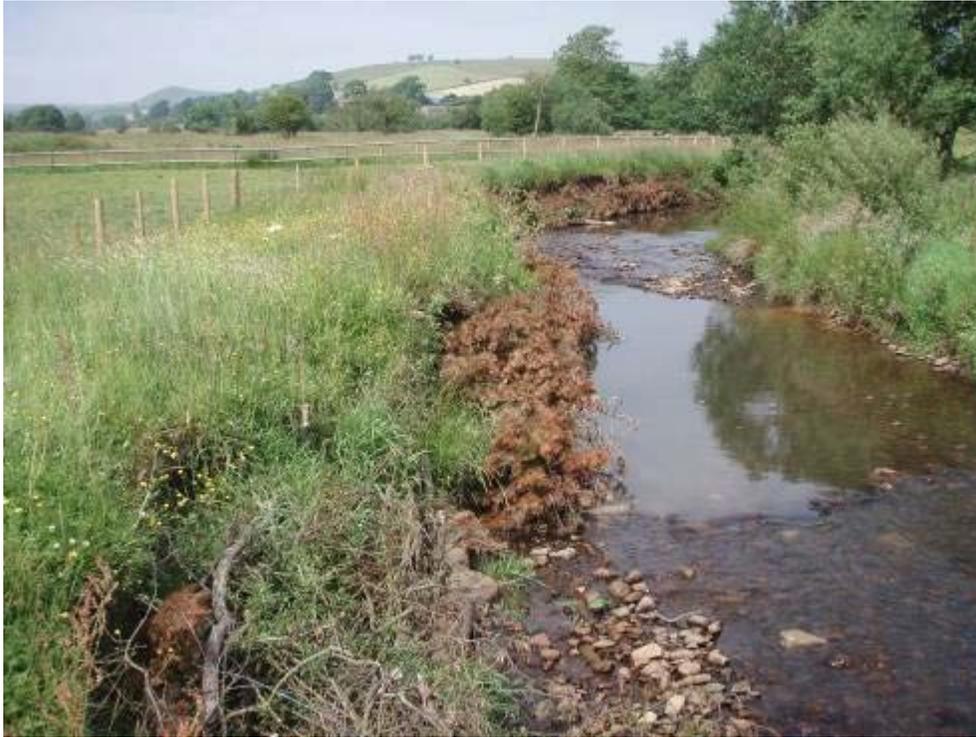
Conifer top revetment against an eroding bank on the River Manifold, Staffs. Note adjacent wide fenced margin which has also been planted with willow slips.

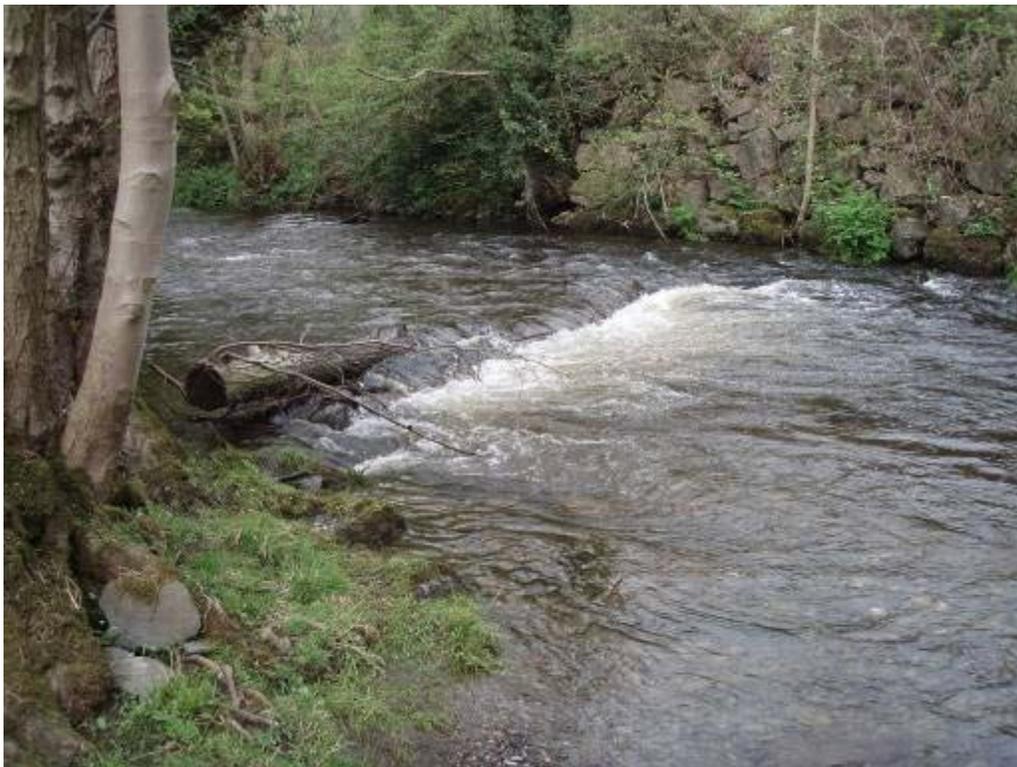
Photo 10 Log deflector installed on the River Ceiriog.

- Log flow deflectors can be fixed to the river bed using steel rebar. They should be angled upstream to deflect flows to the centre of the channel (see below and Photo 10).
