Advisory Visit
River Eden and Scandal Beck
01/05/2015

1.0 Introduction

This report is the output of a site visit to Kirkby Stephen and District Angling Association's (KSDAA) water on the River Eden, undertaken by Gareth Pedley and Jon Grey of the Wild Trout Trust. Several KSDAA members attended the visit (including Alan Swann who along with Colin Edney, requested the visit). Daniel Brazier (Eden Rivers Trust) and John Garner (Natural England) also attended. This report covers observations and discussions made on the day of the visit.

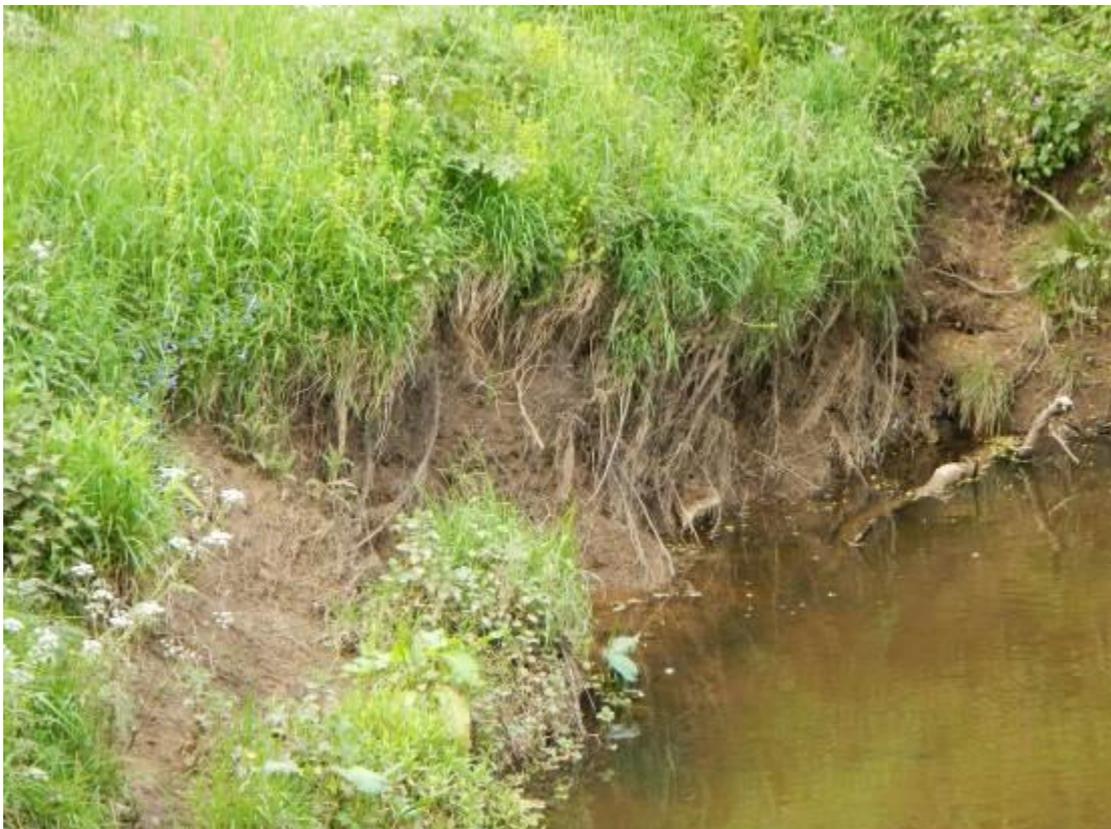
Figure 2. This photograph, taken on another upland river, shows how a well vegetated buffer strip with diverse vegetation provides greatly improved root systems within the bank and greater bank stability/protection. Although erosion does still occur (it's a vital, natural process), the rate and extent is greatly reduced.

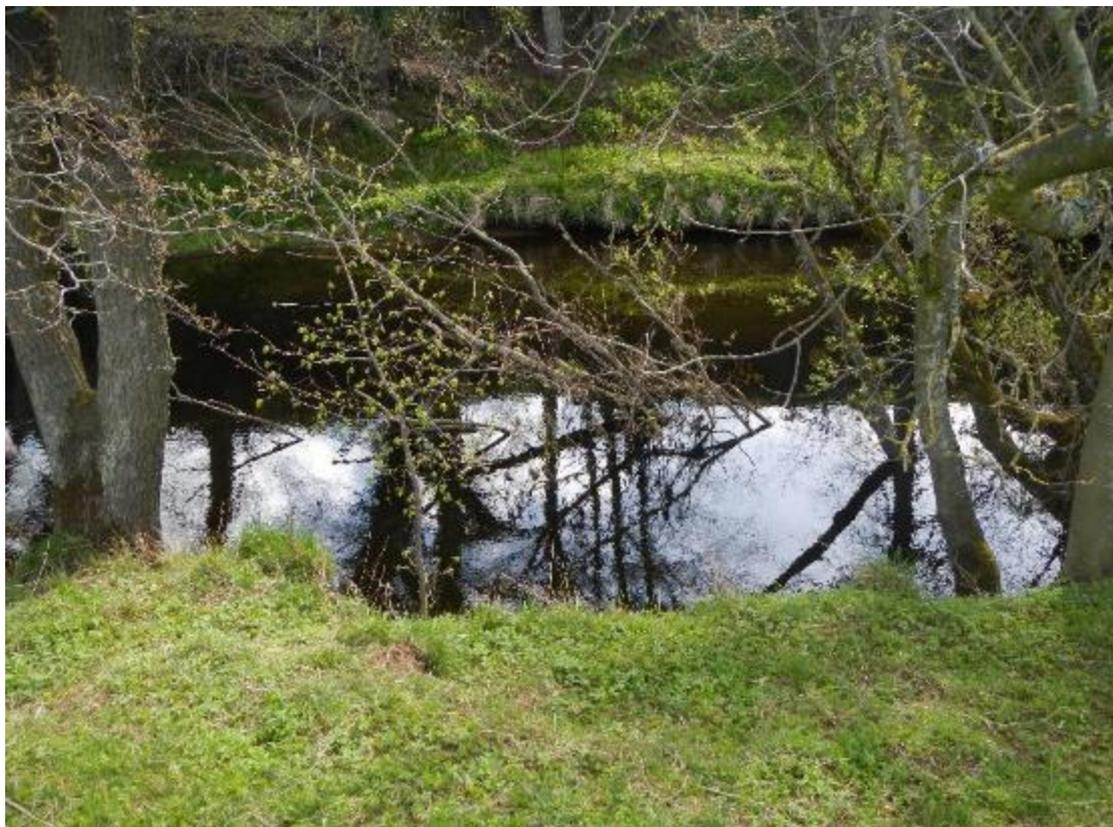
Willows are particularly susceptible grazing pressure as they are highly palatable to livestock (particularly sheep), and as a consequence, they are often the first species to be lost. Due to its affinity for water (it is one of the few species that can actually grow in the river), willow provides great in-channel structure and low-level or trailing cover for fish, often facilitating beneficial sediment deposition and channel narrowing (Figure 3). The structure it provides within the channel is also vital cover in which to evade predators, so its loss from the river is a significant issue.

Figure 3. A fallen willow tree growing within the river channel provides high quality cover and shelter for fish. Willow is one of the few species capable of growing in such conditions so its loss constitutes a great loss of habitat diversity.

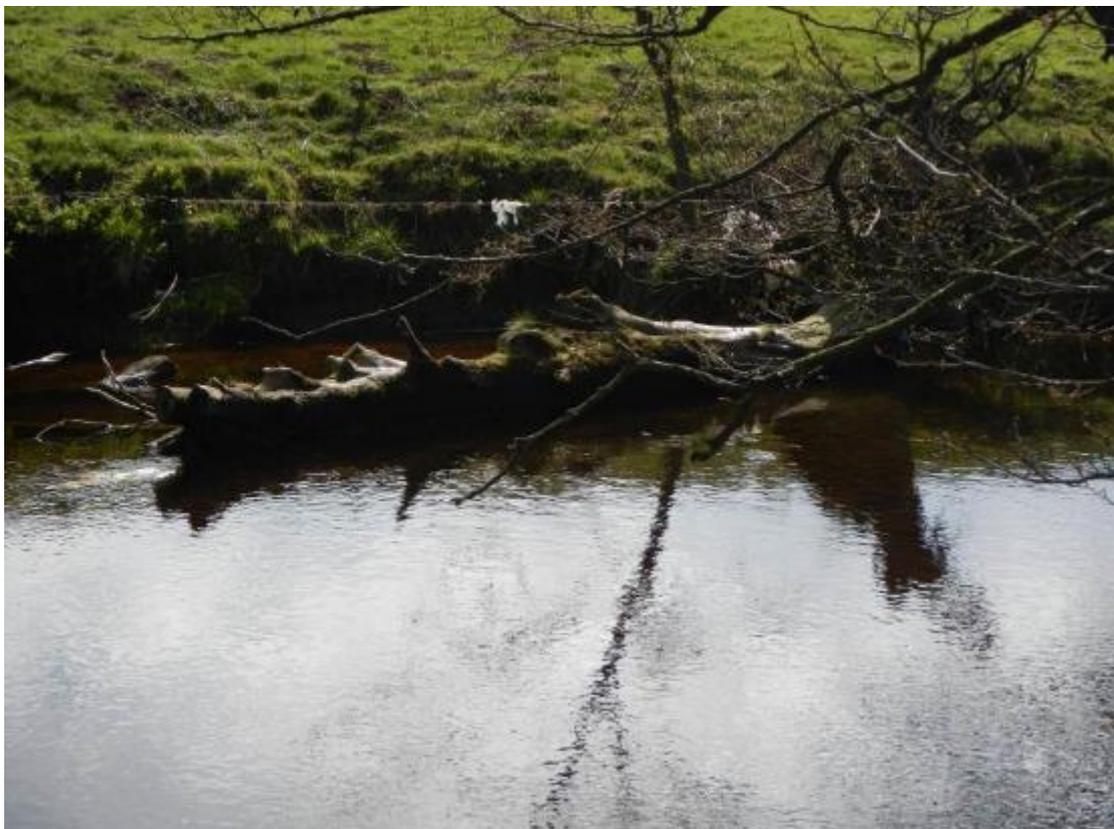
Where present, large woody debris (LWD) and fallen trees within the channel create important habitat features (Figure 4). They provide structure, increasing valuable flow diversity and scouring within the channel that maintains depths, cleans and sorts gravels and deposits finer material elsewhere. Dead wood also provides important habitat for many invertebrate species along with a readily available source of food. For these reasons it is important to maintain LWD to a natural abundance, rather than being tempted to tidy it away.

Figure 5. LWD provides a wide range of benefits, from scour and deposition that benefit trout lies, to structure and food for many invertebrate species. It is very important to maintain and, where absent, reintroduce LWD to the river.

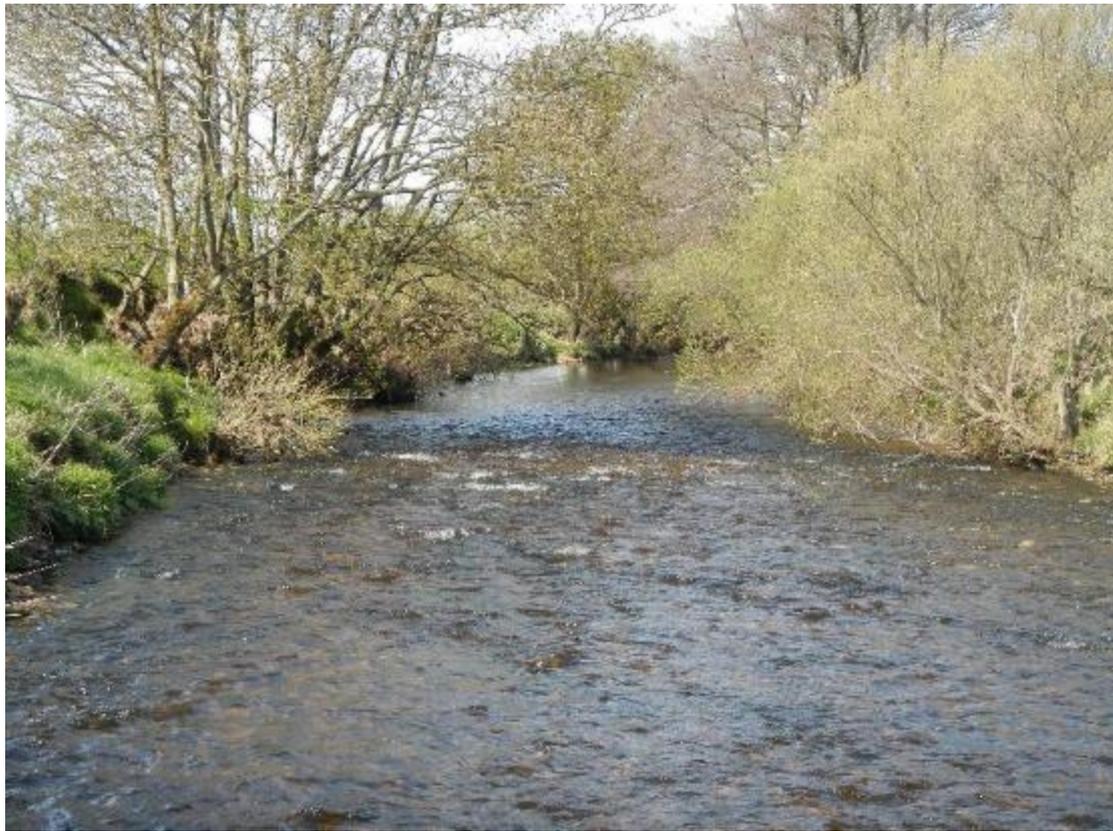
Downstream of the bridge, a beneficial buffer strip protects the LB and allows a much greater diversity and extent of vegetation. In the absence of grazing, small willows have also become established (Figure 10). Habitat along the right bank is also of a much higher quality as the banks appear to be too steep for the horses in the adjacent field to graze. With the greater bank protection/stability and marginal structure, the river is much narrower and displays a greater diversity of geomorphological features. Much higher habitat quality!

Figure 10. Downstream of Eastfield Bridge, in the absence of grazing, river banks are more stable, with better cover and a greater diversity of in-channel features.

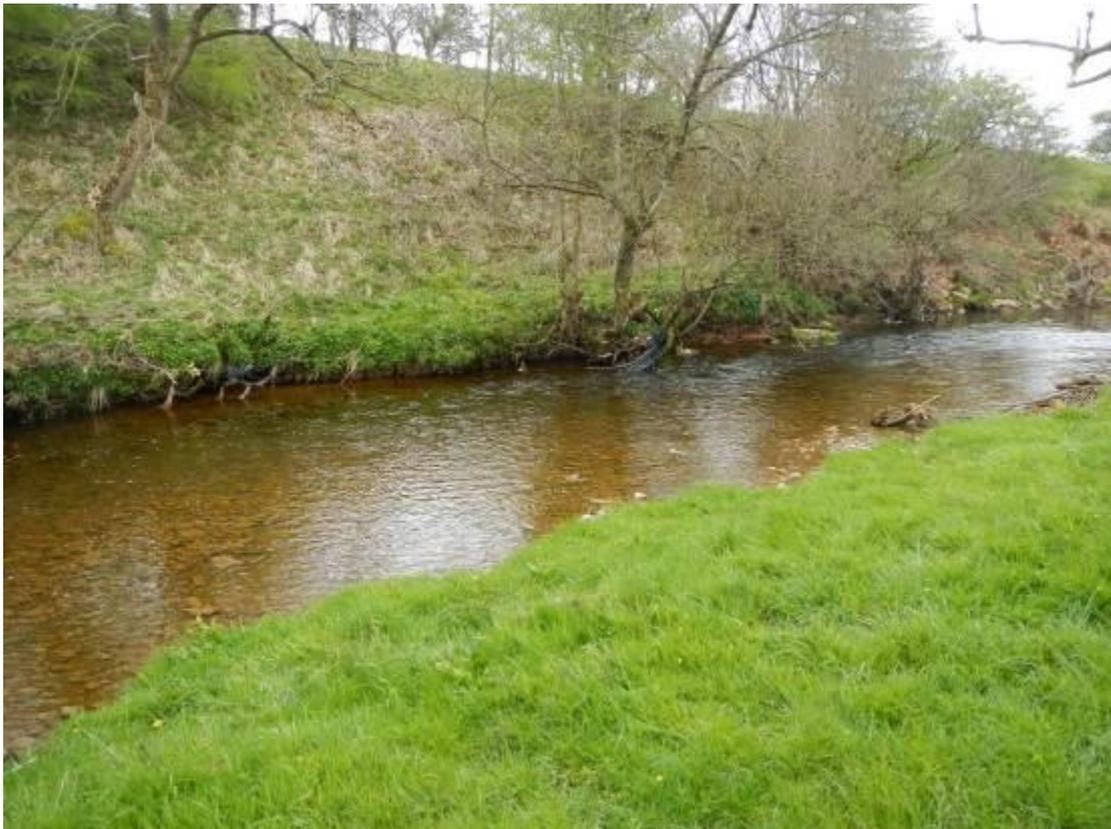
In the un-grazed areas, better habitat is evident where diverse vegetation and trees provide greater bank stability; this forces deeper areas to be scoured down, into the bed (Figure 16), rather than laterally into the banks. The tree canopies also provide valuable cover. However, decreased bank stability on the grazed bank still poses a risk of channel over-widening through erosion in higher flows and a loss of water depth.

Figure 16. Where livestock is excluded from the bank and trees are present, some better habitat is available.

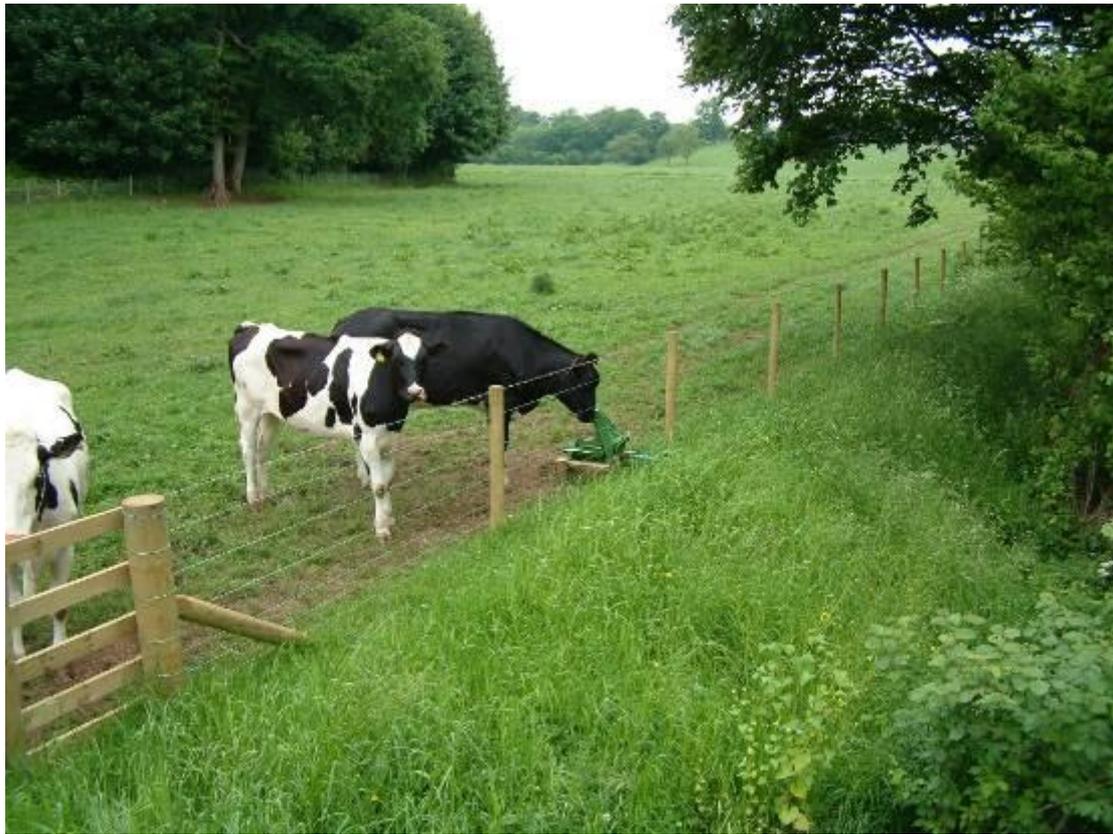
Figure 29. Cattle excluded from a riverbank and watered via a pasture pump. The cattle draw water from the river through a pump which they activate themselves by pushing it with their nose.

Ideally, fencing should completely exclude livestock from the river bank which may then require solar pumps (Figure 29) or pasture pumps (Figure 30) to supply water for drinking.

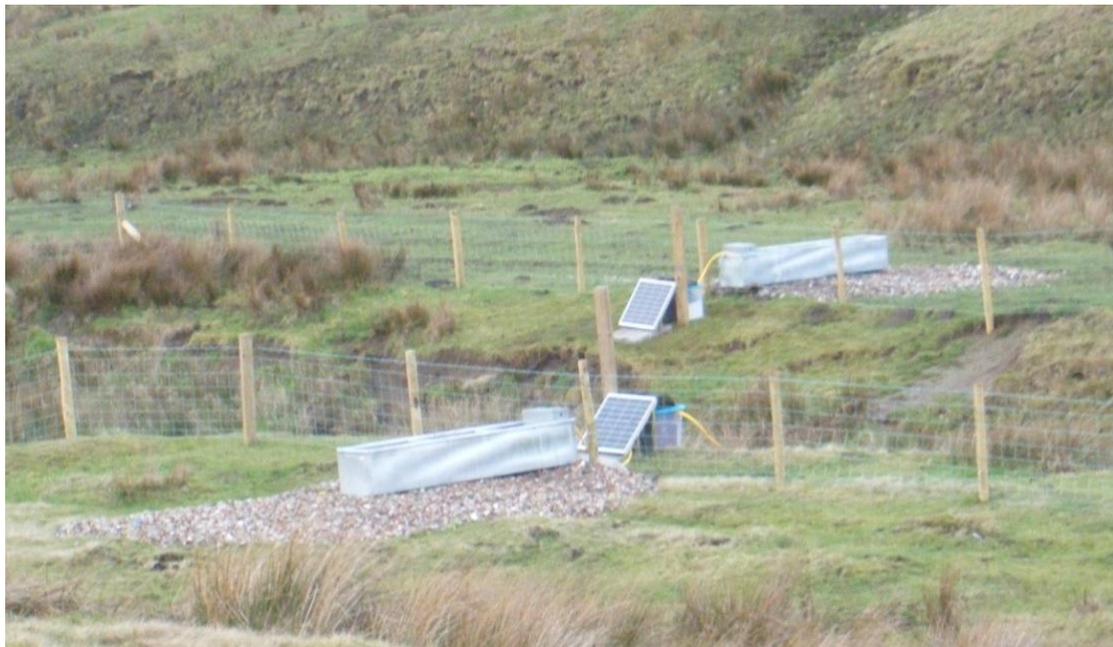
Figure 30. Solar panel powered pumps employed to fill standard water troughs. (Photograph courtesy of Ribble Rivers Trust)
