Advisory Visit
River Enler, Newtownards
Northern Ireland
5th April 2016

1.0 Introduction

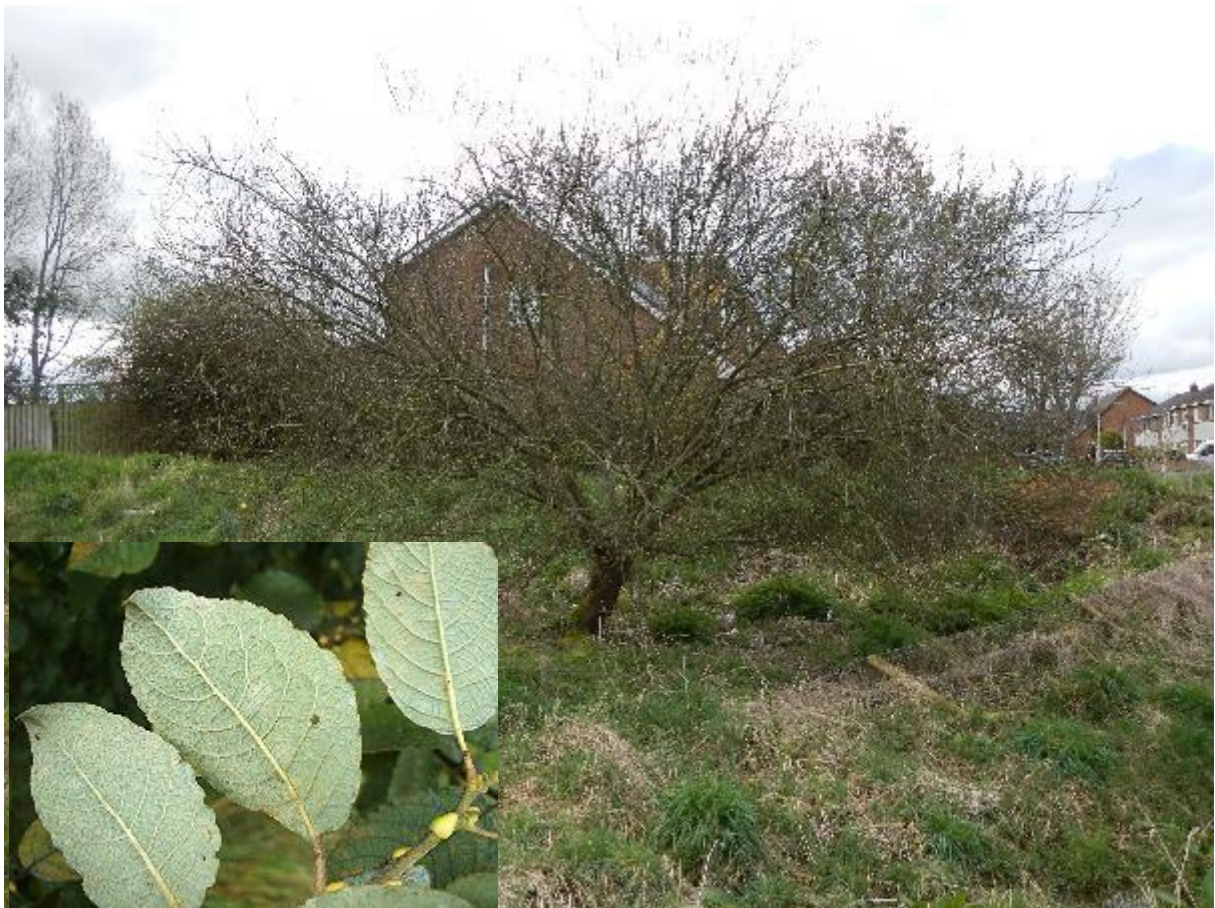
Some areas of low/trailing cover are present, and should definitely be retained (Fig. 11). These are the obvious locations that resident fish will chose to hold and form likely lies from which to catch resting migratory fish. However, there is again a general lack of this type of cover through the Middle Section. Planting the occasional small, shrub willow species (*Salix* spp.), particularly goat willow (*S. caprea*) that do not grow too large or rapidly and provide valuable low, bushy cover will greatly increase the fish-holding potential of the section (Fig. 12).

Figure 12. A typical goat willow with small, dense canopy which could provide valuable fish cover if located on a riverbank. Note the more oval-shaped leaves than many willow species and the pale underside (inset). This tree c.100m d/s of the gauging weir (NW 5788724062) would make a useful donor for cuttings.

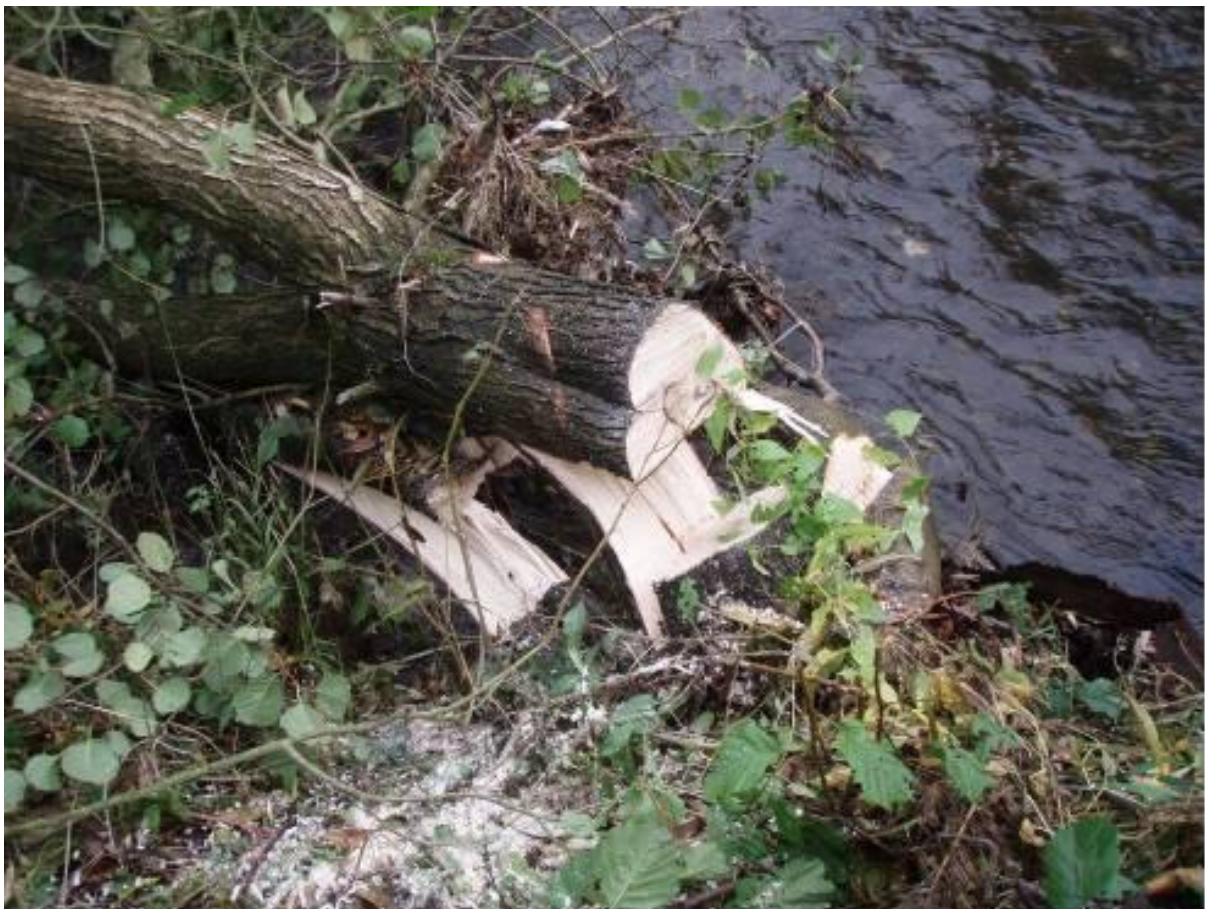
Figure 29. Hinged willow.

The process of laying a tree or branch is simple: it involves cutting part way through the stem/trunk, a little at a time (while it is under light tension) until it can be forced over into the river (Figs. 29 & 30). The depth of the cut should be limited to only that which is required to bend the limb over, as this will retain maximum strength in the hinge and maintain the health of the tree/shrub. On smaller shrubs, simply cutting the stem/trunk at a very shallow angle and then putting an axe blade into the cut and hitting it with a hammer can also help the laying while retaining a good strong hinge.

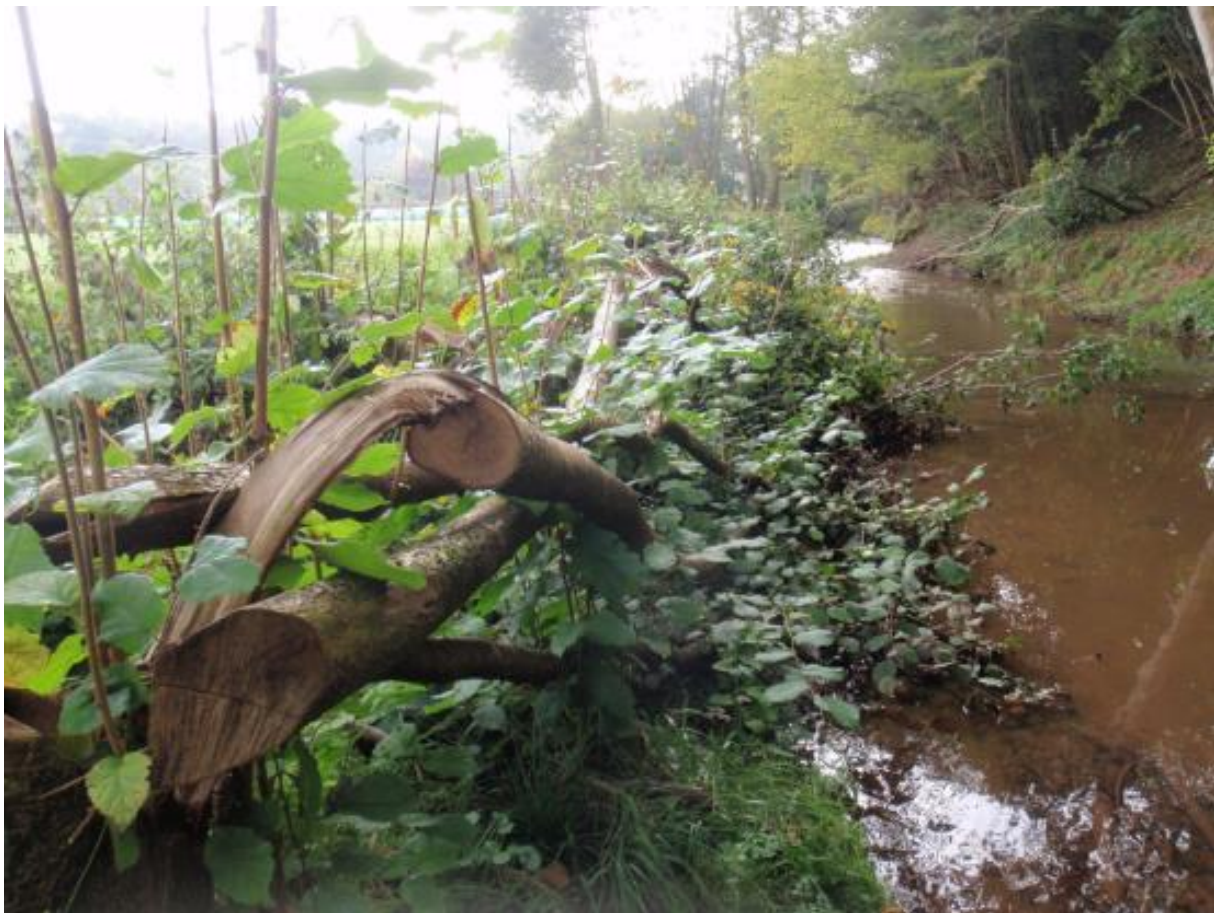
Figure 30. Hinged hazel.

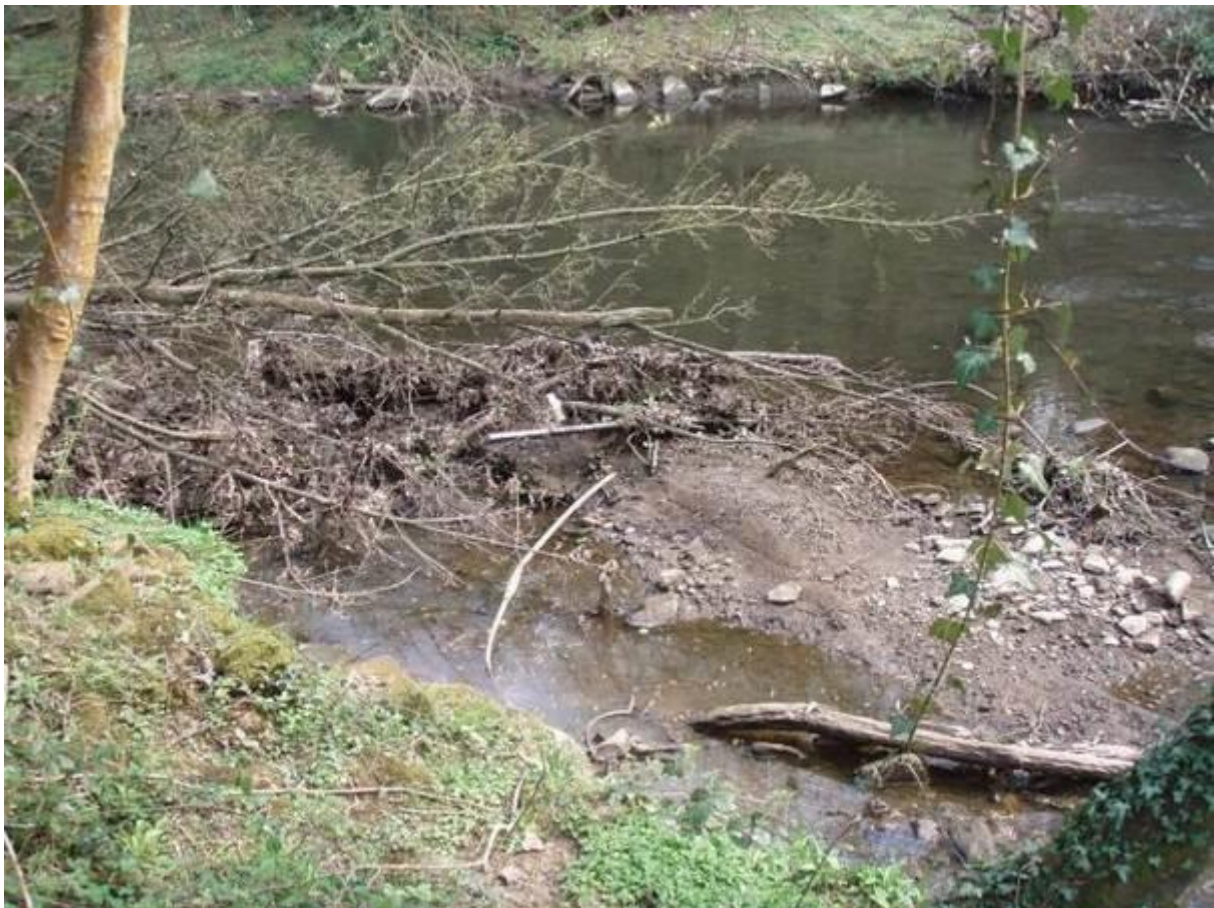
river then focusses flows into the rest of the channel while creating a baffling effect and diffusion of flow energy around the kicker to encourage substrate deposition and natural channel narrowing (Fig. 31). See how the kicker in Figure 31 has caused sediment to be accumulated at the d/s side, focussing flows along the far bank of the previously over-wide channel.

Figure 31. A perfect example of how a tree kicker can be employed to create deposition in the river margin that will focus flows down the far side of the channel.

This technique would work well alongside notching weirs in the Upper section at alternating sides (see Fig. 24). Sediment can then be allowed to accumulate, consolidate and form new, vegetated in-channel bars or even encouraged by planting with willow whips. A further step could be to employ living willow tree kickers that then also have the potential to take root into any fine sediment that accumulates around their canopy in exactly the same way that laid willows will often strike root from their branches and start to grow back into the ground.

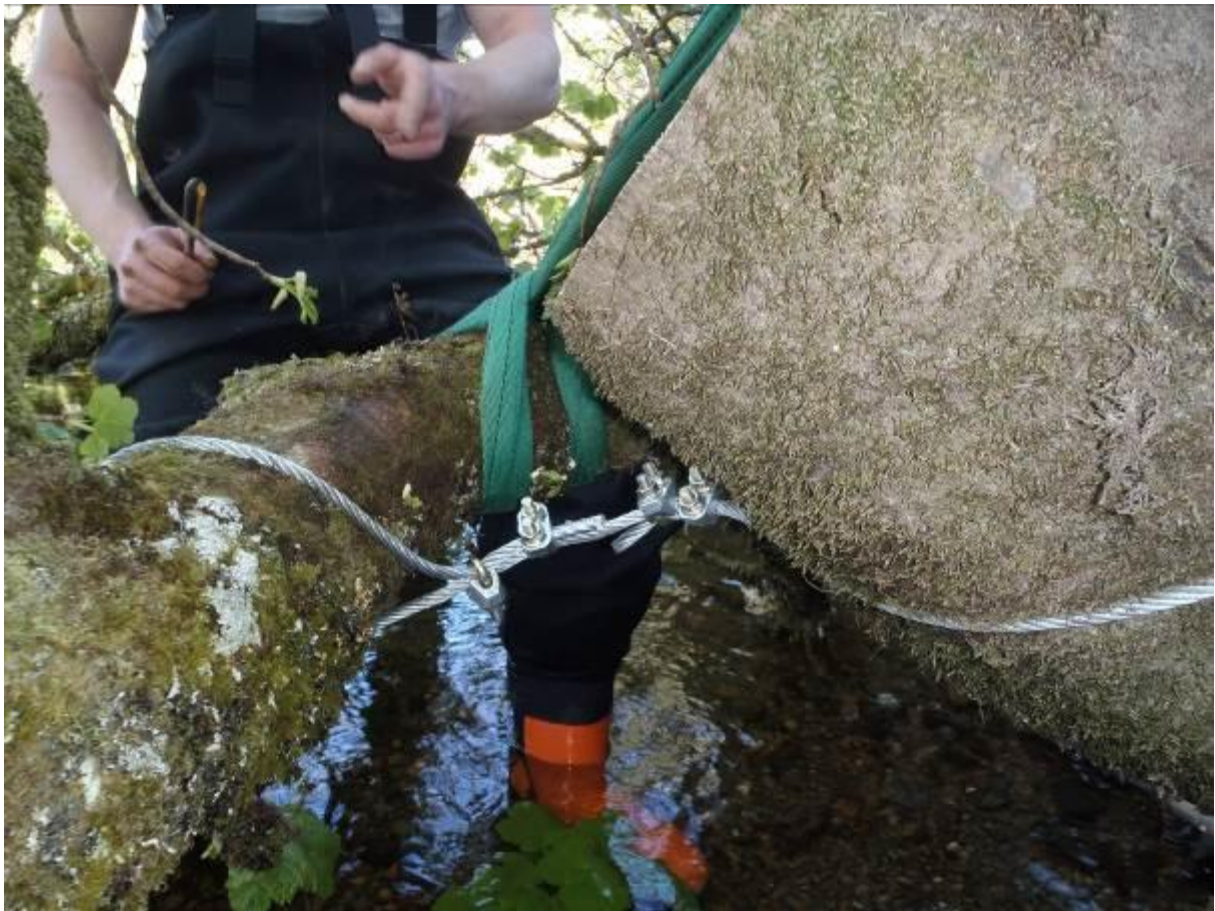
Figure 32. A basic tree kicker cable setup using 4000kg braking strain cable and two sets of cable clamps. The webbing strap in the background is used to pull the kicker close to the stump but is removed once the cable is fully fixed in place.

Tree kickers can be easily anchored in place with a simple steel cable setup (Fig. 32) or by winching the trunk of a tree between the vee of two closely adjacent trees or branches, as can other large logs (Fig. 33).

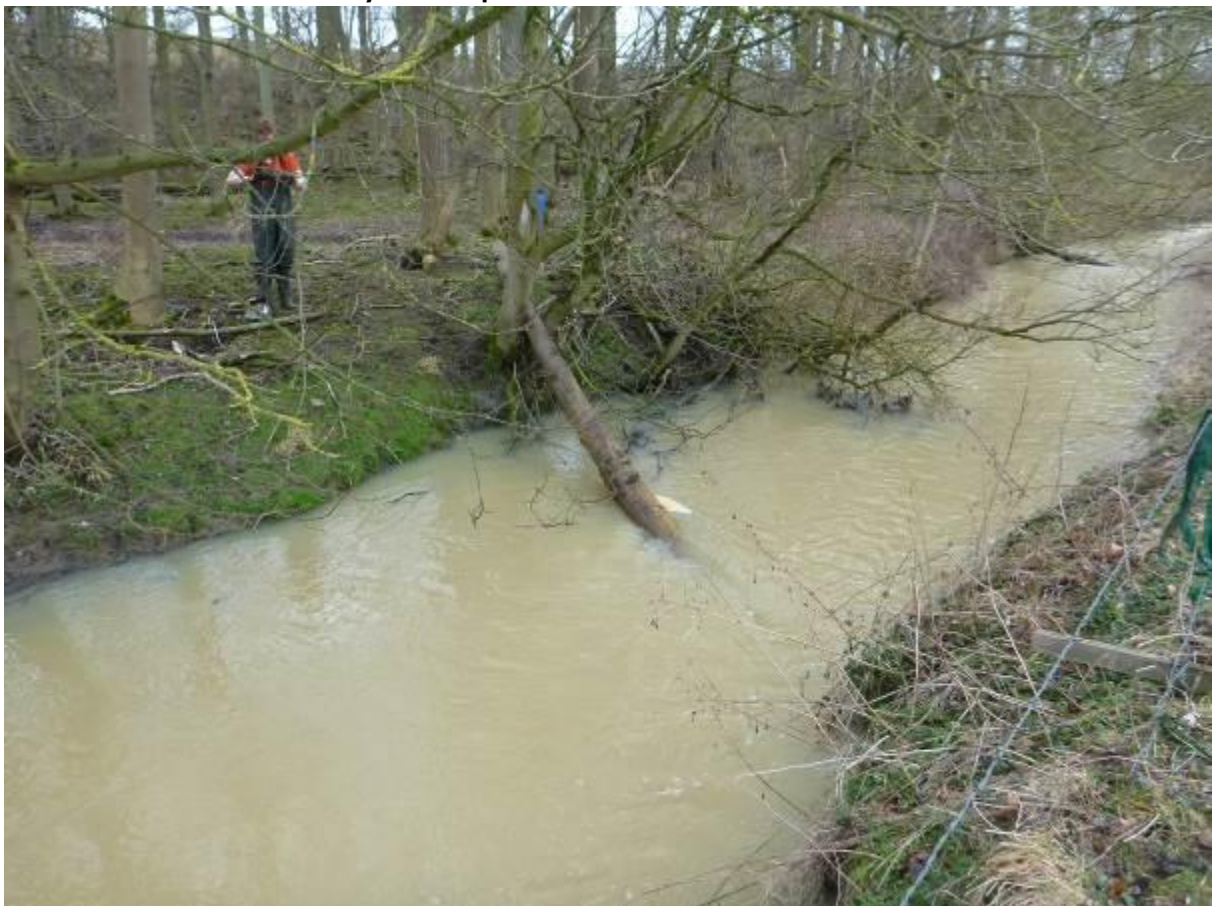
Figure 33. An alternative way of anchoring a tree kicker or log/woody material without manmade fixings. This technique simply relies on winching the butt end of the wood between two adjacent trees/branches and allowing friction to hold the material in place. Best for low flood risk areas but still a very secure method of fixing.
