**Advisory Visit for the North Yorkshire Moors National Park and
Glaisdale Angling Club**

River Esk, North Yorkshire

13th June 2013

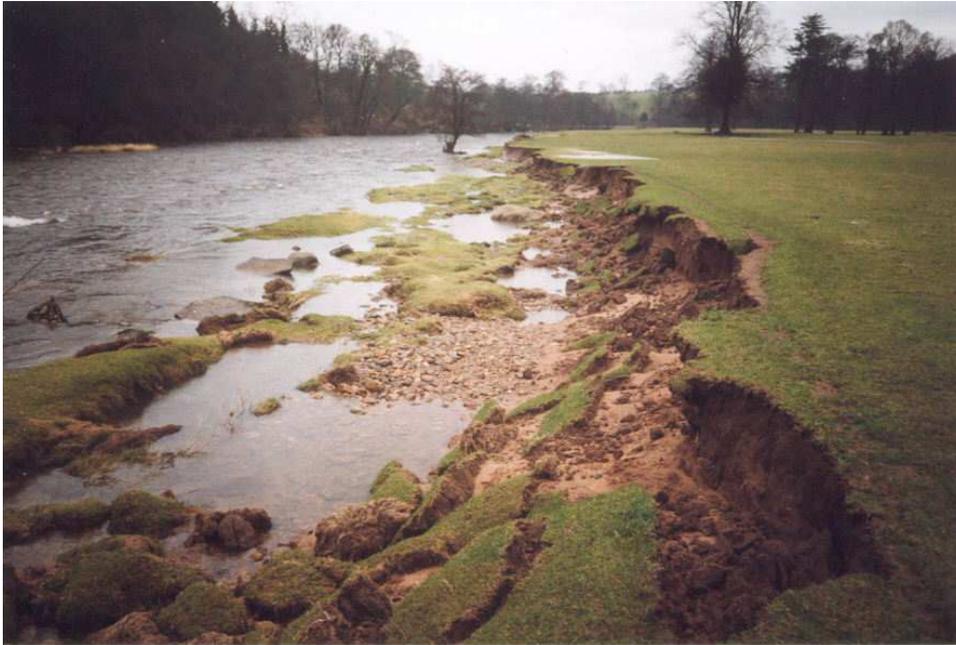
The River Eden Nr. Crackenthorpe before fencing, subject to significant erosion issues due to a lack of vegetational cover and root structure.

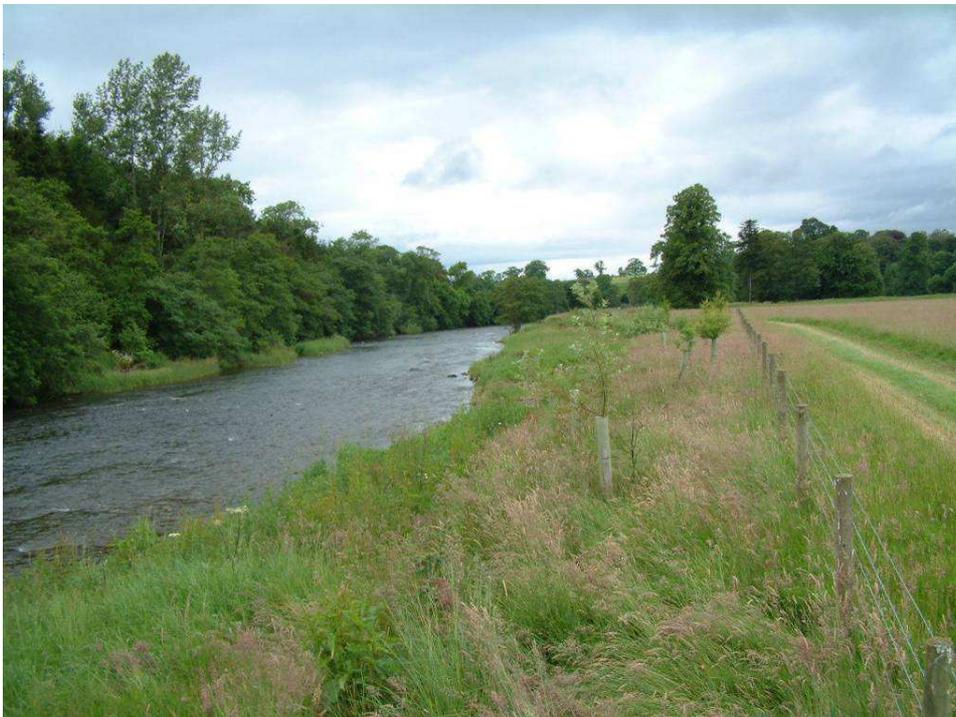
The exact same section of the River Eden as shown above following buffer fencing to remove livestock from the river banks.
