Pont and Blyth Investigation

River Pont – from Med Burn to Small Burn

Date – 25/10/12

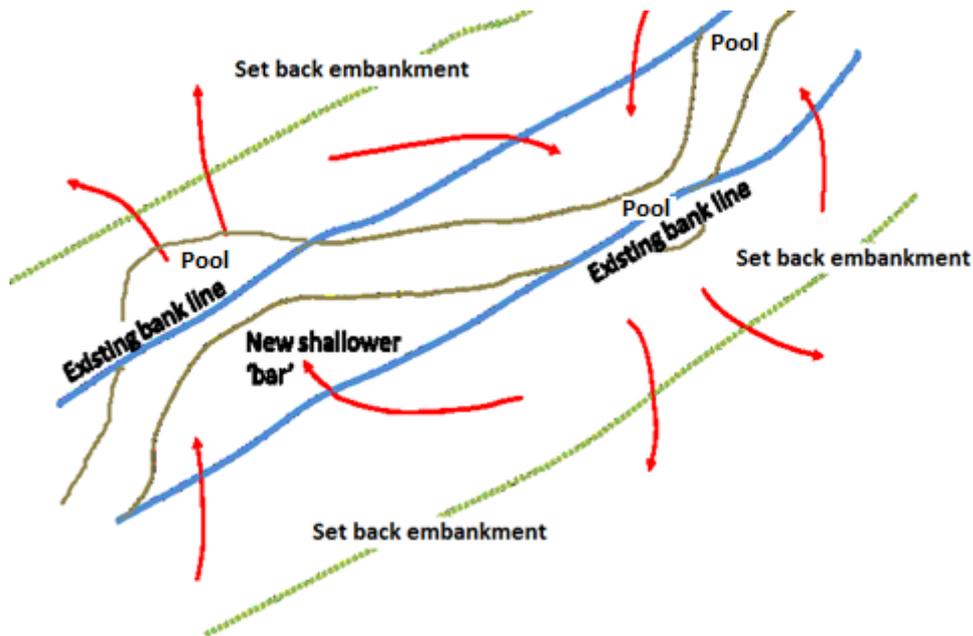
Picture 21. A diagram of the type of channel re-meandering that could be undertaken (adapted from the River Restoration Centre). The red arrows indicate areas where bank materials could be removed and/or placed within the channel.

The level of dredging and re-alignment throughout much of this waterbody has left the river straight and deeply incised for long sections. The ideal solution would be to reinstate the original course of the river wherever possible. Where this is not possible, a second option would be to re-meander the channel with dig and dump type channel re-working (Picture 21), or at least re-grade the banks to increase the river's ability to naturally adjust.

This kind of re-alignment project would involve major work, moving large volumes of earth and involving significant amounts of time and money. It is understood that at present there is no budget for this, but if funds were available significant habitat benefits could be gained. The prime locations for this treatment would be within areas already generously buffer fenced, or where new large buffer zones could be negotiated. This is something that might be feasible, and could be investigated with the landowners.

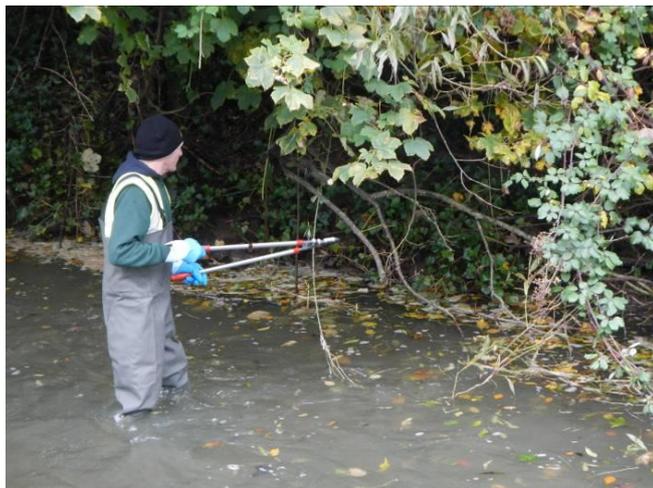
After

All of the beneficial aerial cover has been removed. This prescription was carried out throughout Ponteland and upstream towards Darras Hall, removing almost all of this type of habitat for an extended section of river.
