Pont and Blyth Investigation

River Pont - from source to Fenwick Burn

(Waterbody ID - GB103022076850)

Date 07/03/12

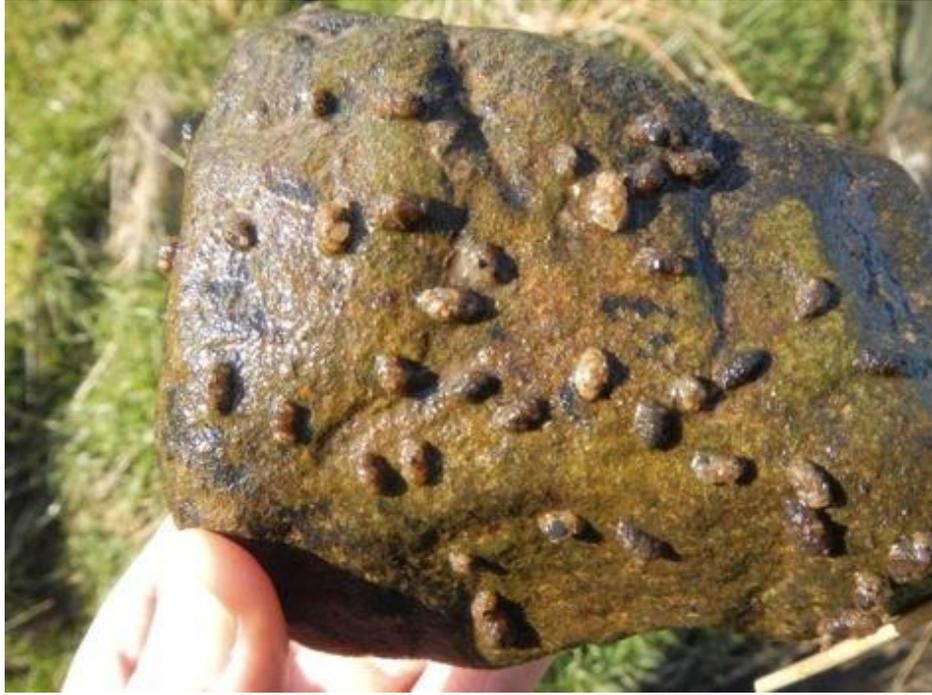
(Trichoptera) were observed on the bed in this area, indicating that other than sediment, the water quality was reasonable (Picture 8).

Picture 8. Cased caddis flies on a riverbed cobble.

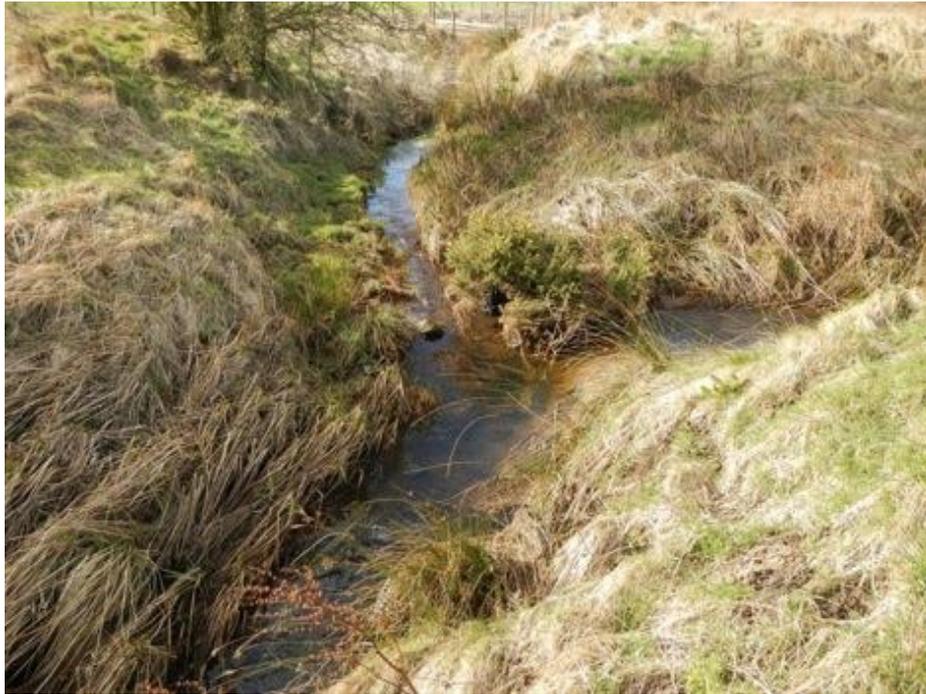
At NZ9968269262 another very small tributary joins the Pont, almost doubling its size, and at this point the first starwort (*Callitriche stagnalis*) is observed. The increase of aquatic vegetation within the River will be beneficial for invertebrates, providing food and shelter.

Picture 11. To the left of shot a small tributary provides around 40% the River's flow at that point. From here downstream starwort was observed.

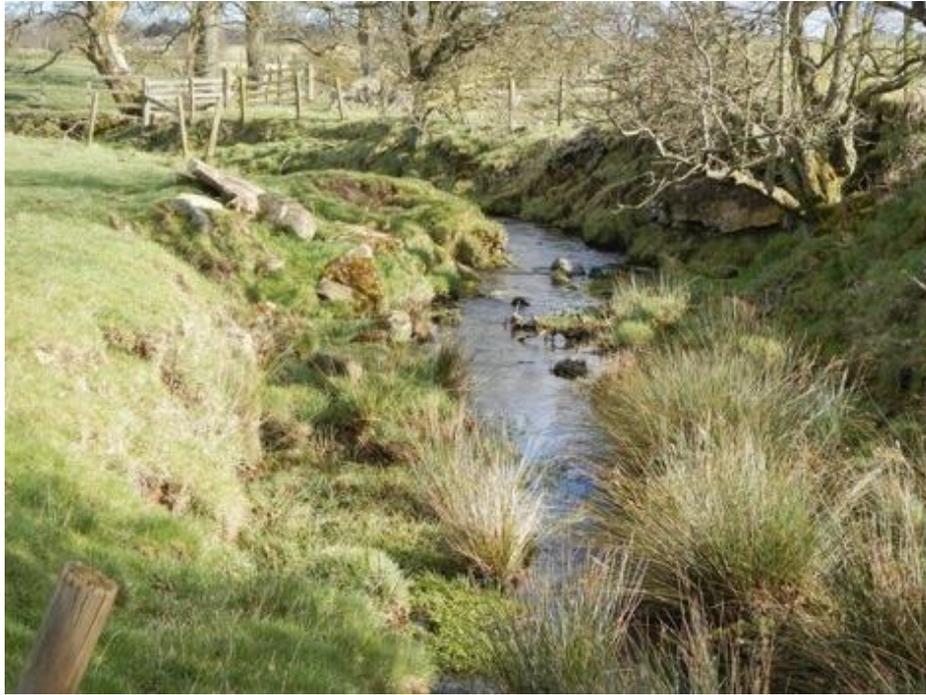
Downstream of the heavily straightened and dredged reach the habitat improved for salmonids, with some increase in sinuosity and flow diversity (Picture 16). An increased amount of coarse substrate was also observed, and stone turning revealed that invertebrate abundance and diversity had improved.

Picture 16. More natural channel with cobble bed. Dredging possibly limited by bedrock.

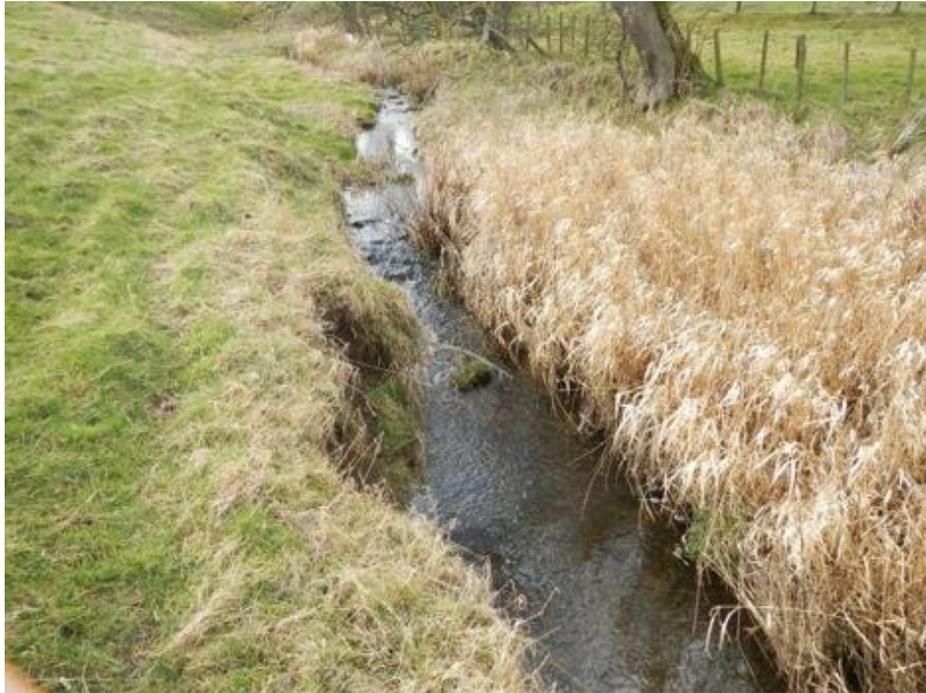
The reach downstream to Whittington Mill was narrow, and within a long enough section of reduced sediment input, to maintain coarse gravel and cobble bed (Picture 18). The field, directly upstream of

Picture 18. Narrower channel with coarse clean substrate.

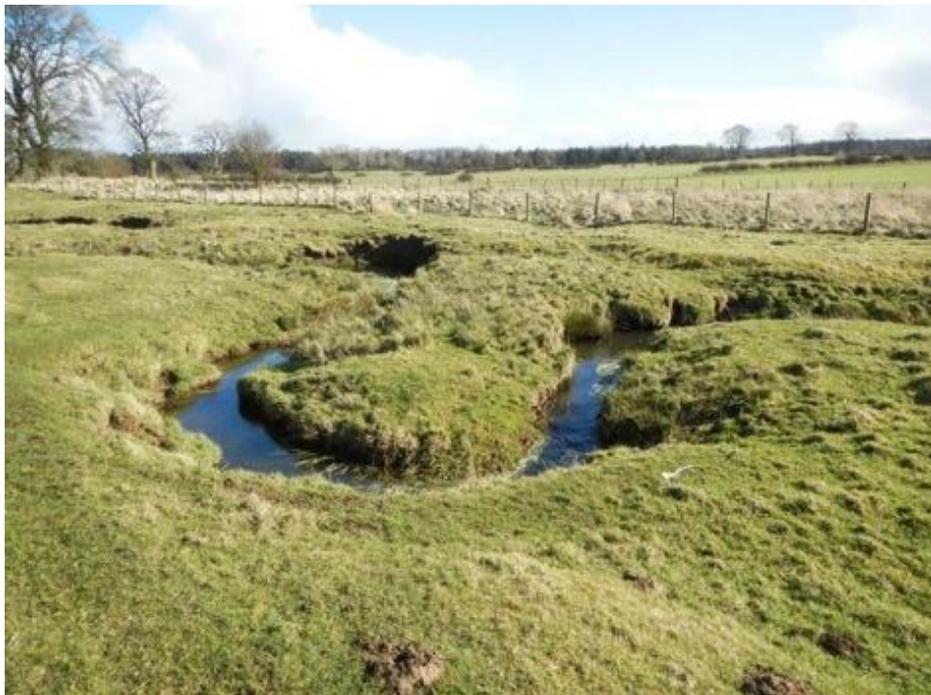
In the third field downstream of the culvert the potential sinuosity of the River was apparent, with a more natural, meandering plan form.

Picture 24. Very sinuous, naturally meandering river course (NZ0183270796).

- NY9841769500 - Picture 2, and fields upstream
- NZ0049269488 – Picture 13, large area of poaching around drinking pond
- NZ0138670320 - Picture 19
- NZ0183270796 – Picture 24 & 25
- NZ0076471030 – Next field u/s of picture 27
- NZ0091470969 – Picture 27
- NZ0229571031 - Picture 29

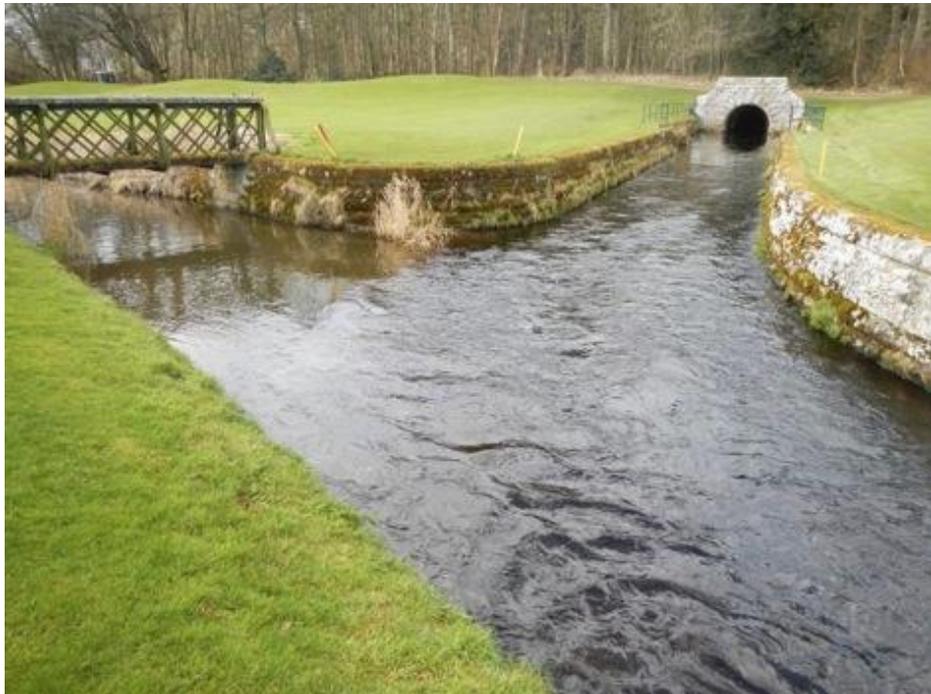
The river also receives a significant input of water via a transfer channel, from Hallington Reservoir at NZ0305771483 (Picture 34), as the Pont is used to transport water into the Whittle Burn Reservoir system. The water originates from a different catchment, with different geology and soil type, creating a notably clearer, humic-stained appearance. The difference in chemical composition

Picture 34. The point at which the Hallington Transfer water enters the Pont. The water is of a notably clearer, with much lower fine sediment content, but exhibited a humic-stained appearance reflecting the different catchment origin.

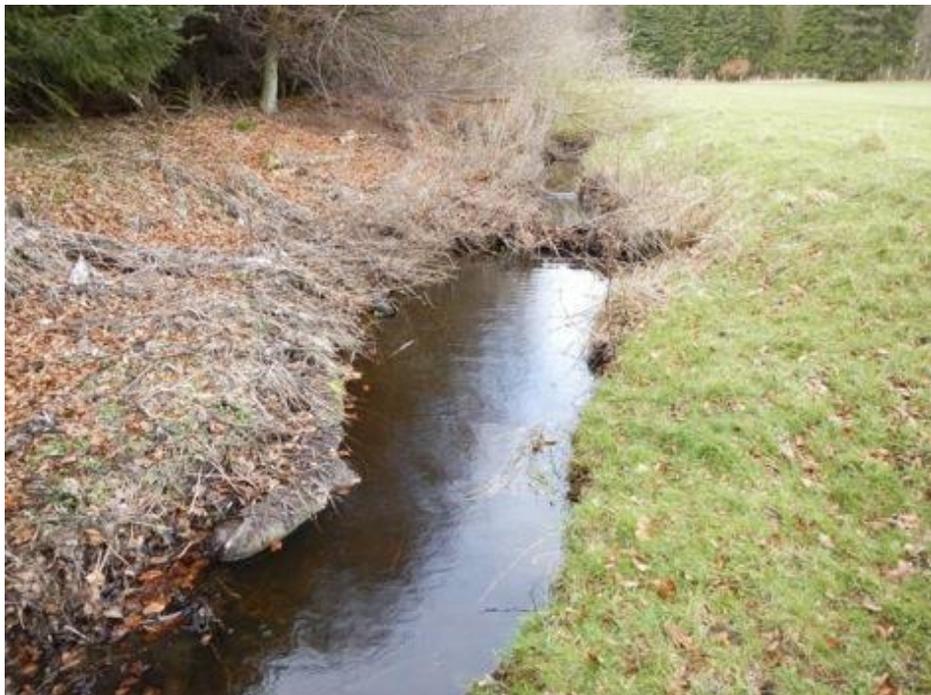
Downstream of the Golf Course, the first of two channels originating in Matfen Village discharges to the Pont (Picture 38). This channel supplied significantly less water than the other (Picture 42, c. 820m downstream) and was only of use to juvenile salmonids.

Picture 38. Small channel with minimal flow that discharges to the Pont below just below the downstream limit of the Golf Course.

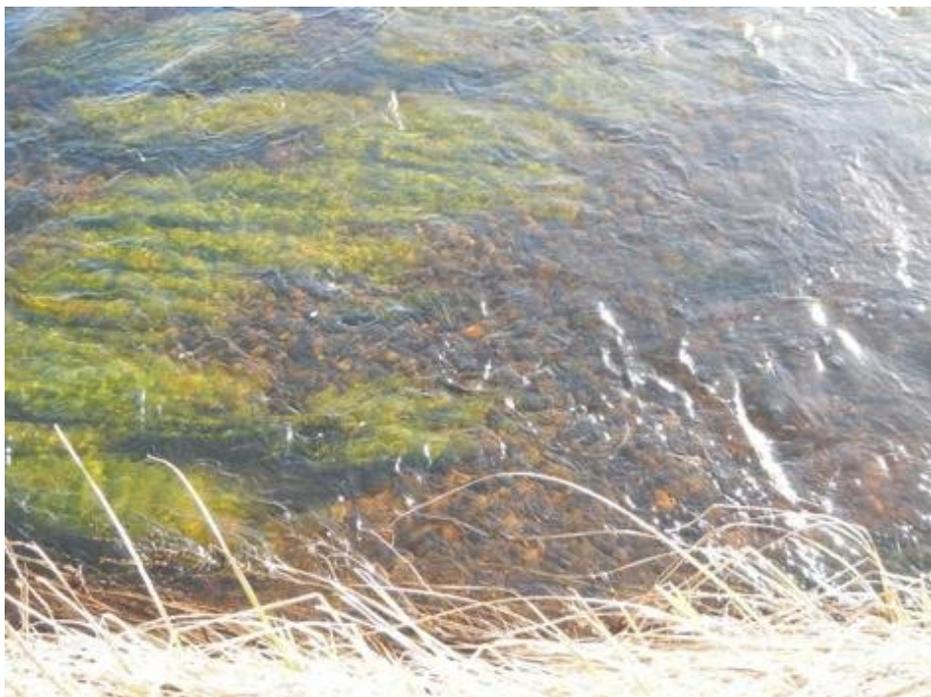
The reach of the River that carries the additional water from Hallington is also the first area where water crowfoot (*Ranunculus* sp.) was observed, with good beds visible around NZ0433971550. Interestingly, the areas where water crowfoot was present also provided good areas of spawning substrate, demonstrating the close relationship between flow and vital salmonid habitat features.

Picture 42. Good beds of water crowfoot associated with salmonid spawning substrate.

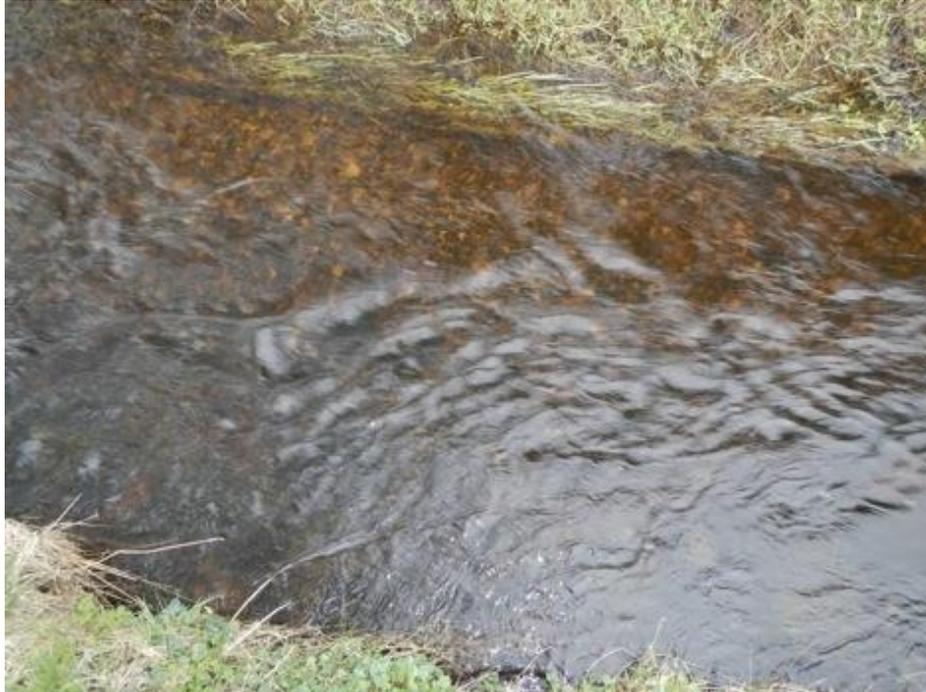
Additional spawning substrate was also provided c.200m downstream, where the second of the channels originating in Matfen Village discharges to the Pont. This channel carried significantly more water and provided clean, salmonid spawning substrate (Picture 43).

Picture 43. Salmonid spawning substrate provided by the second of the two channels originating in Matfen.

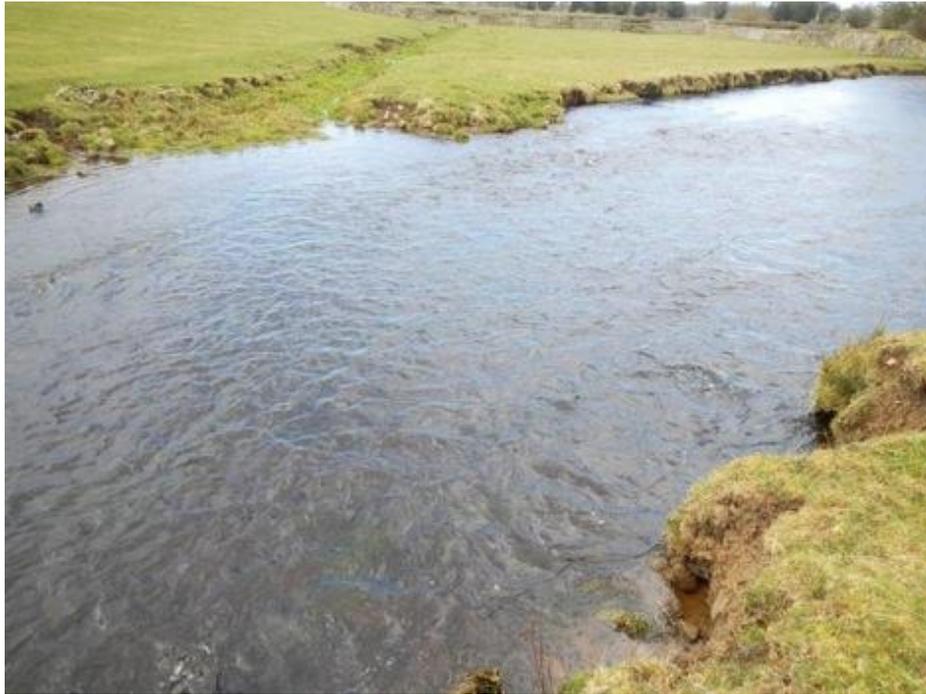
The habitat here was again of a high quality and provided the kind of diversity lacking in most other areas of the reach, below the addition of the Hallington water. Water crowfoot beds were present and good areas of potential salmonid spawning substrate were present, making the area of great significance for recruitment within the reach (Picture 44). Fencing within this reach would enhance and protect this potential, as the ongoing grazing and associated erosion is likely to lead to over-widening and increased sedimentation. This would also facilitate marginal vegetation becoming established, which would greatly benefit emerging fry.

Picture 44. Significant area of wide shallow riffle, providing some of the vital habitat that is lacking in the reach upstream.

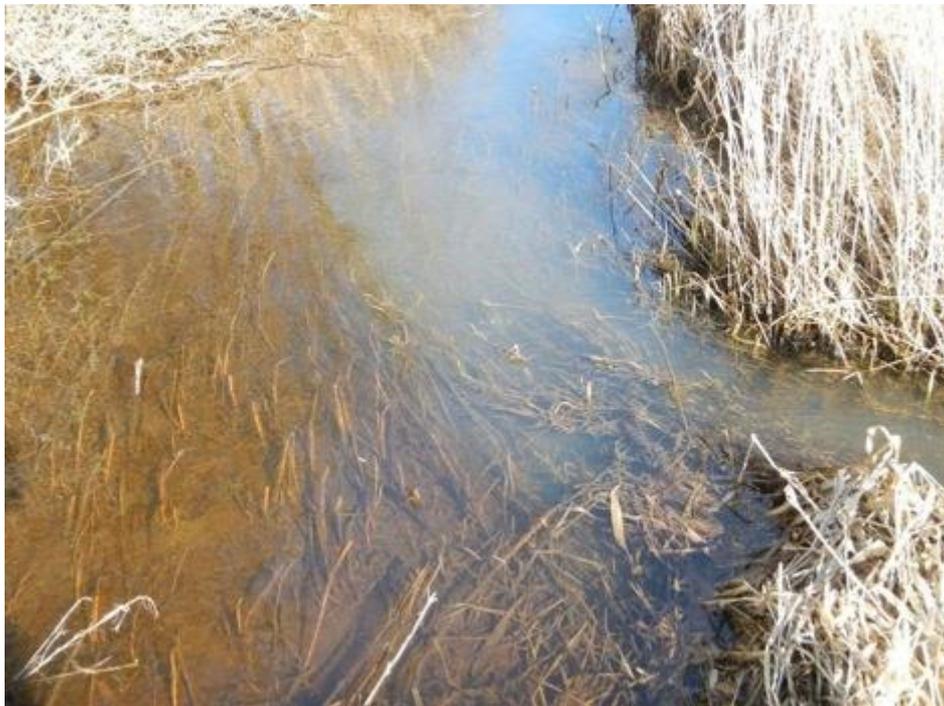
The contrast in water predominantly originating from Hallington Reservoir, as opposed to the natural water of the Pont system was again observed here (Picture 50). The darker water, with less fine sediment on the left of the picture is the Pont, and the lighter water on the right of shot is the tributary. Sedimentation from the tributary appeared to be a minor issue, to be expected, as it appeared to be subject to much of the channel alteration/maintenance and livestock issues of the rest of the catchment.

Picture 50. The contrast between water originating from Hallington, and the transfer, and a Pont tributary can be seen.
