**Walkover Assessment**

**River Wear – Frosterley Angling Club**

**July 2014**

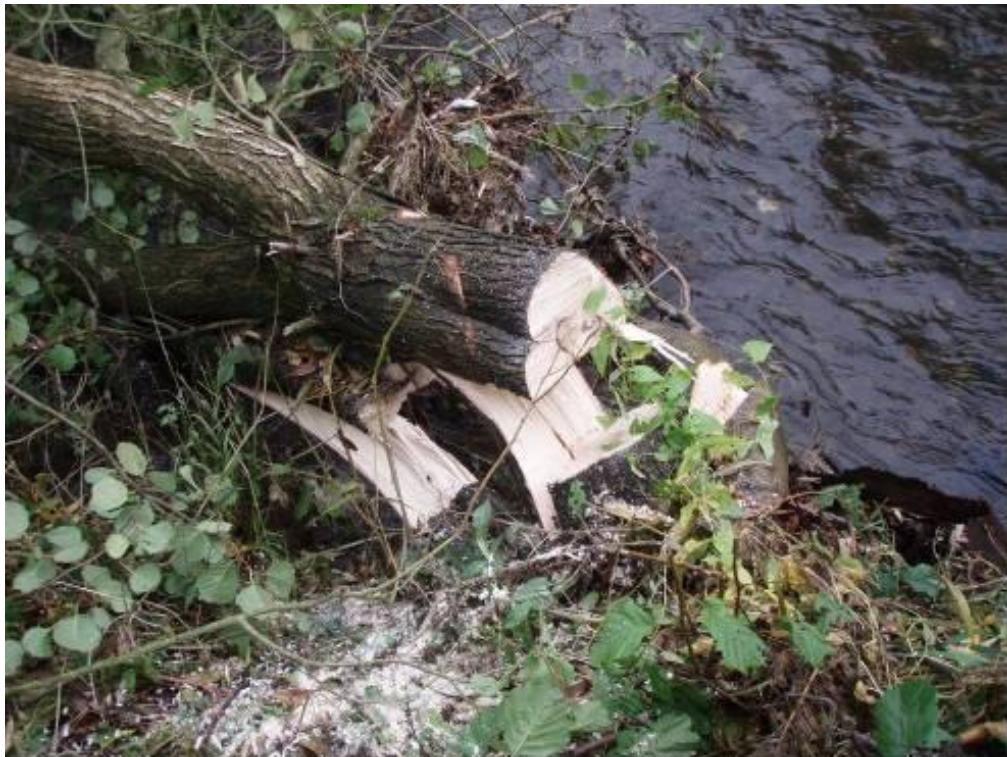
**Figure 15. Hinged willow**

The process involves gradually cutting part way through the trunk until it can be forced over into the channel (Figure 15). The depth of the cut should be limited to only that which is required to bend the limb over, thereby retaining a substantial hinge to provide maximum strength and health of the tree. This treatment can also be undertaken on any planted willows, once they have reached a suitable size.
