Advisory Visit

River Bure, Blickling Estate, Norfolk

December 2017

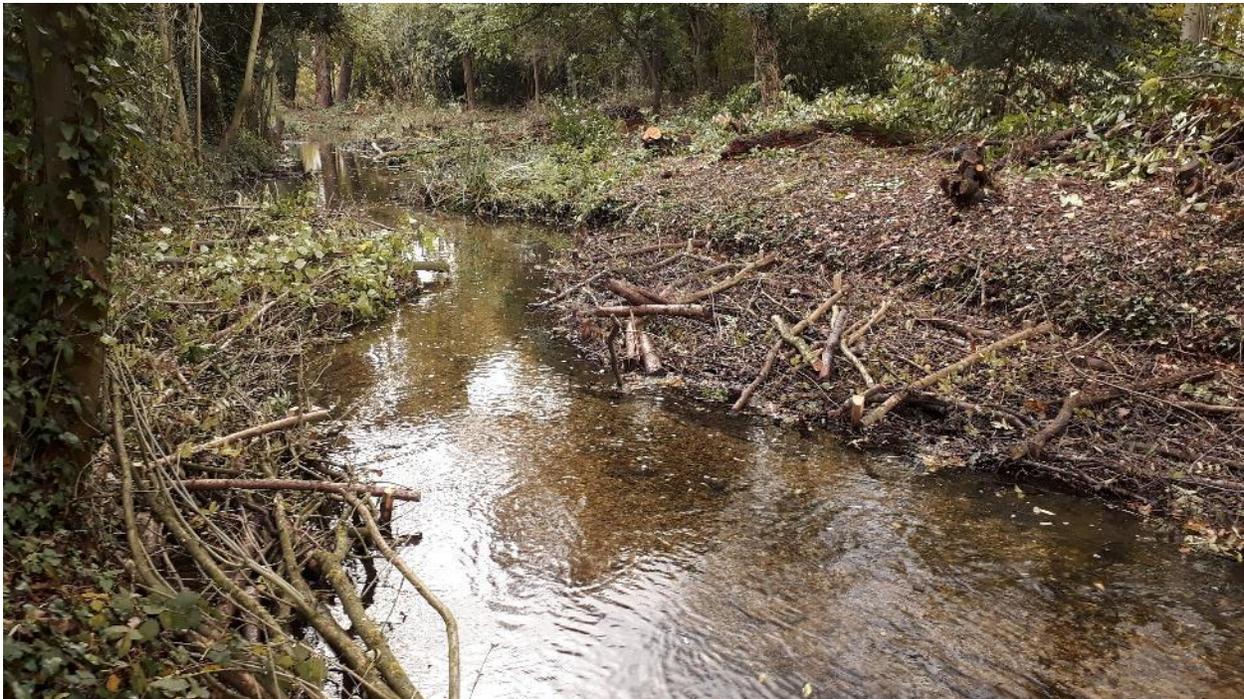
Picture 21 – Examples of low level brush berms created on the River Misbourne following tree thinning work. Brush berms can be used to protect banks from erosion, to create in-channel sinuosity and to entrain silt and sand.

The river is overwide in many locations. Channel narrowing using brush berms to re-align the flow within the existing channel would be beneficial. This could form the basis of a significant restoration project on this reach which would see tree thinning used to provide a source of woody material used for the benefit of the river.

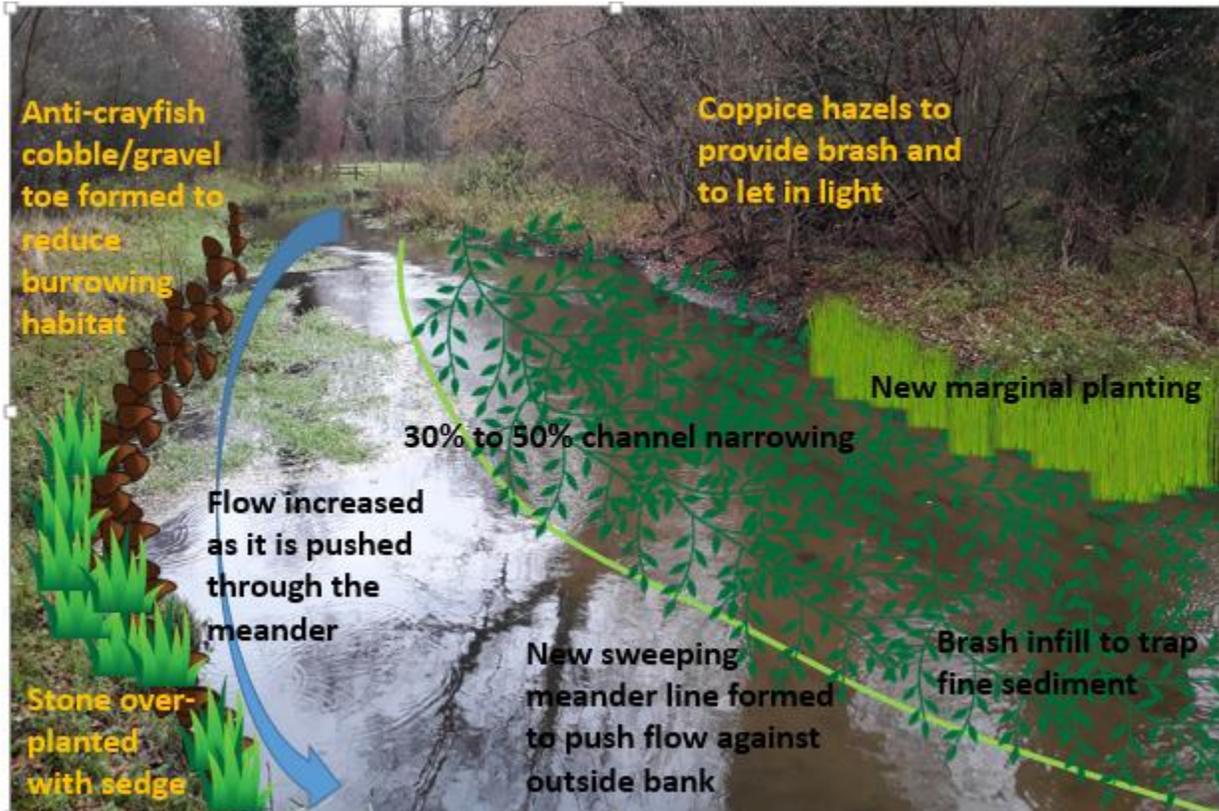
Picture 22 – An annotated picture to illustrate how various habitat enhancement approaches could be used to improve the River Bure’s wild brown trout holding capacity.

With regard to the signal crayfish issue, the creation of brush berms could provide further cover for adults. The club may wish to undertake a similar approach to that done on the River Lambourn at Hunts Green (see www.therrc.co.uk/sites/default/files/projects/p306.pdf). At that site the river was narrowed and a firm base of mixed-grade gravel was firmly bedded against the bank toe to produce a small bar which prevented scour from the river and burrowing by crayfish. This work was done extensively (>1mile). It has significantly reduced the adult holding capacity of the river which has led to a collapse in crayfish numbers (although not total elimination). However, the Bure is a more challenging river to undertake such work upon but it may be possible to strengthen some banks whilst undertaking a habitat enhancement scheme.

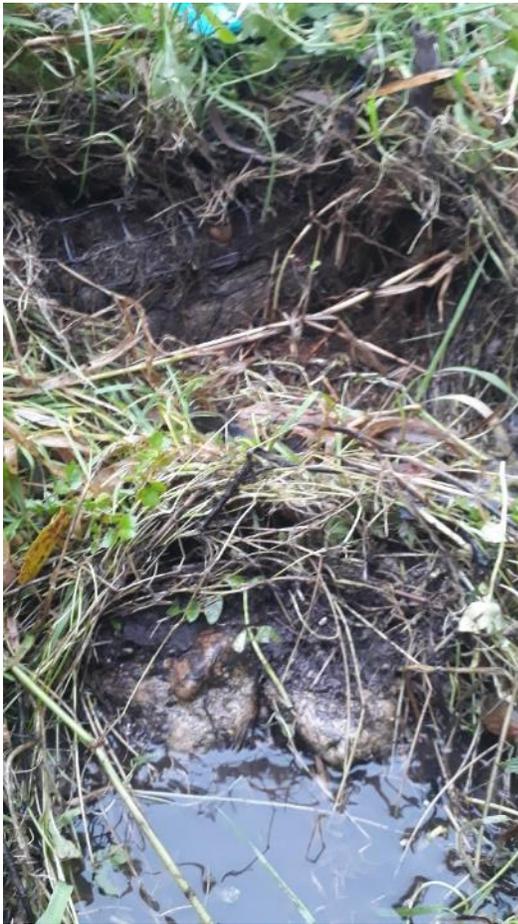
Picture 23 – The firm base created by compacted gravel against the bank toe had significantly reduced the burrowing opportunities for adult crayfish on the River Lambourn.

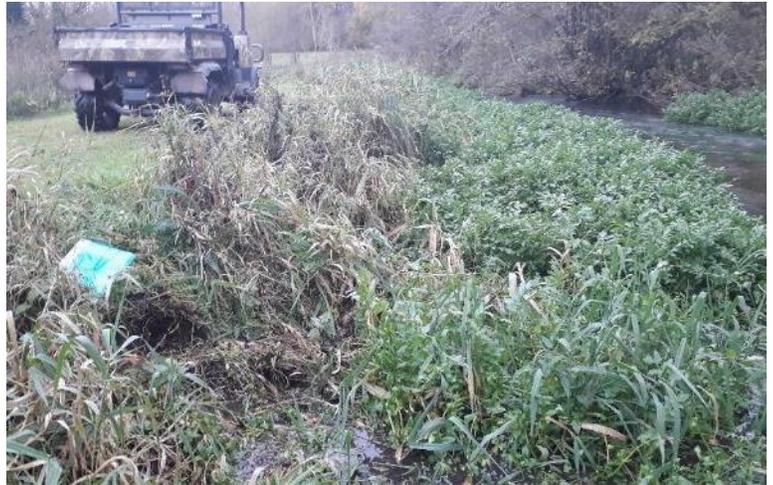
Picture 24 – On the River Lambourn, the compacted gravel bar had also been extended out to create a low level berm. That enabled marginal vegetation to grow out in to the channel producing natural channel narrowing at a range of water heights.

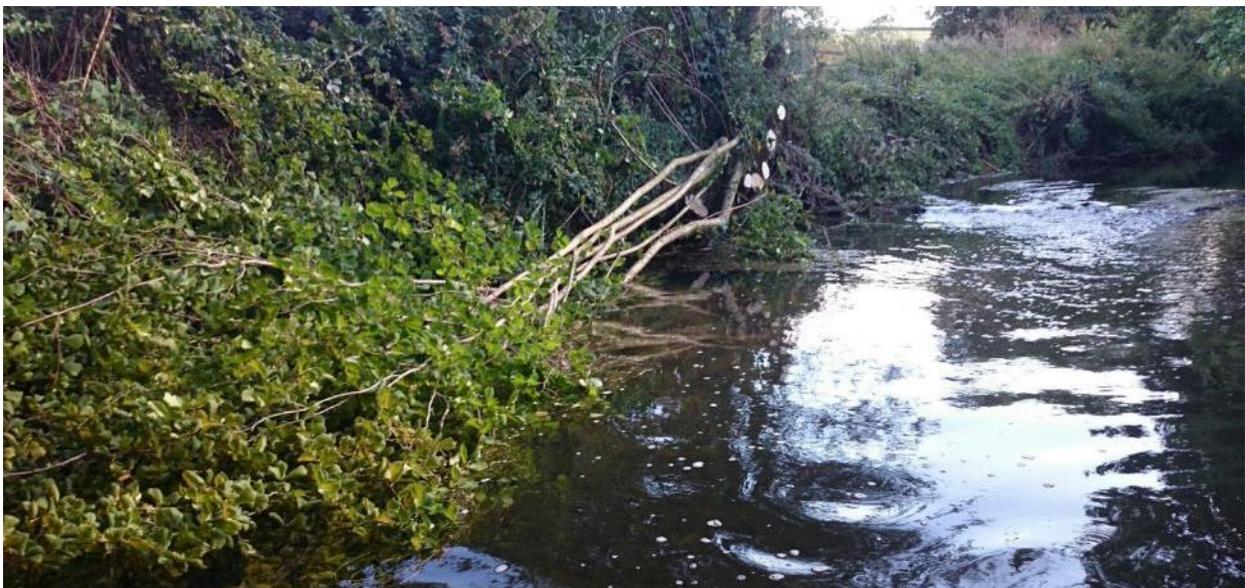
Picture 26 – An example of tree hinging, a simple and effective technique for increasing cover in a river.
