Advisory Visit
River Fynn, Suffolk
May 2019

Key findings

1.0 Introduction

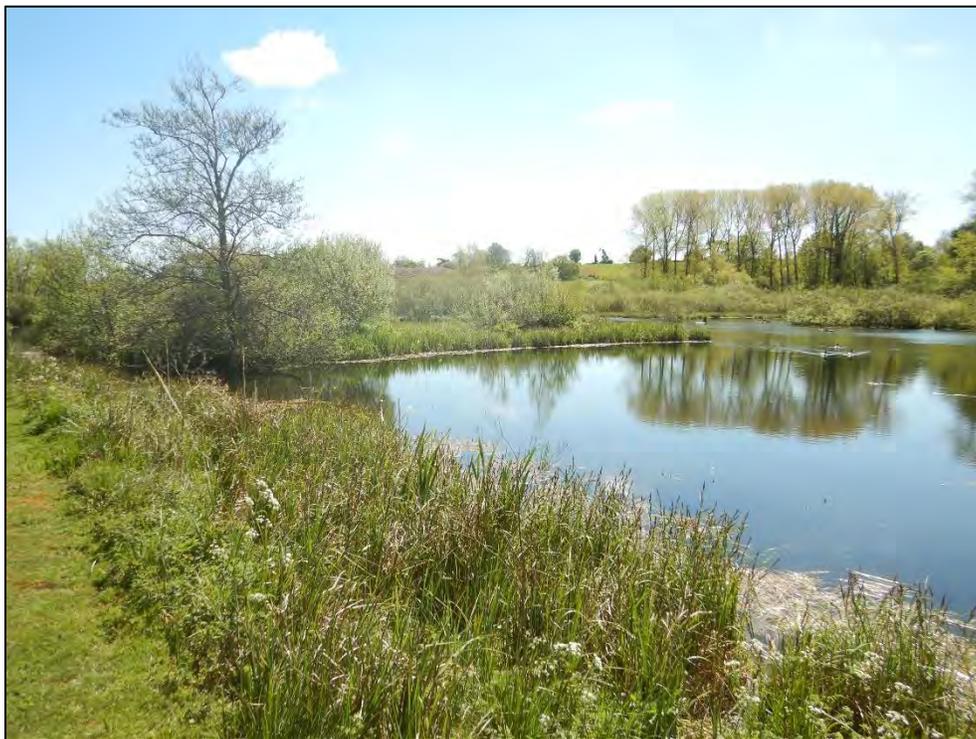
Moving upstream along a mown footpath and bank of ~20m width separating the river from the mere on its RB, there continued to be a general lack of trees especially on the LB. The mere provided a shallow open water habitat, complementing the river (pic 2).

Pic 2 – Playford Mere which is located within ~20m of the River Fynn.

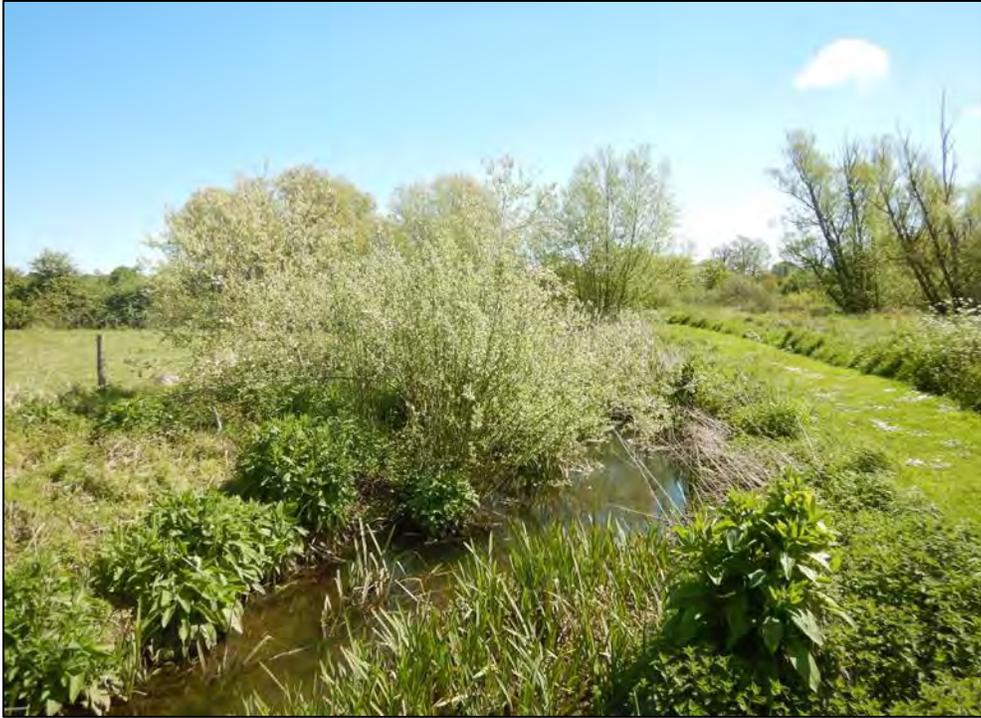
Continuing upstream, the riparian trees became slightly more numerous (pic 7) and greater in size and age. It is possible that previous drainage works had sought to retain trees near to property.

Pic 7 – Riparian willow providing cover and shade to the river.

- Tree planting should be undertaken, especially on the lower reaches. Quick-growing shrubs such as goat (or sallow) willow and hazel could be planted on the banksides (not just bank top) to provide cover over pool habitats. White and crack willow could be planted as larger trees that may ultimately act as a source of LWM to the river. Longer-term planting may see the use of oak, field maple and ash (subject to ash die-back) to provide bank strength.

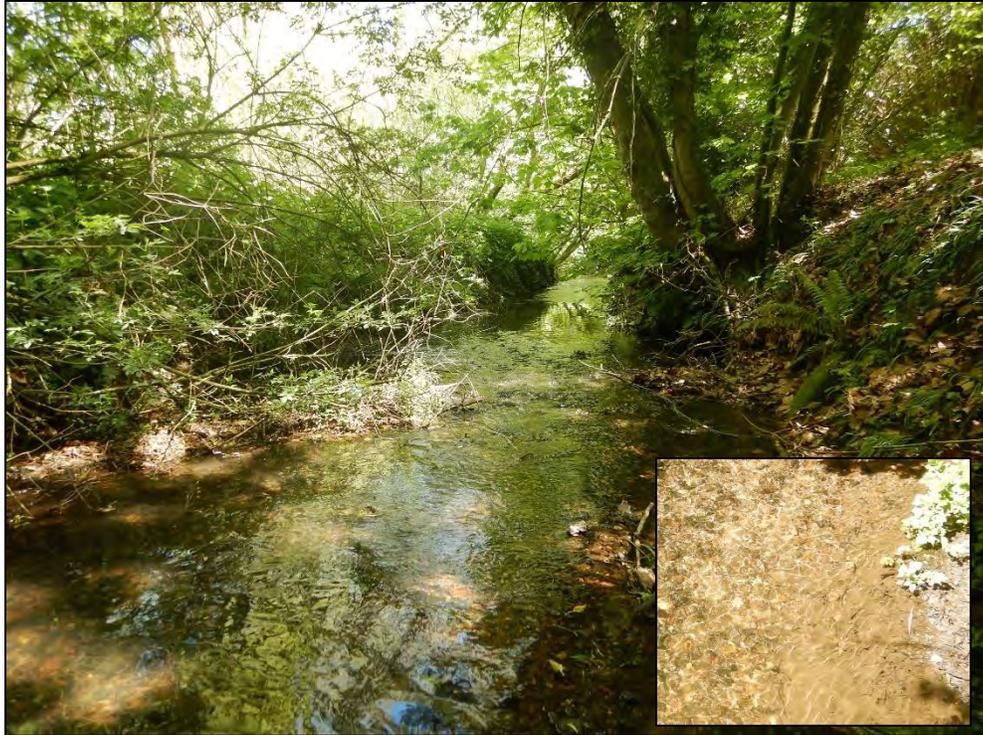
It was a pleasing contrast to be taken a short distance upstream to land within the same ownership at the nearby Playford Hall. The river at that point was a complete contrast to the focus of the advisory visit. The channel contained a shallow gravel bed (pic 12), consisting of a range of well-sorted particle sizes from large cobbles to grit. The river had a pool and riffle sequence along with accumulations of LWM (pic 13). Accumulated LWM provides habitat for invertebrates which in turn provide food for fish.

Pic 12 – The River Fynn near Playford Hall: a gravel-rich stream making a pleasant contrast to downstream habitat. Inset photo shows the well-sorted gravel mid-channel ranging to fine sediment and marginal vegetation.

- To secure a quick-win, it is recommended that simple habitat enhancement techniques (see recommendations) are deployed near Playford Hall utilising the adjacent trees and shrubs as a source of material to enhance the low-flow channel.

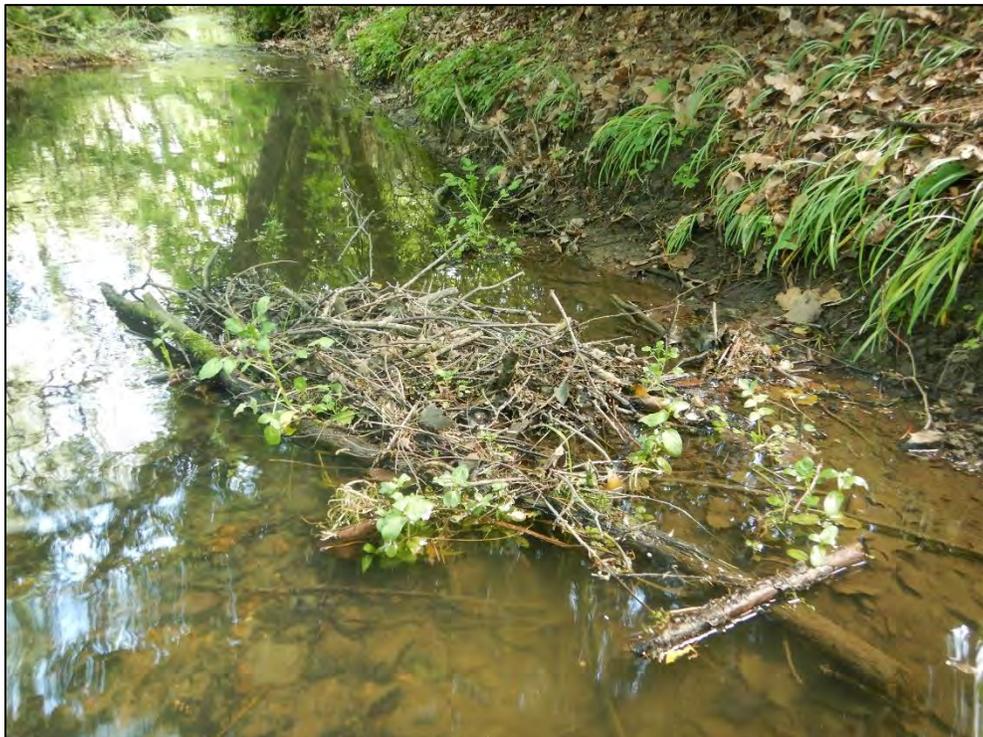
Pic 13 – Coarse woody material was present and provided cover for invertebrates, in addition to aiding sediment transport and marginal deposition.

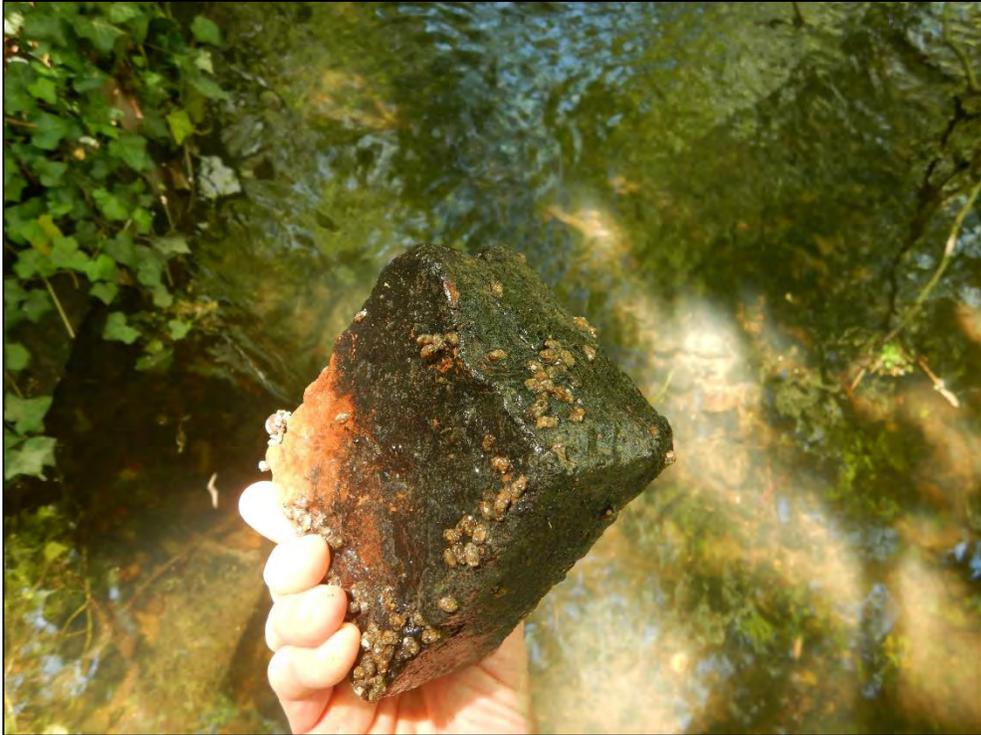
Inspection of large stones revealed an immature eel (of ~20cm), live freshwater mussels, cased and uncased caddis larvae (pic 14).

Pic 14 – Coarse substrates provided surfaces for invertebrates to utilise. The photo shows many cased caddis, but stone-clinging mayflies were also present. The occurrence of these invertebrates downstream would have been significantly restricted by poor habitat. (The stones also harboured small fish like eels and bullhead.)

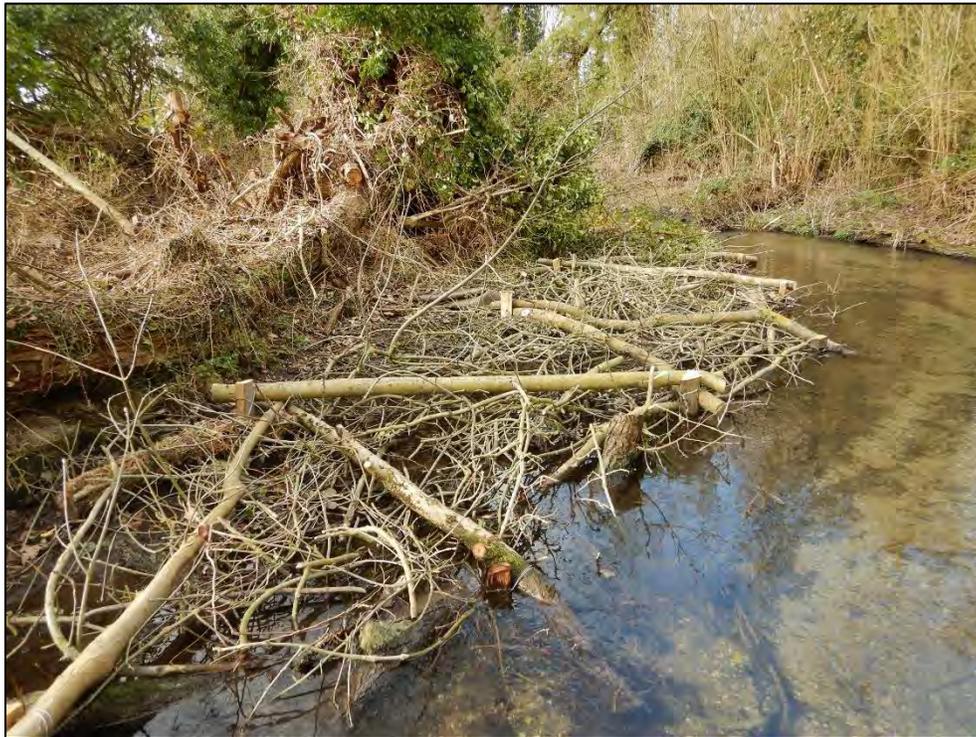
Pic 15 – A low-level brushwood ledge created on the River Misbourne following tree work.

Brushwood ledges (pic 15): provide complex cover at, and below, water level. Brush from tree thinning is pinned against the bank in alternating directions of increasing stem thickness, and is securely wired down or held with battens. The brushwood lattice provides niches for invertebrates and small fish, aids silt entrainment and provides a rooting substrate for plants to establish. In time (~3yrs), the brushwood ledge will become a vegetated berm if exposed to full sunlight. Vegetated ledges can also help to address bank erosion.

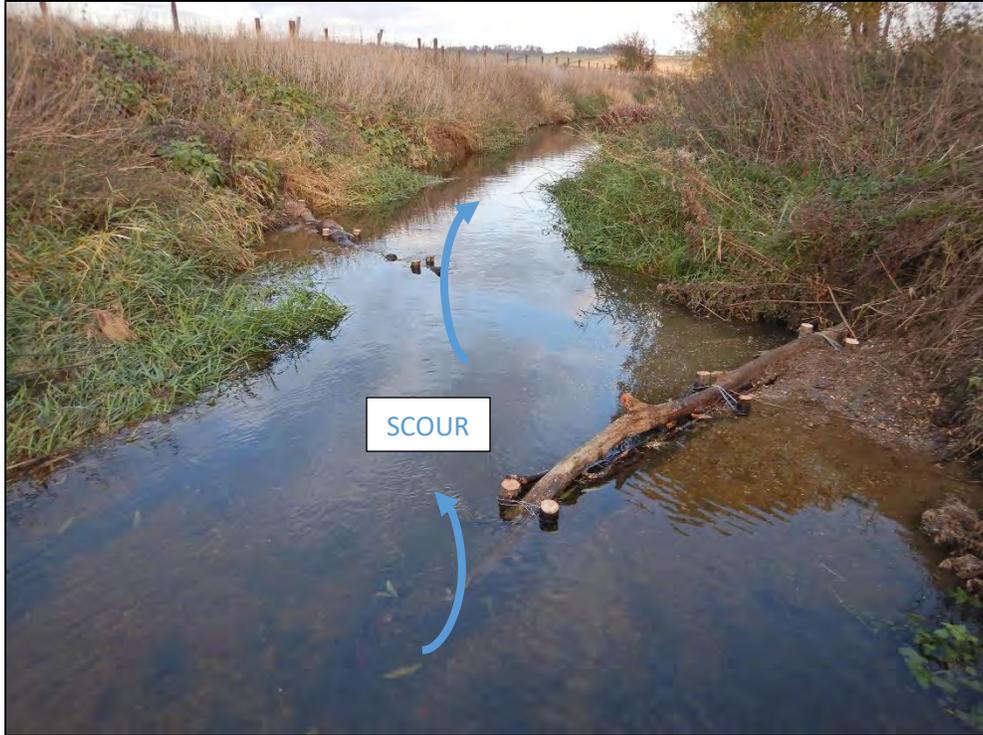
Pic 16 - Flow deflectors used to focus flow and scour to the centre channel of the River Welland.

Flow deflectors: these features can be used to increase flow diversity. They can be simple log deflectors or tethered tree stems. The complex flow they create results in bed scour, depth cover, sediment sorting and sediment transport.

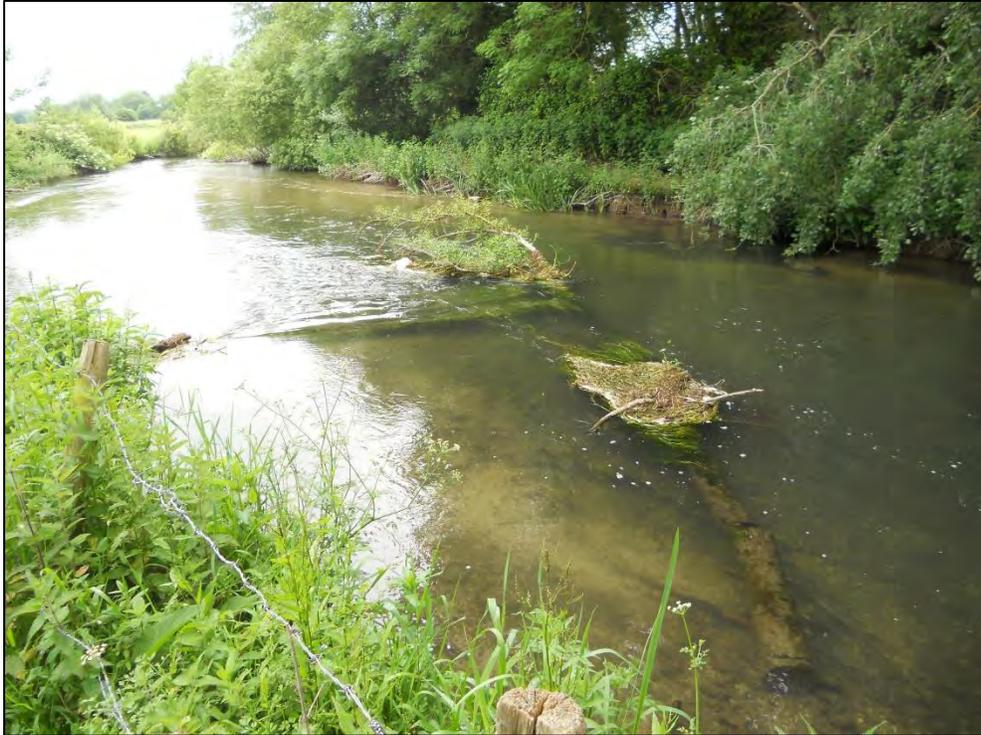
Pic 17 - LWM pinned to the bed of the River Nadder to increase habitat diversity.

Fixing LWM to the riverbed (pic 17): this is a means of increasing flow diversity and in-channel cover. In gravel-rich rivers such as the upper Fynn, the positioning of LWM mid-channel is likely to increase scour, thus aiding the development of deeper pools, new riffles and gravel bars. This diversifies the channel with complex flow patterns and greater habitat diversity.

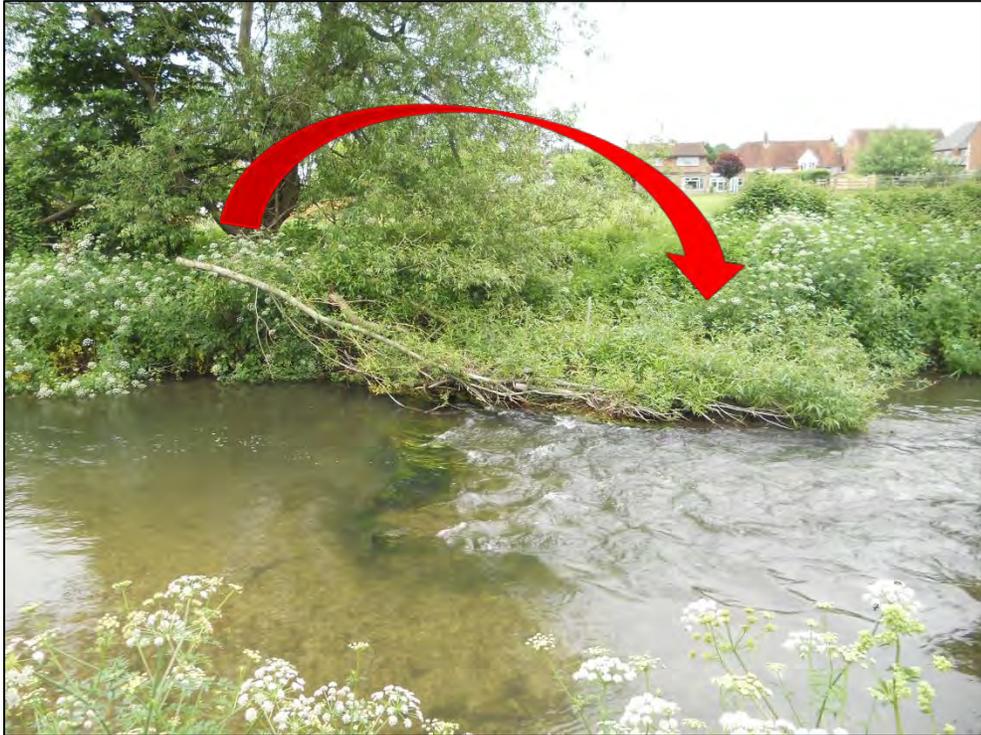
Pic 18 - Tree hinging, a simple and effective technique for increasing cover in a river

- Tree-hinging would be a simple first approach to managing the tree stock whilst providing cover at water level (pic 18). Trees (large or small) are cut to produce an effect similar to hedge laying. Species such as willow and hazel respond particularly well. Laying retains a living hinge that secures the cut stem to the tree stump. With the tree-top laid at water level, it provides excellent over-head cover, flow deflection and, if beneath the surface, increased habitat for aquatic invertebrates and cover for fish from predators.
