**Advisory Visit**  
**River Granta, Babraham, Cambridgeshire**  
**October 2019**

**Rob Mungovan**  
[rmungovan@wildtrout.org](mailto:rmungovan@wildtrout.org)

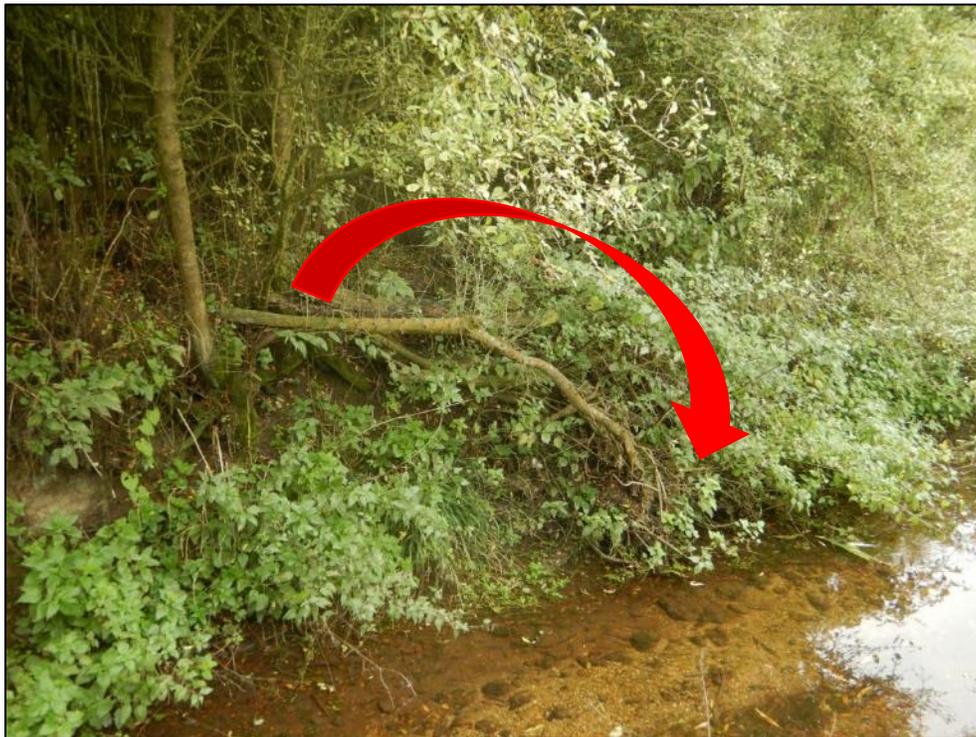
It was encouraging to find further evidence of habitat enhancement work; this time in the form of tree hinging of blackthorn (pic 8). Tree hinging is a technique favoured by the Wild Trout Trust for delivering instant woody cover at water level. Trees (large or small) are cut to produce an effect similar to hedge laying. Species such as willow and hazel respond particularly well. Laying retains a living hinge that secures the cut stem to the tree stump so structural strength is retained. With the tree-top laid at water level, it provides excellent over-head cover, flow deflection and, if beneath the surface, increased habitat for aquatic invertebrates and cover for fish against predators.

Pic 8 (TL 49742 51382) – Tree hinging of blackthorn.

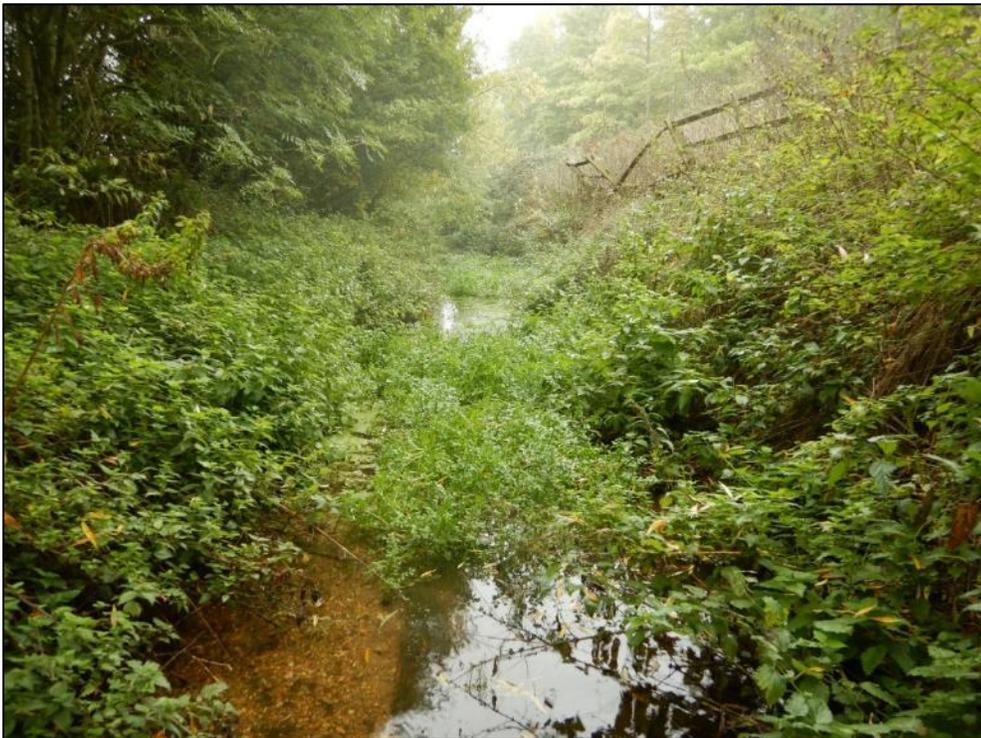
From this point upstream (TL 49723 51391) the river lost the feel of a "maintained drain" and started to have a greater occurrence of marginal and aquatic vegetation, with areas of clean gravel present (pic 11). Notably, the water had lost its brown tint. It is supposed that the EA did not use herbicide above this point.

Pic 11 (TL 49753 51372)– The river provides good marginal cover, clean gravel and has lost the brown tint to the water.

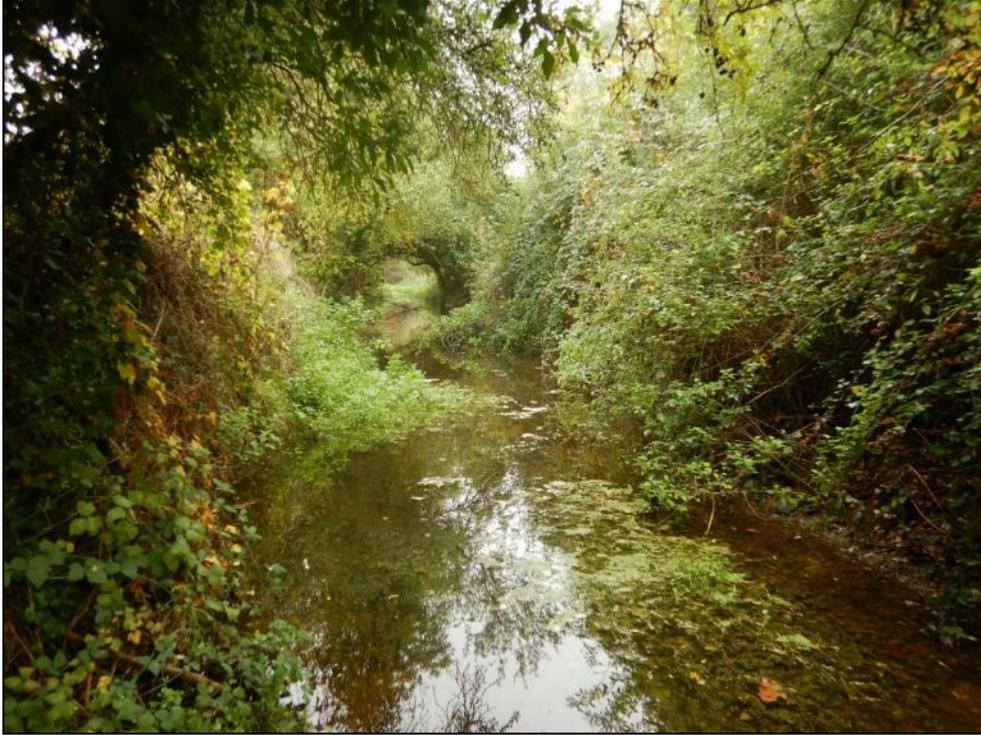
In stark contrast to the “maintained drain” reaches seen downstream, the river was more open with banks that graded down to water level at a relatively shallow angle, providing opportunities for plants to find a niche. It was hugely encouraging to see lesser water-parsnip growing from both banks, narrowing the channel and creating in-channel sinuosity (pic 12). This enhances flow diversity, aids sediment transport and increases habitat diversity. The trailing of bramble onto the water provided important overhead cover when no other woody material was present (due to the EA having removed it in the spring).

Pic 12 (TL 49803 51358) – Lesser water-parsnip enhances flow sinuosity.

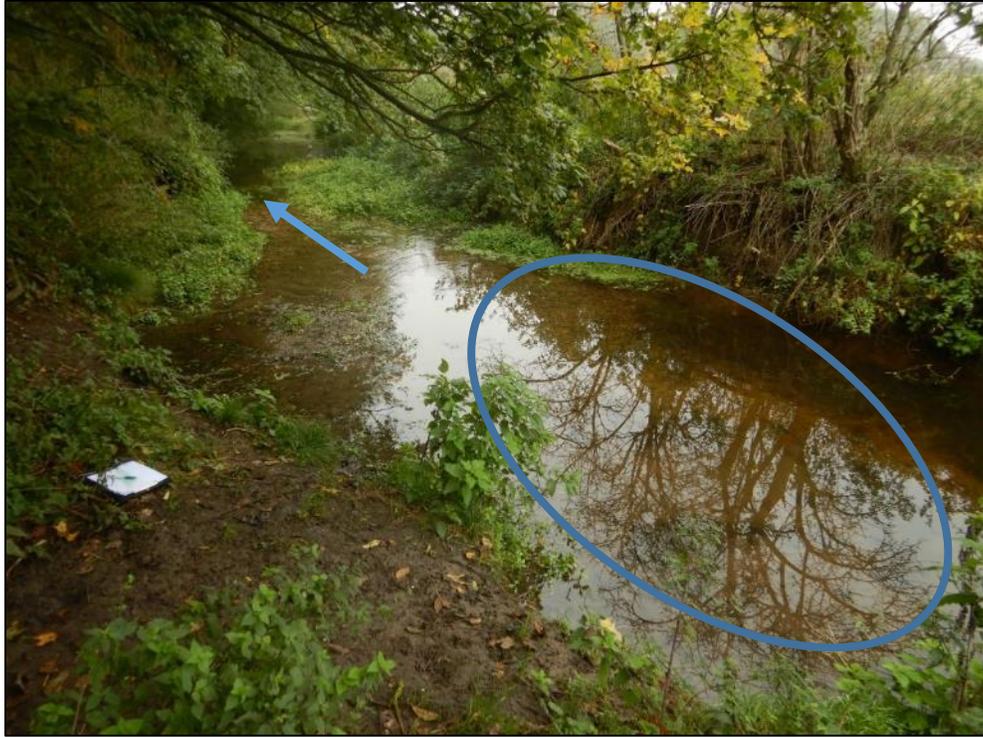
The bedform showed a greater extent of variation, with deeper pools (to 0.70m) providing depth refuge during the drought period. The presence of watercress upon the gravel riffles provided enough cover to sustain juvenile trout (pic 21).

Pic 21 (TL 50086 51253) – An example of a pool (blue oval) and riffle habitat (blue arrow).

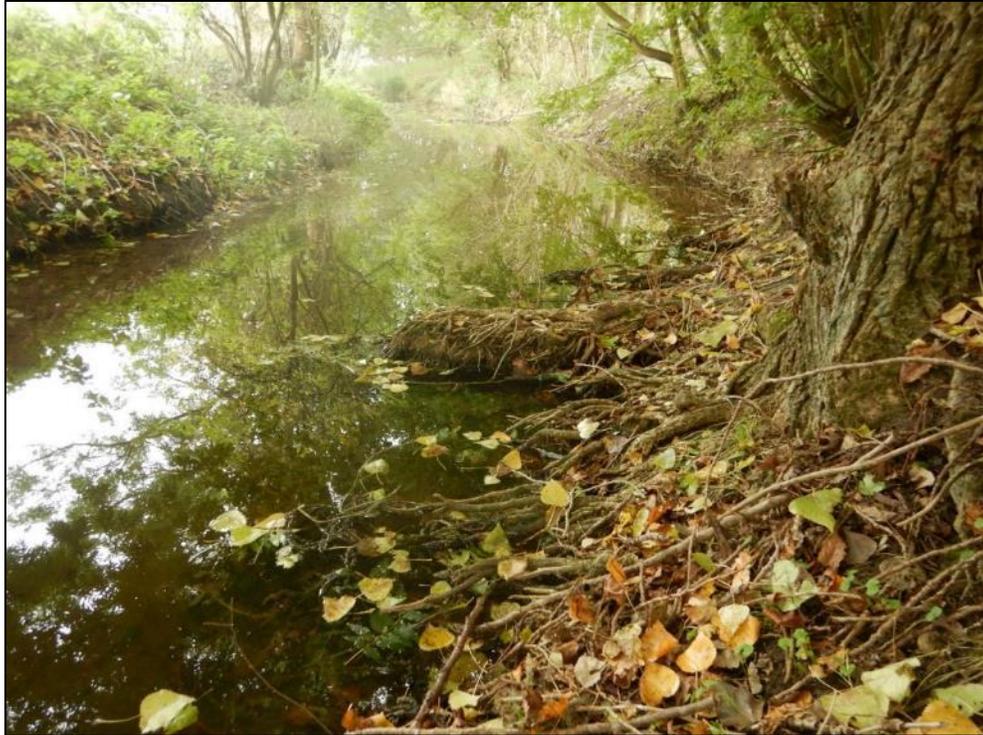
The river became lined by pollard willows with their roots providing good underwater cover for both fish and invertebrates (pic 22). The roots also give bank strength where people and dogs access the river. Occasional plants of pendulous sedge provided the most notable marginal cover where shade suppressed most vegetation. Pendulous sedge is a useful plant for marginal cover, particularly where recreational pressure suppresses other plants. Its tussock growth form makes it resilient to trampling, and it is not readily grazed by deer nor rabbits.

Pic 22 (TL50225 51219) – Willow tree roots provide important underwater cover and bank strength.

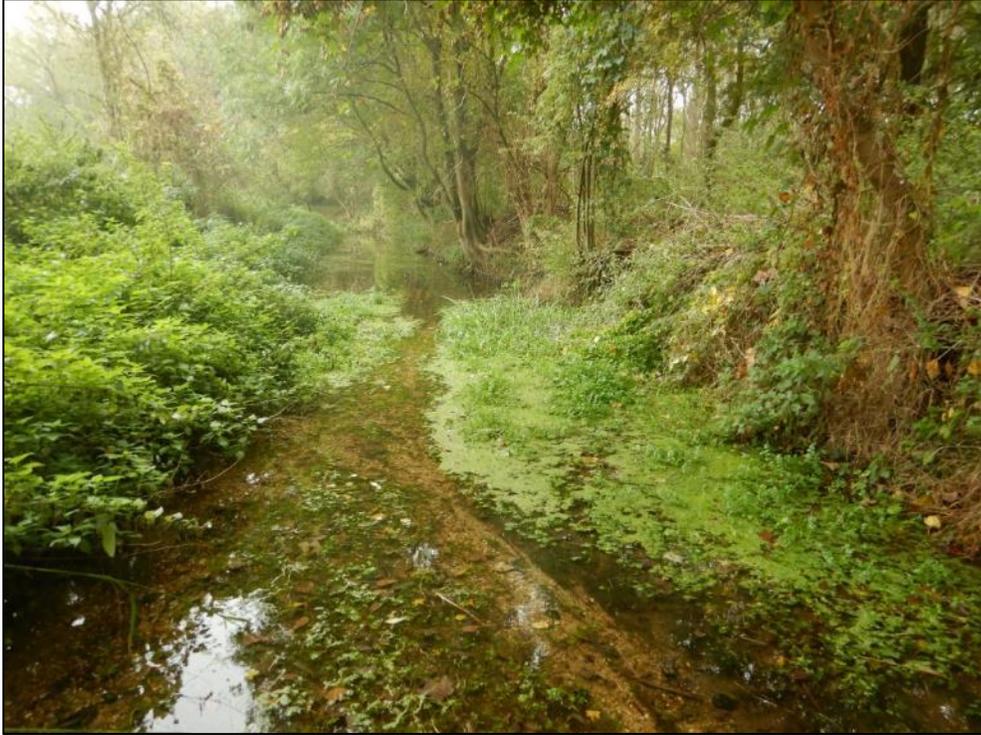
Interestingly, a point was reached where the width was  $\sim 5.5\text{m}$  with trees casting shade. Consequently, the in-channel flora was limited (pic 23). That view contrasted starkly with the view immediately above it (pic 24), where light reached the river and vegetation grew resulting in abundant marginal cover.

Pic 24 (TL 50289 51217) – The same location of river as pic 23 but looking upstream; light reaches the river initiating beneficial vegetation growth.

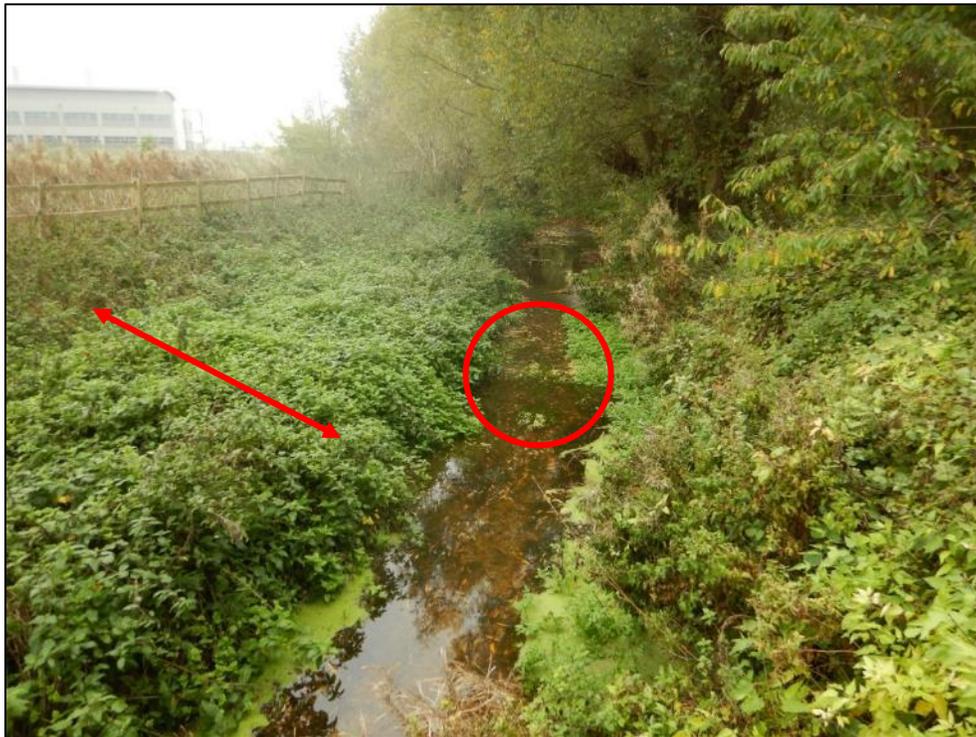
The bed of the river at TL 50572 51106 remained relatively free of fine sediment, and occasional plants of water crowfoot were present suggesting that even in an exceptionally low-flow year, the Granta has the capacity to sustain flow-sensitive plants and flow-sensitive species such as trout. The river then became deeper again (most likely due to past dredging) and lacked flow diversity and bed scour. Consequently, the riverbed was choked by organic matter and fine sediment.

Pic 26 (TL 50572 51106) – The Granta near to BRC, note the wide vegetated berm (red arrow) and the water crowfoot plants (red circle).

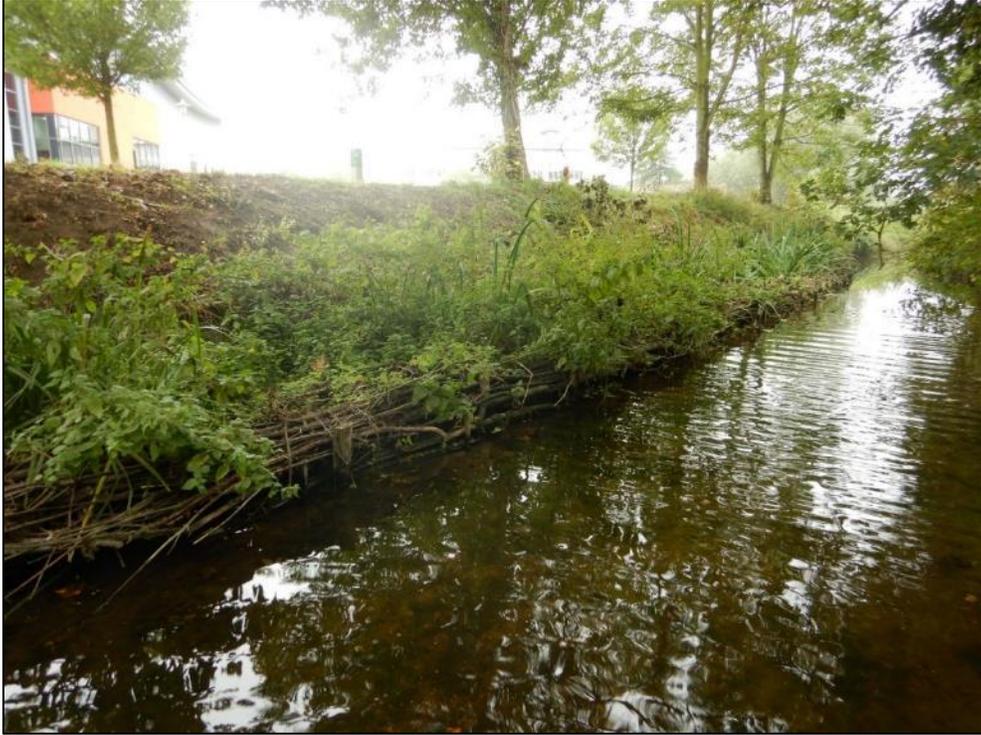
Alongside the BRC, previous river enhancement structures were found. Pre-planted coir rolls set on hazel faggots were used to narrow the channel and to provide marginal habitat. The original work appears to have been topped-up by recent brushwood addition.

Pic 29 (TL50784 50685) – A well-constructed brushwood ledge providing marginal habitat.
