Advisory Visit

River Granta, Cambridgeshire

August 2019

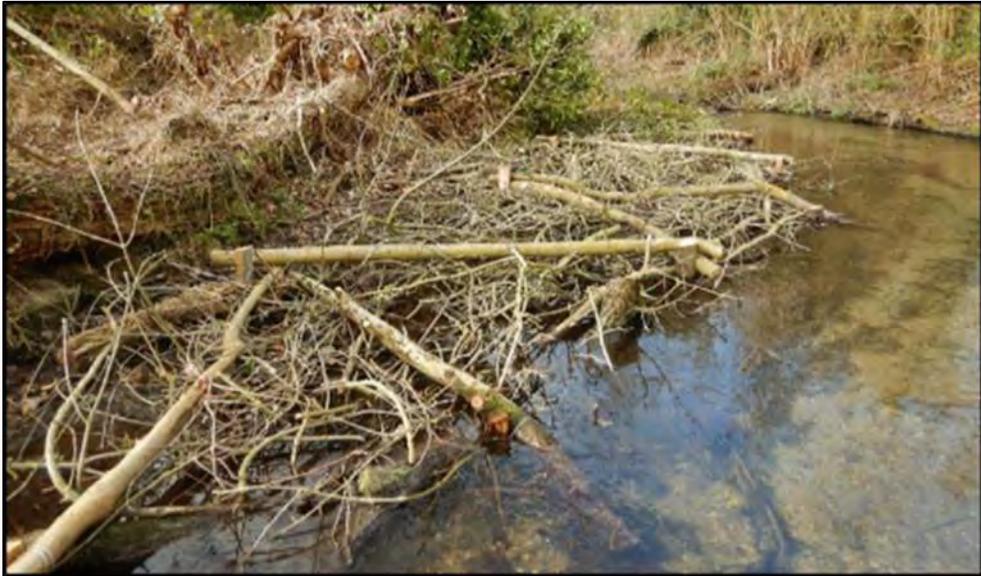
Pic 31 – A low-level brushwood ledge created on the River Misbourne following tree thinning work. Brushwood can be used to protect banks from erosion, to create in-channel sinuosity and to entrain silt and sand. They are particularly effective for enhancing low-flow rivers.

- **Brushwood ledges:** these features can be created following tree works. A brushwood ledge provides complex cover at, and below, water level. Brush from tree thinning is pinned against the bank in alternating directions or increasing stem thickness, and is securely wired down or held with battens. The brushwood lattice provides niches for

invertebrates and small fish, aids silt entrainment and provides a rooting substrate for plants to establish. In time (~3yrs) the brushwood ledge will become a vegetated berm if exposed to full sunlight.

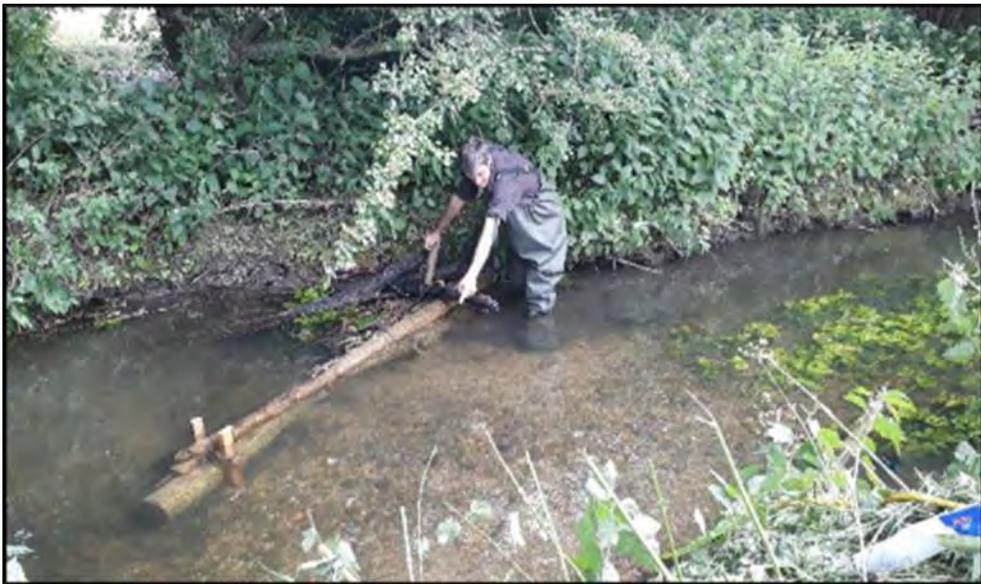
Pic 32 - A flow deflector used to focus flow and scour into the centre of the channel.

- Flow deflectors: these features can be used to increase flow diversity and bed scour. They can be simple log deflectors or tethered tree stems. The complex flow that arises creates increased depth variation, cover and sediment sorting.

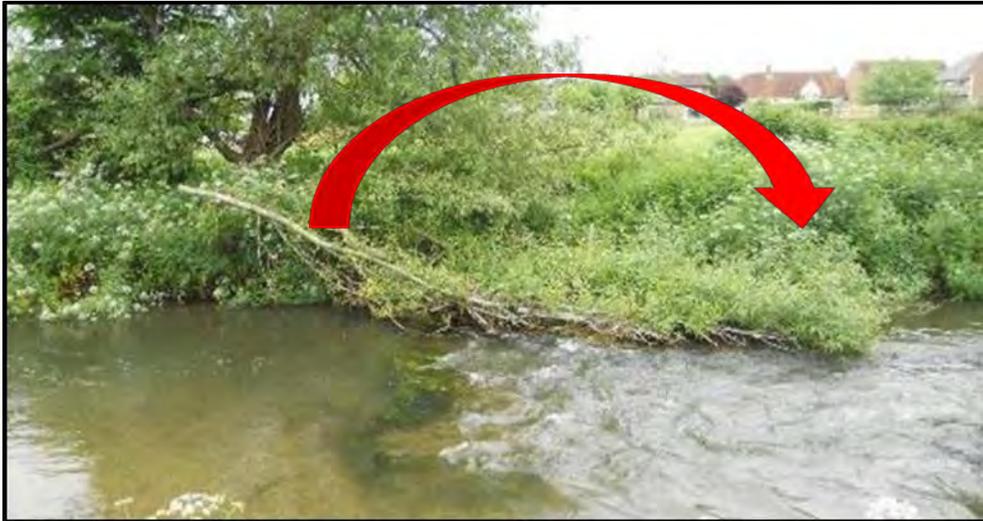
Pic 33 - An example of tree hinging, a simple and effective technique for increasing cover in a river.

- Tree-hinging would be a simple first approach to managing the tree stock whilst providing cover at water level (pic 33). The process and benefits of tree-hinging has already been discussed on page 19.

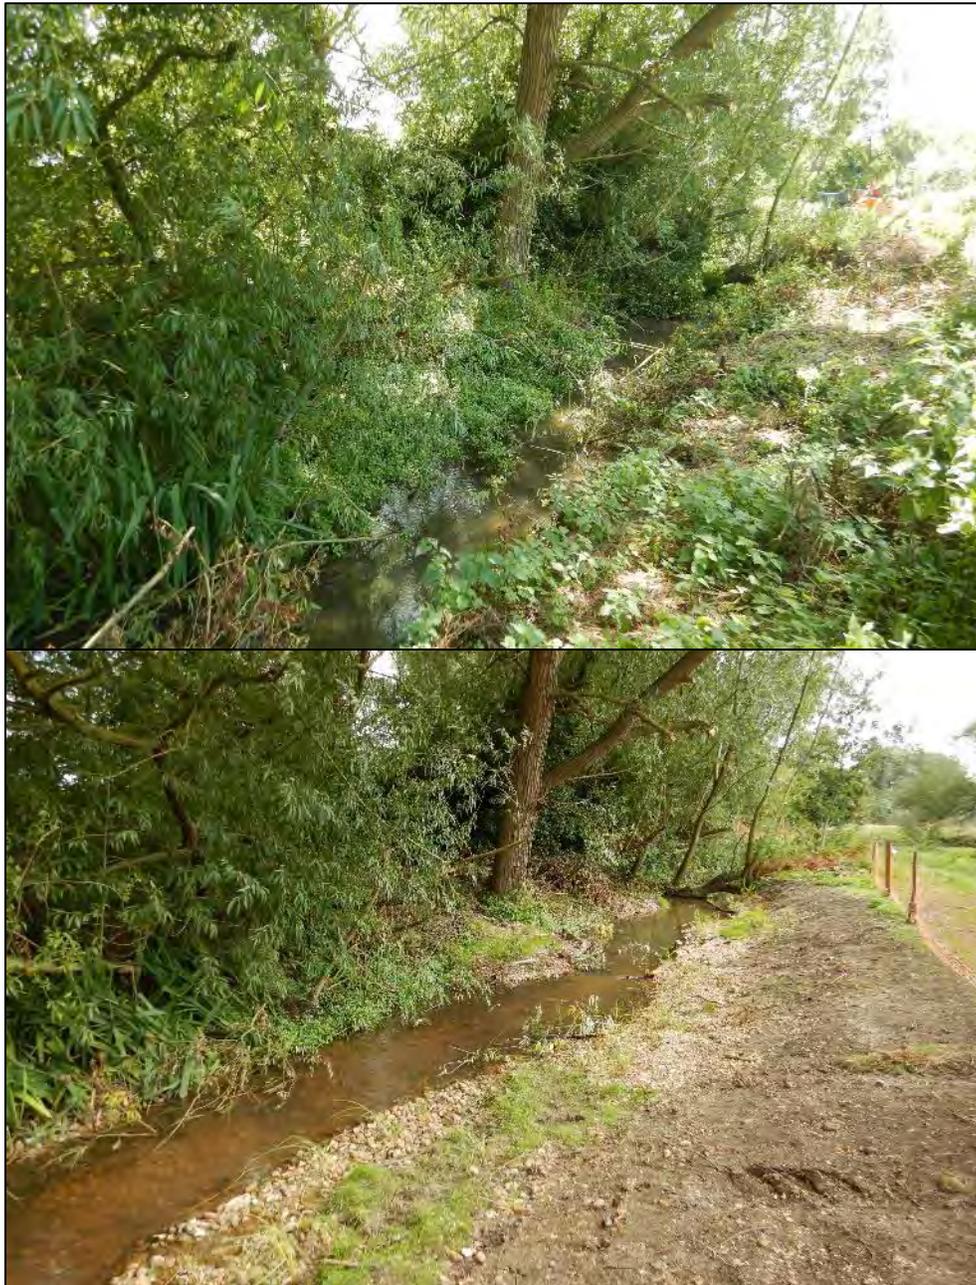
Pic 34 – Before and after views of bank re-grading work on the River Shep to enhance public access to the river at a less ecologically sensitive location. The river was previously steep-sided and inaccessible, with a deep muddy bed. It is now a clean stream suitable for children to explore.

Identify a suitable location at the recreation ground to allow bank re-grading work to specifically enhance public access to the river. This could be through a combination of bank adjustment and/or the placement of gravel shoals to

enable ease of access to the river. Provision of new, and better, river access points would allow some of the more damaging dog slides to be blocked off.
