Advisory Visit

River Roden, Shropshire

June 2019

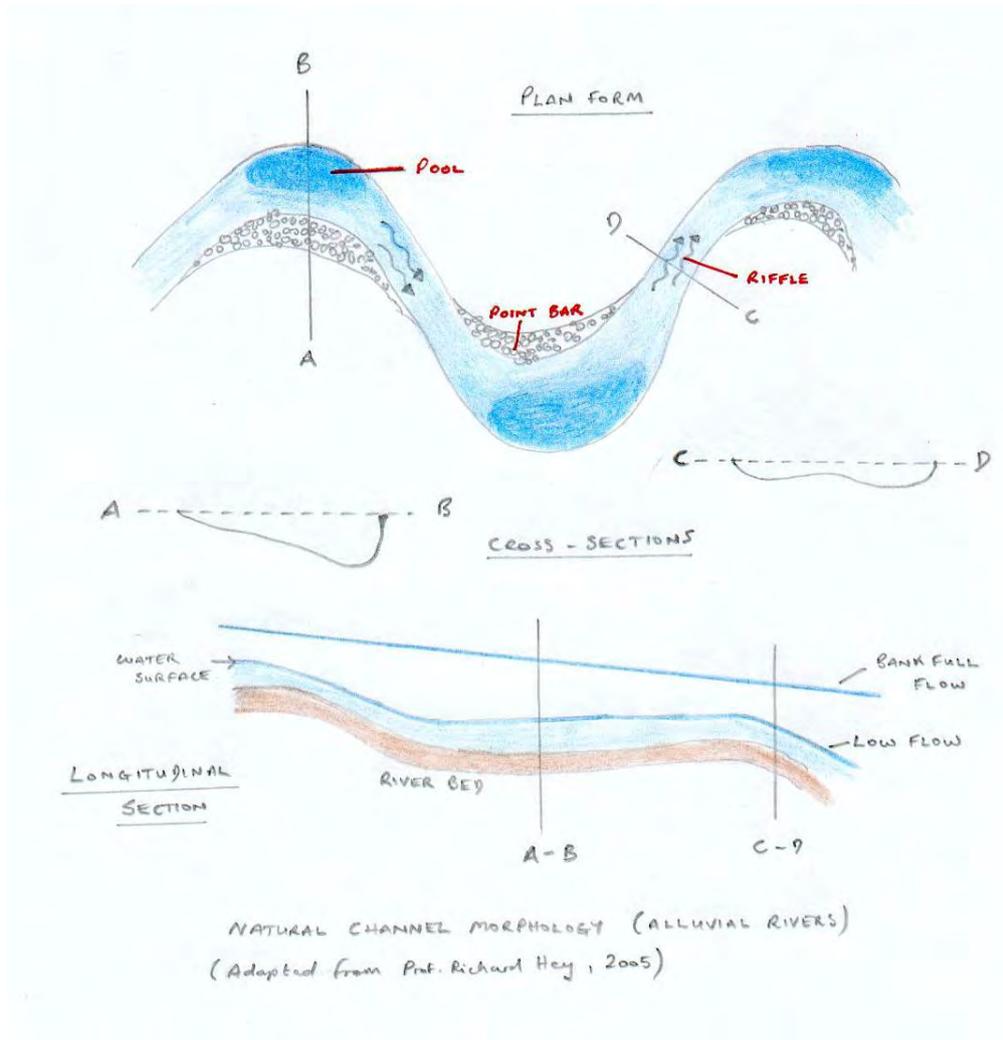
Throughout the reach inspected, the form of the river channel indicates it has been engineered to improve land drainage: the channel is over-wide and incised well below the natural level of its floodplain. The flow pattern within the channel is predominantly a steady glide, with an absence of the natural pool-and-riffle sequence that should occur in an unaltered river of this type (Figures 1 and 2).

Figure 1 Showing the natural form of alluvial rivers, with a pool-and-riffle sequence, asymmetric depth profiles and a 'stepped' gradient. The diversity of depths and flow velocities, plus the resultant grading of bed materials, are the fundamental elements of good river habitat and productivity for aquatic invertebrates and fish.

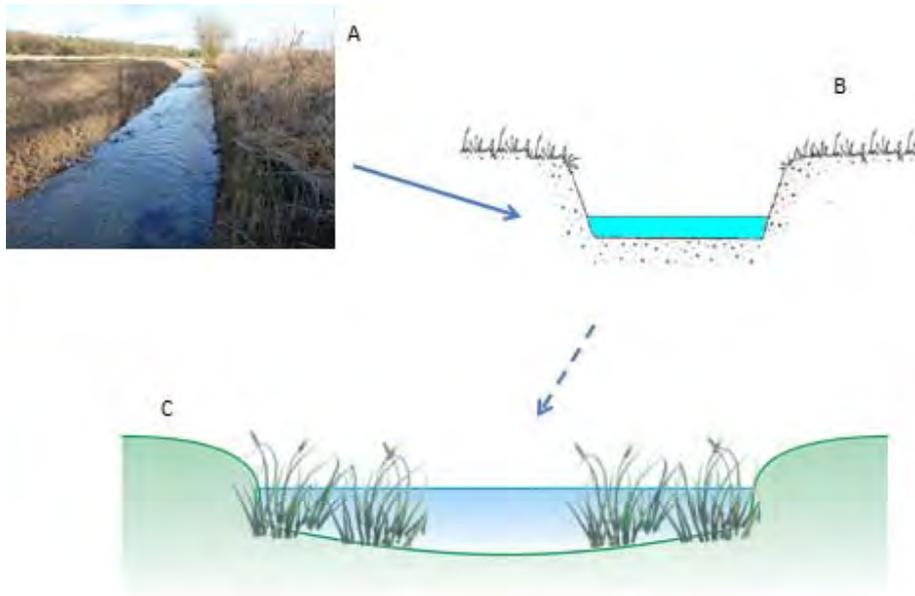
Figure 2 Engineered channels (A) have a uniform, trapezoid-shape cross-section (B). At low flows, these channels tend to be shallow and have little variation in depth, riverbed composition and flow pattern, thus lacking the features needed for healthy fish populations. The greater bank-full flows contained by these modified channels have much higher energy than natural channels (which spill out earlier on to the flood plain) and create a hostile environment for fish during periods of high flow. Where channels have also been widened, over time the river tends to return to its former width through deposition of sediment and colonisation with plants (C), depending upon the amount of shading.

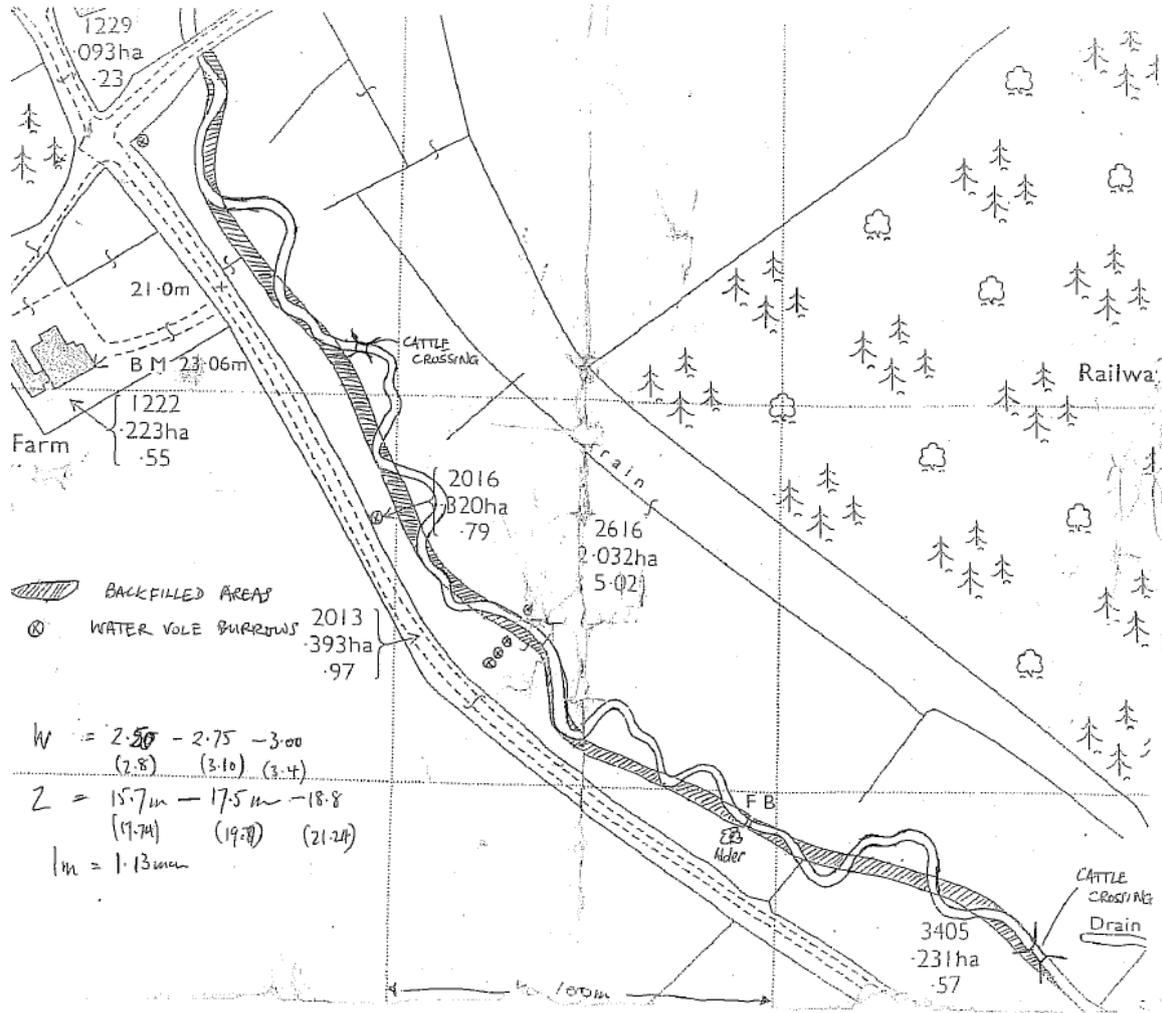
Figure 3 Plan of river re-naturalisation project carried out on River Glaven, Hunworth, Norfolk. The shaded line is the original engineered channel, the open line is the new, restored course. The engineered channel was back-filled with spoil excavated from the new channel (River flowing SE to NW) and large quantities of spoil removed from site to lower the floodplain.

- Investigate the feasibility of river restoration in the floodplain areas alongside Preston Springs and between the A49 and Harcourt Mill.

These are large capital projects which involve significant alterations to previously engineered channels, re-creating meanders and re-connecting the river with its floodplain. There are permanent alterations to land drainage (re-wetting of adjacent land) and implications for future land use that need to be considered at an early stage. Figure 3 and Photo 19 - Photo 21 illustrate such a project carried out on the River Glaven, Hunworth, Norfolk in 2010.

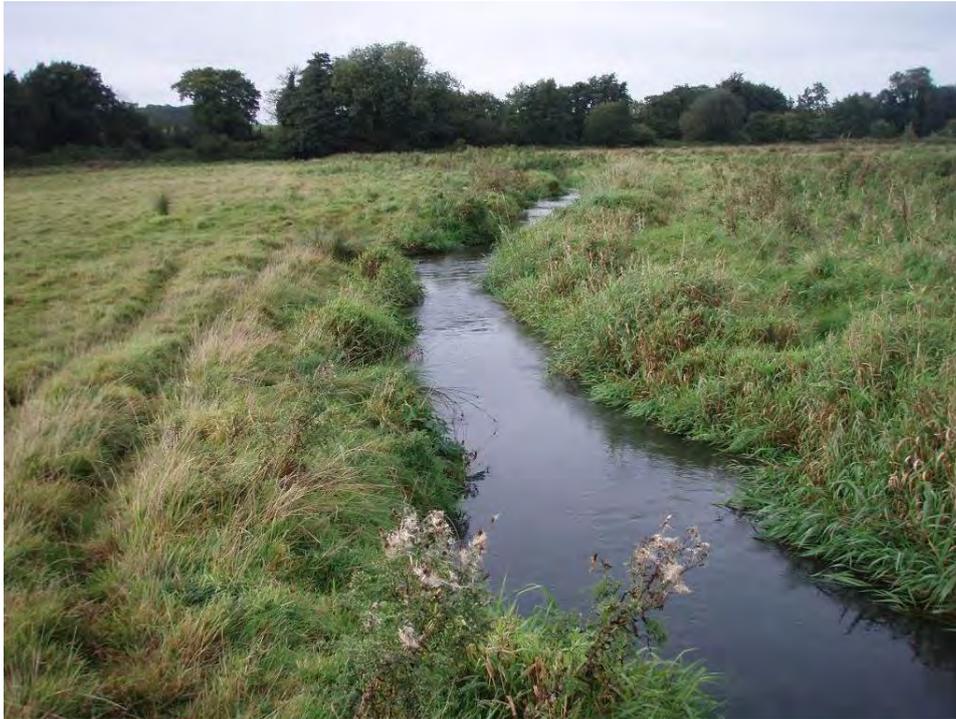
Photo 19 Typical condition of River Glaven pre-restoration – straightened, incised channel disconnected from the floodplain and lacking a pool-riffle sequence.

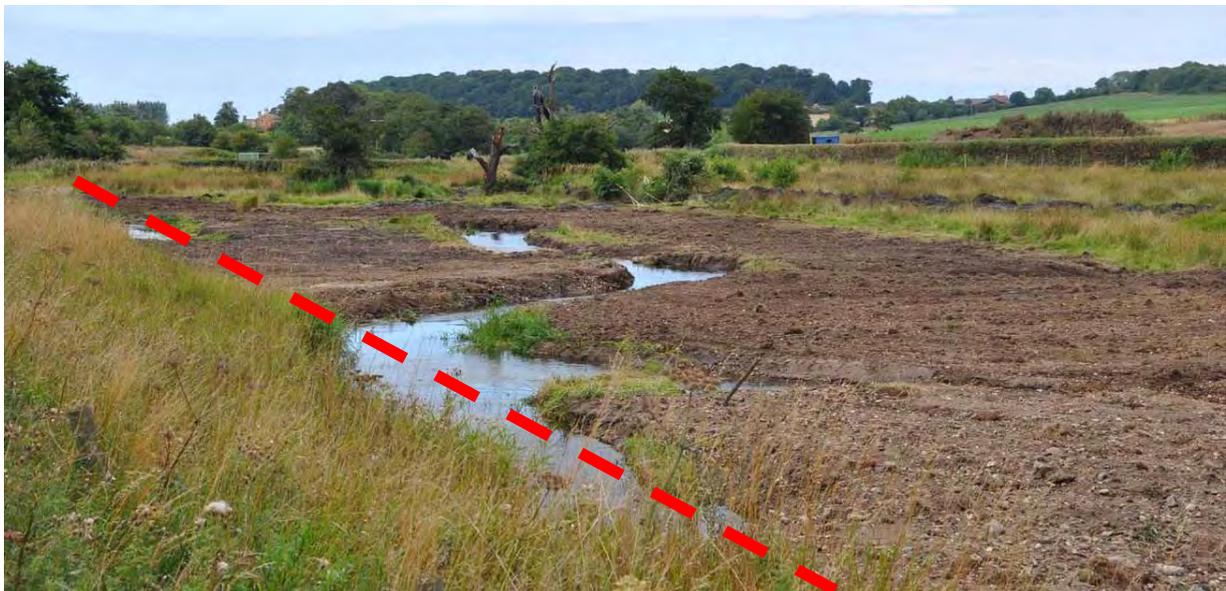
Photo 20 River Glaven at Hunworth immediately post-restoration. Original channel course indicated by dashed line. (Picture: Ross Haddow)

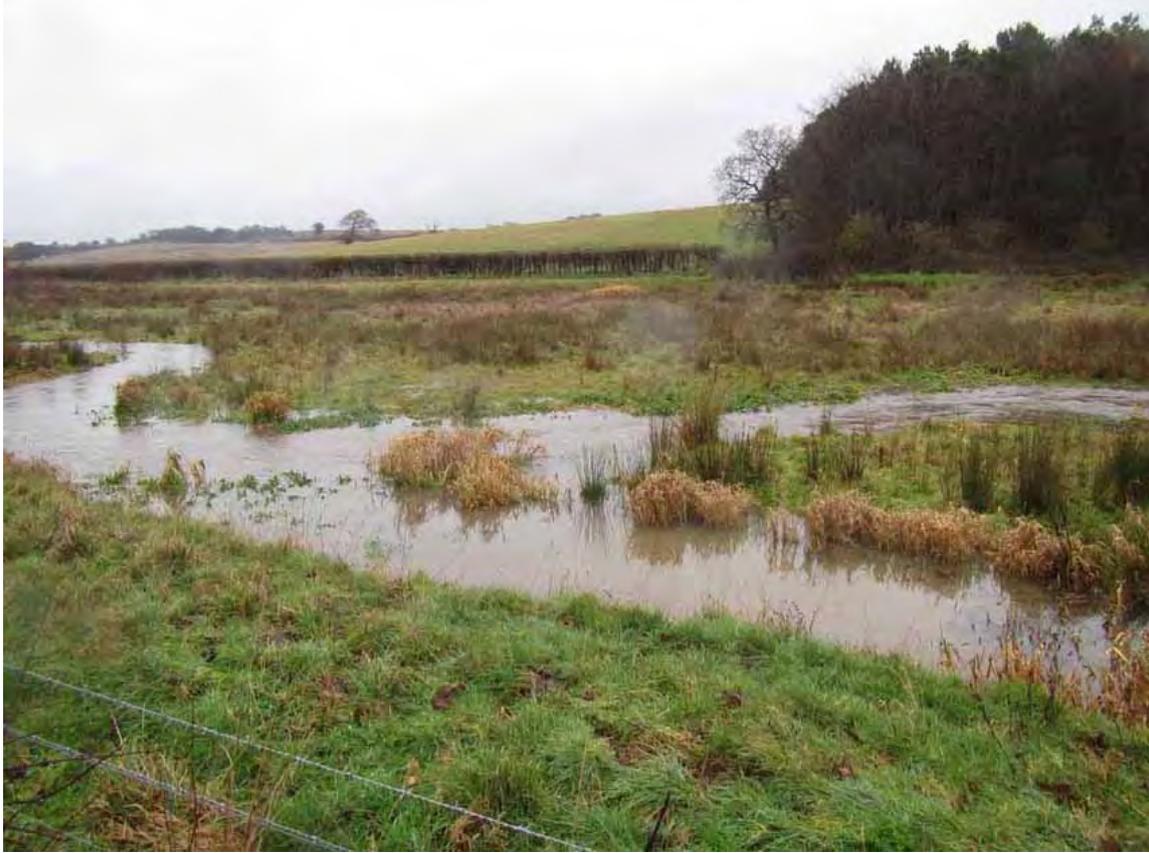
Photo 21 River Glaven at Hunworth four years post-restoration, in flood conditions, illustrating flood storage function of the reconnected floodplain (Picture Ross Haddow).

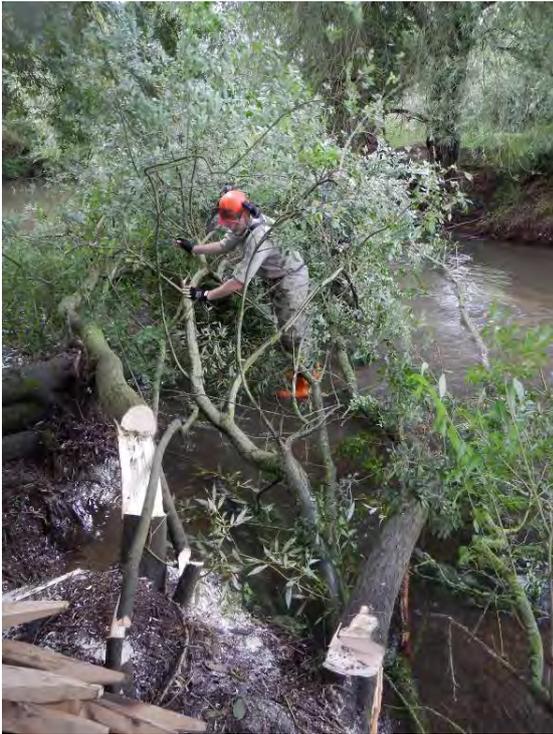
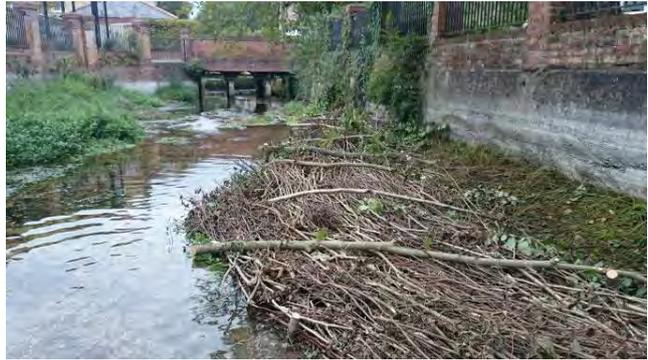
Photo 22 Hinging and laying trees into the river margins to narrow the channel and reduce shading (left) and brushwood shelf (right) to narrow the low-flow channel.

- If restoration of the natural form of the channel is not possible, various techniques could be used to improve habitat within the existing channel. Where the river channel is over-wide and shaded, hinging and laying trees and creating brushwood shelves (Photo 22, Figure 4) will introduce more variety to the river channel shape and encourage growth of aquatic plants. Where the river channel is deeply incised, bank re-profiling with an excavator could be used to create an inset floodplain and introduce more variety to the channel.

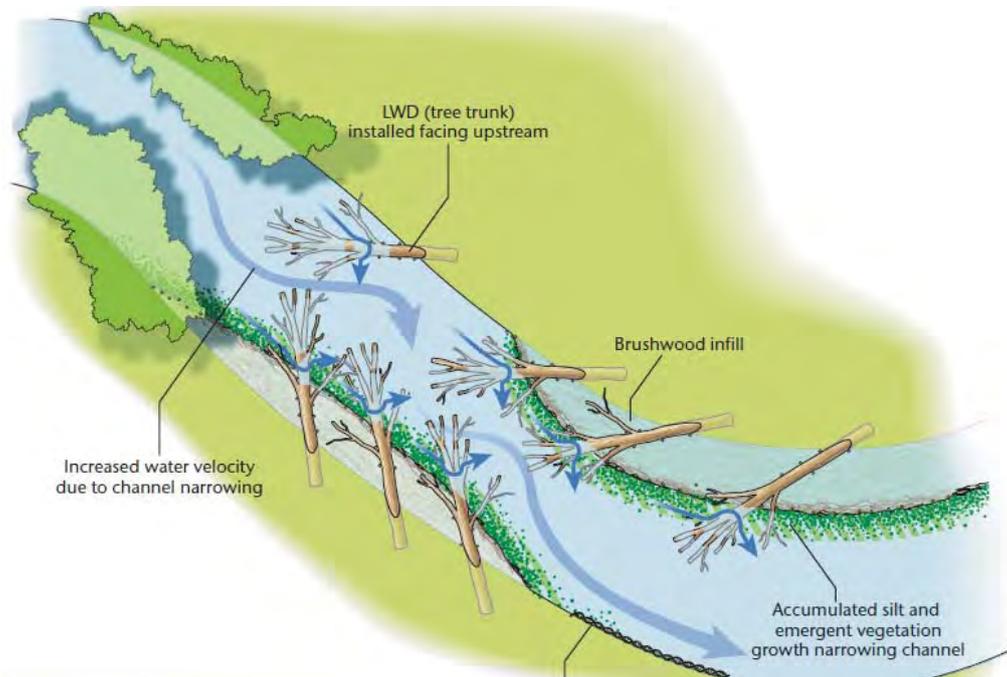
Figure 4 Illustration of the principle of using riparian trees and introduced brushwood margins to pinch the channel width. Trees can be hinged in a downstream direction to achieve the same effect.

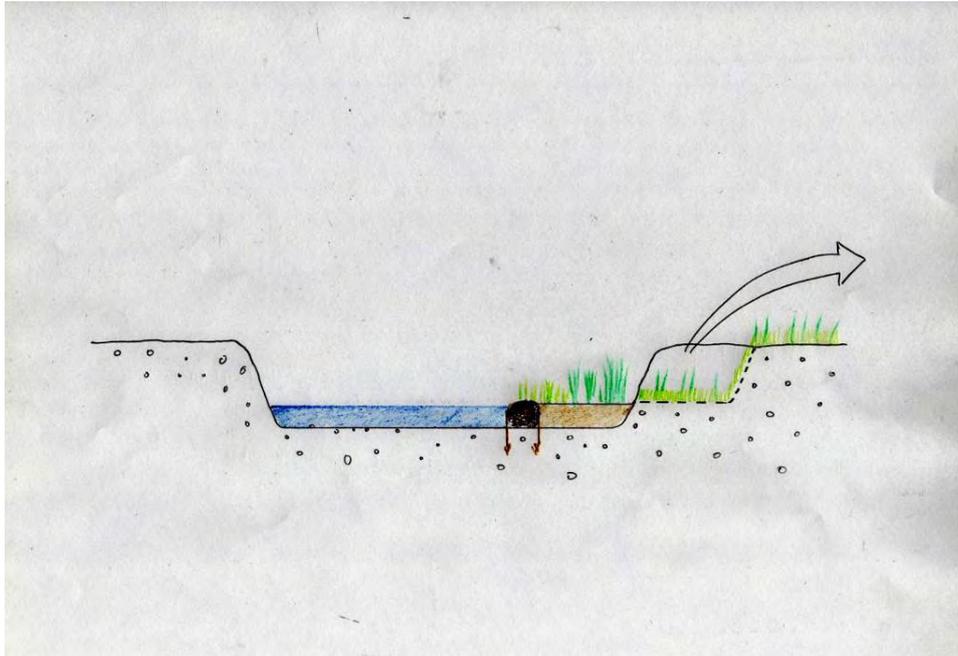
Figure 5 Schematic of bank re-profiling, utilising the spoil arising for channel narrowing (backfill behind an introduced brushwood margin) and removing surplus from the floodplain. This creates an 'inset floodplain', essentially a low margin which improves riparian habitat by providing a more natural, wide transition from aquatic to terrestrial habitats. It also makes a more convenient access for angling.

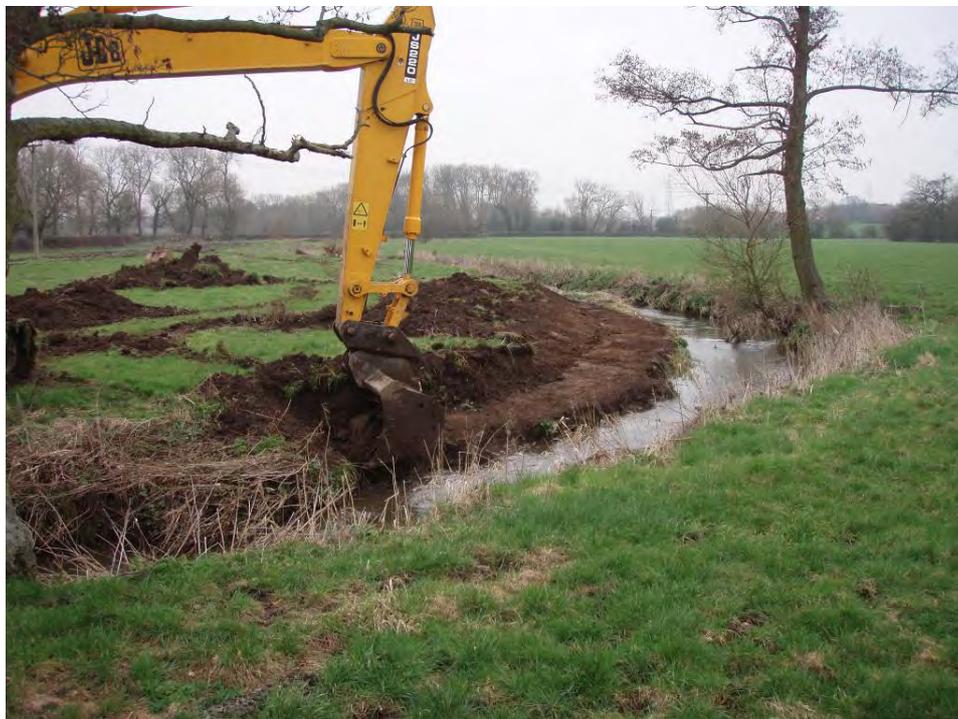
Photo 23 Bank re-profiling in progress on the Etwall Brook, Derbyshire.
