River Rother - Empshott

A advisory visit by the Wild Trout Trust – October 2013

1. Introduction

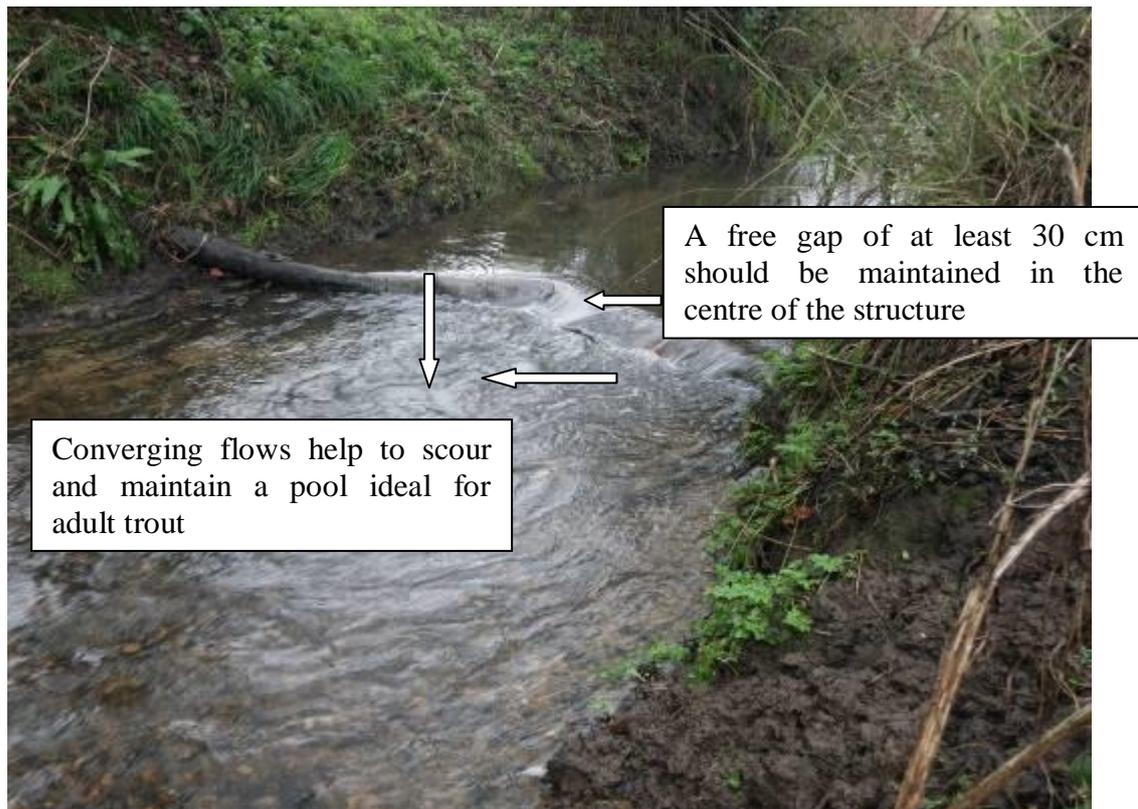
Photo 2. Upstream facing V deflectors. These can be made from tree trunks or stones.

An example of what upstream facing stub groynes might look like is shown in photo 2

Stub groynes made from simple tree branches can be secured in place either with driven chestnut clefts and wire, or can be drilled through with a wood auger and nailed to the bed with pieces of steel reinforcing bar. Information on these techniques can be found on the WTT web site www.wildtrout.org
