Advisory Visit

Sandybeck (Tributary of the River Cocker, Cumbria)

26/07/2016

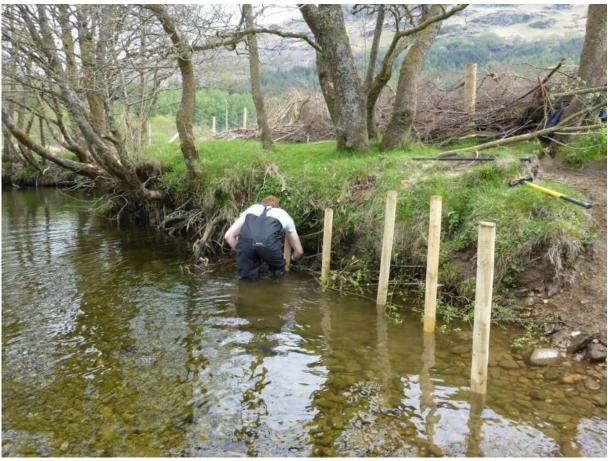
Figure 6. Note how the start of the bank protection should start tight up against the more stable bank area (in this case, the roots of a tree). Starting at the u/s end, the brash is tucked in amongst the tree roots to help anchor the whole structure. Bank protection needn't be tied into tree roots but should meet an area of stable ground at either end.

To install brash bank protection, posts are driven into the bank toe and top, ensuring to key into a stable area at either end (Fig. 7). Starting at the u/s

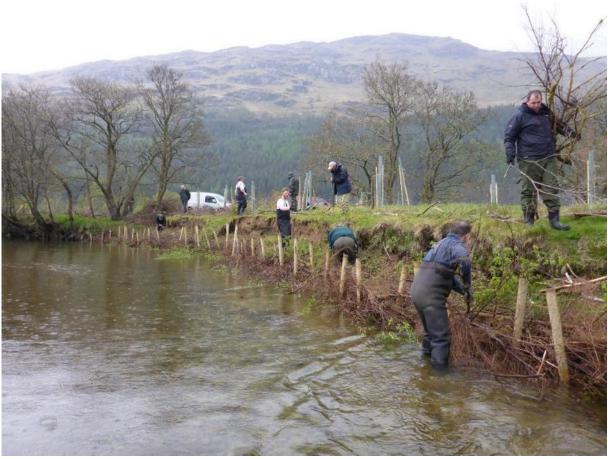
Figure 7. Subsequent brash then linked in to the adjacent brash upstream.

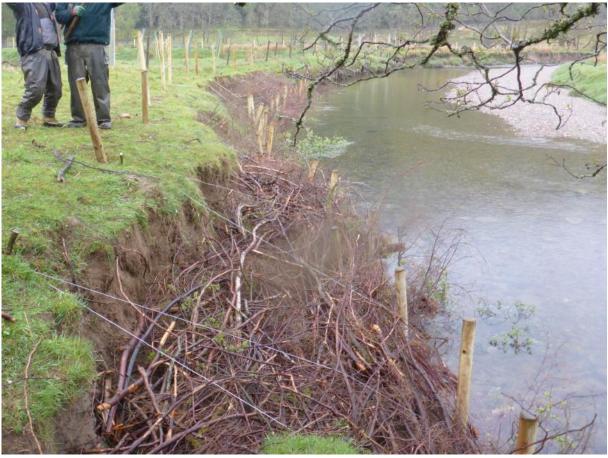
Figure 8. Bank protection secured in place by wiring over the top of the brash between posts. This photo was taken just before the posts were sawn off just above the brash height to reduce the potential for catching debris and being washed out.

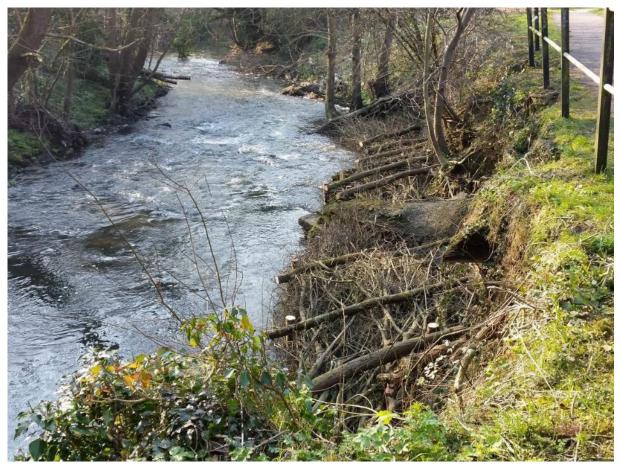
Figure 9. Brash bank protection secured with long branches/batons, rather than wire. The use of more natural materials is always preferable.

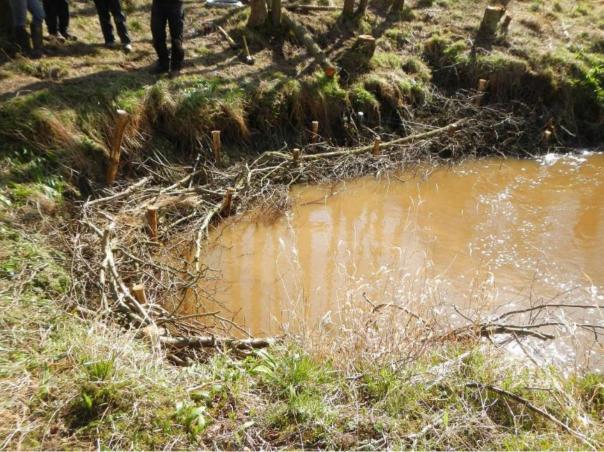
Figure 10. A line of coarse brash bank protection, installed along an eroding bank line. This picture was taken before the posts were trimmed, which should be undertaken upon completion of the brash installation to prevent the posts from being ripped out by debris in high flows. Note how the meander and pool have been retained here to limit the potential impacts associated with inhibiting the natural erosion processes.
