Scampston Beck Catchment Walkover

North Yorkshire

04/08/2015

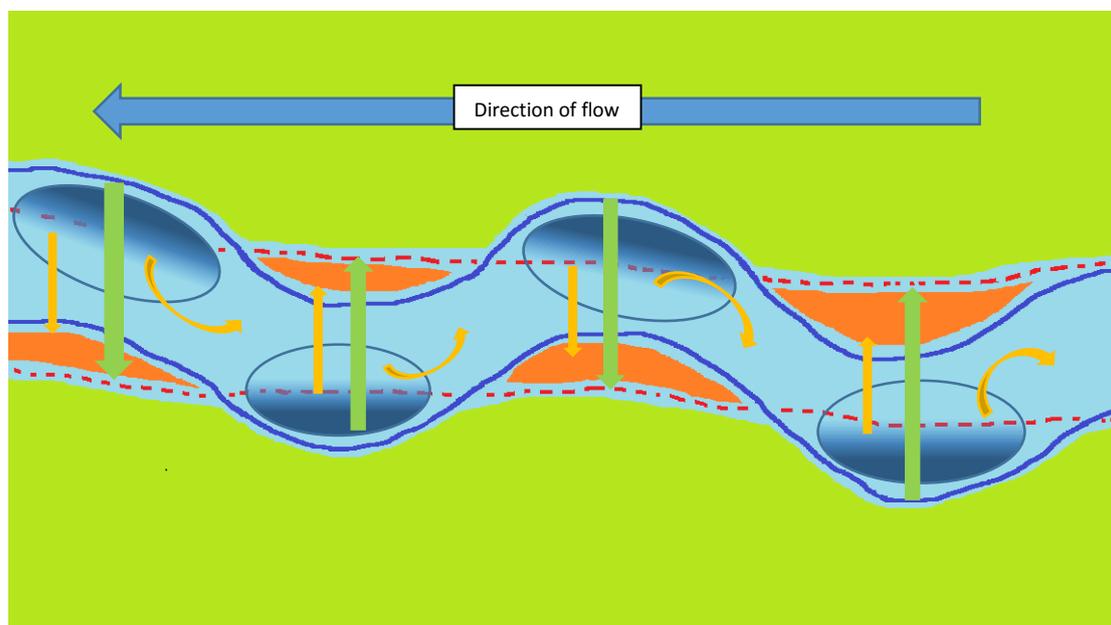
Fig 54. Diagram of a simple 'dig and dump' type river restoration. The dotted red lines represent the original straightened channel course. The dark blue line represents the improved course of the more sinuous channel. The dark to light blue graded ellipses represent deeper pool-shallower areas dug into the bed, with the material generated used to create gravel riffles (curved yellow arrow) and the toe of the gravel bars on the inside of the bends (straight yellow arrows). Green arrows show how material dug out of the bank and bed would be used to create the inside of the bend/gravel bar (orange area).

The work could take the form of a full-scale realignment, moving from the current course to a restored sinuous channel, or a lower cost 'dig and dump' type project where bends and pools are accentuated by removing material from one bank and placing it within the channel along the opposite bank (Figure 54). The choice of action may depend upon landowner agreement and the available budget. As a very basic option, woody material should be introduced to the channel to enhance scour and depositional features. Increasing woody material would be beneficial in conjunction with any other in-channel restoration options.

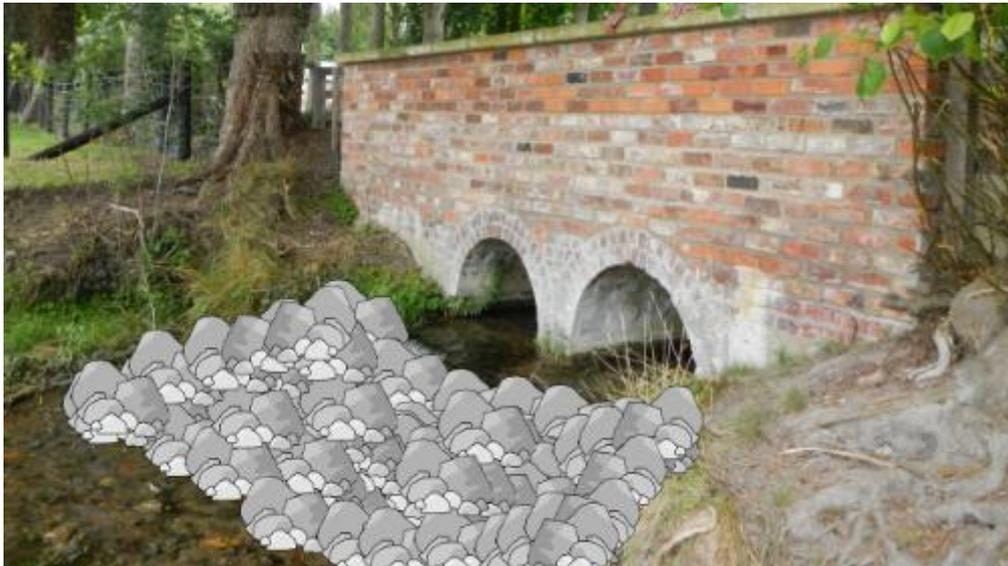
The culvert that carries the road (Fig. 30; SE 88458 73009) is a barrier to fish migration as the shallow water through the culvert and the step up into it are currently a major obstacle to fish. Ideally, when any maintenance is undertaken the culvert should be lowered to bed level, although this is unlikely to happen in the short-term. Until then, fish passage could be improved with a rock ramp, using small boulders, cobbles and gravel d/s to gradually bring the bed level up to slightly above that of the culvert thereby increasing the water depth in the culvert to ease fish passage (Fig. 55).

Figure 55. A small rock ramp, dished in the middle to focus low flows, would significantly increase the chances of fish passage through the culvert.

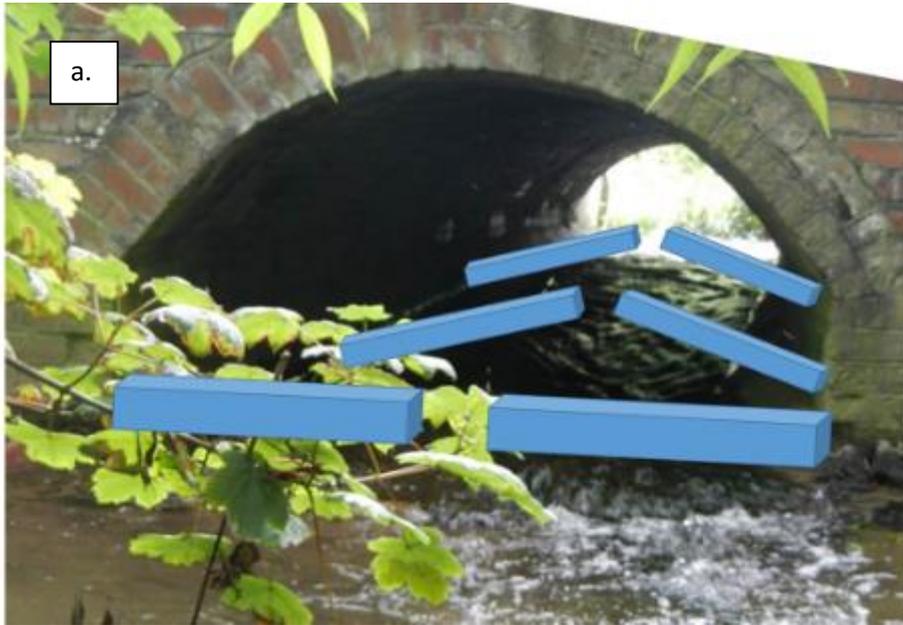
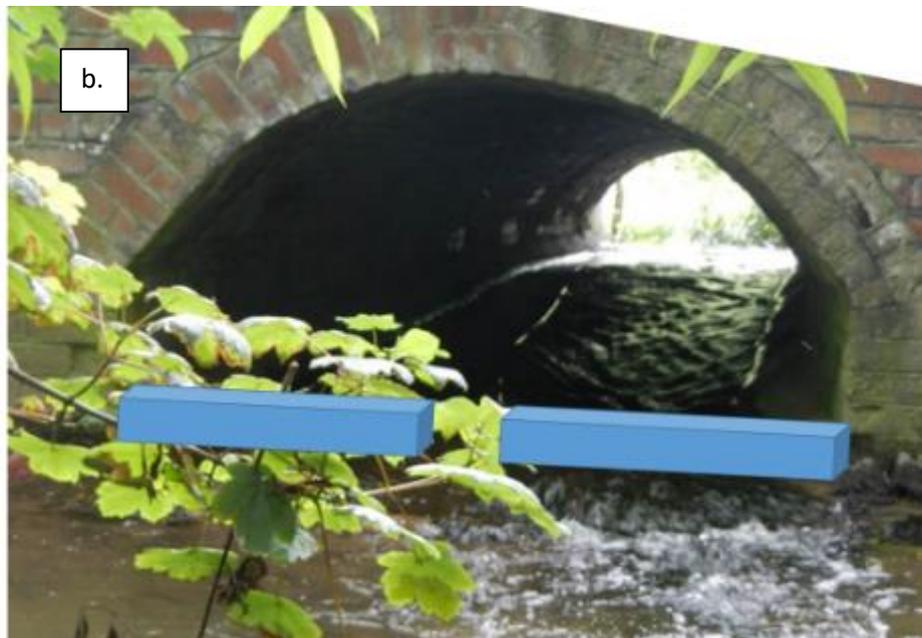
Improvements for fish passage could be undertaken at the A64 road culvert (NGR SE 87008 75091) via the installation of a rock ramp, in a similar manner to that of the culvert u/s, or by installing baffles along the base of the culvert (Fig 56a). As a bare minimum, a notched baffle across the d/s end of the culvert would provide some improvement by increasing water depth (Figure 56b).

Figure 56a & b. Potential baffle designs to improve fish passage by increasing water depth while maintaining sediment transport.
