Advisory Visit

River Sence, Sheepy Magna, Leicestershire

November, 2012

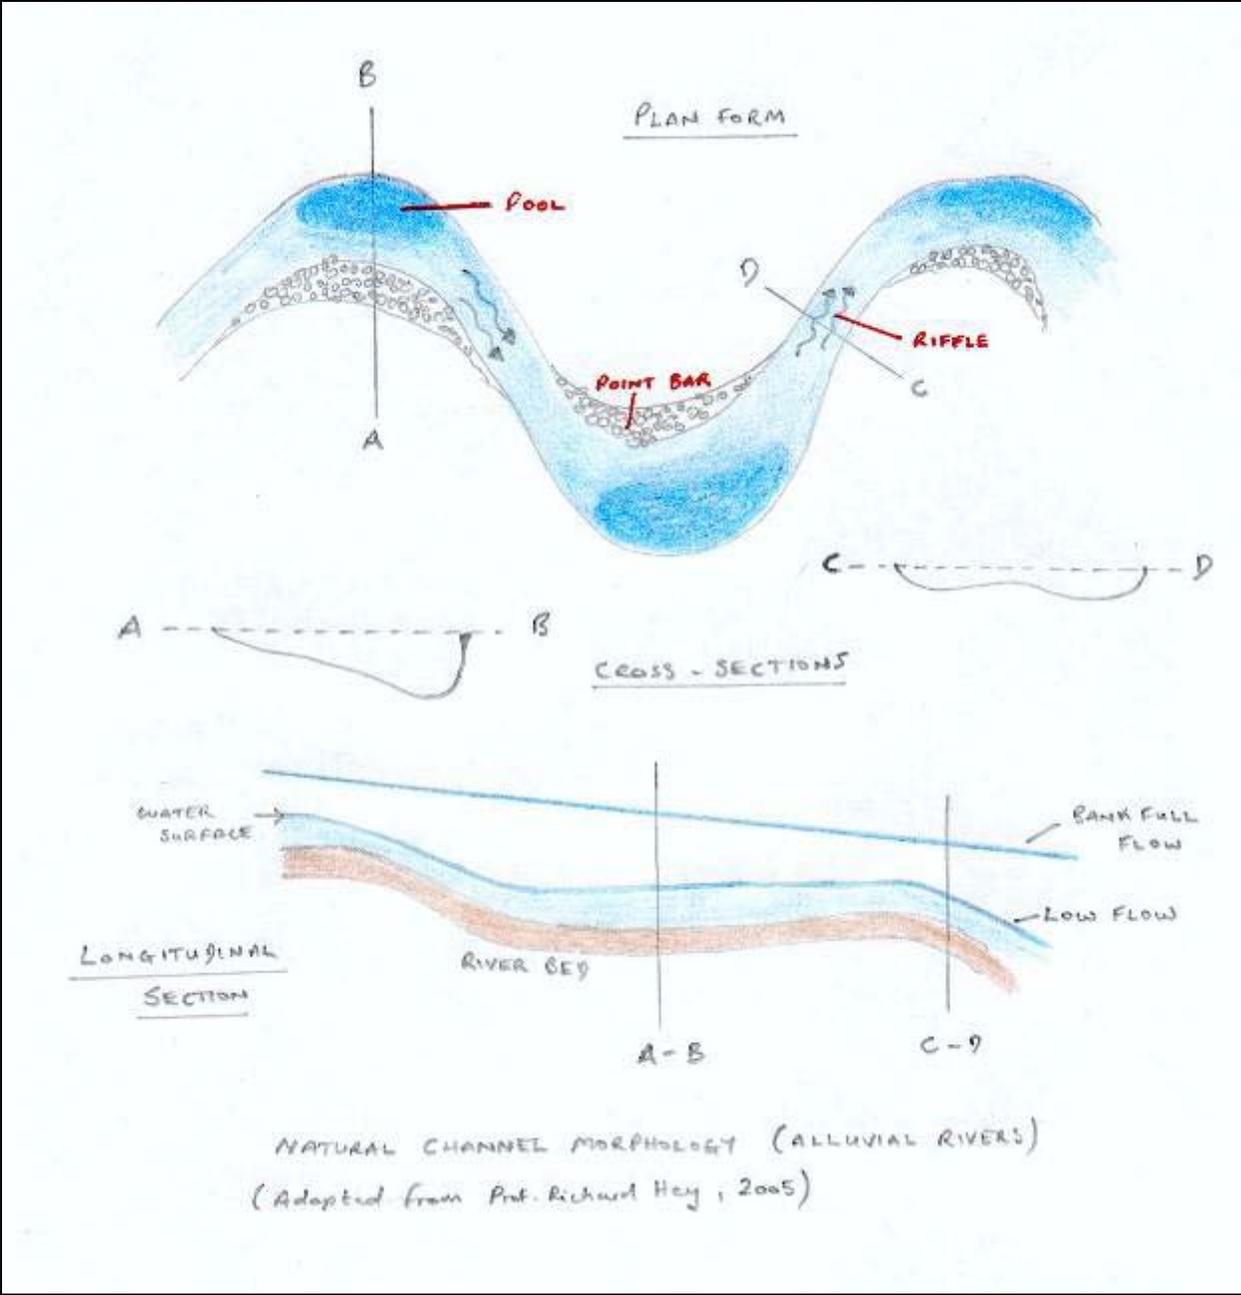
Figure 2 Natural channel form in alluvial rivers

The river here has a meandering plan-form, indicating that the course of the river has not been altered or straightened. The meandering course is the basis of good in-stream habitat because it forms pools (deep water on bends) and riffles (shallow, gravelly sections between bends) (Figure 2).

- The cross-section of the channel is altered from the varied profiles of a natural river (e.g. sections A-B and C-D in Figure 2), to a uniform, trapezoid-shaped section (Figure 3). In a meandering channel like this section of the Sence, natural cross-sections can re-establish, particularly with some assistance in the form of bank re-profiling (Photo X).
