Advisory Visit
Settrington Beck
04/11/2015

1.0 Introduction

This report is the output of a site visit to Settrington Beck, at the request of East Yorkshire Rivers Trust. The purpose of the visit was to assess habitat and make recommendations for habitat improvements that could be undertaken on the beck.

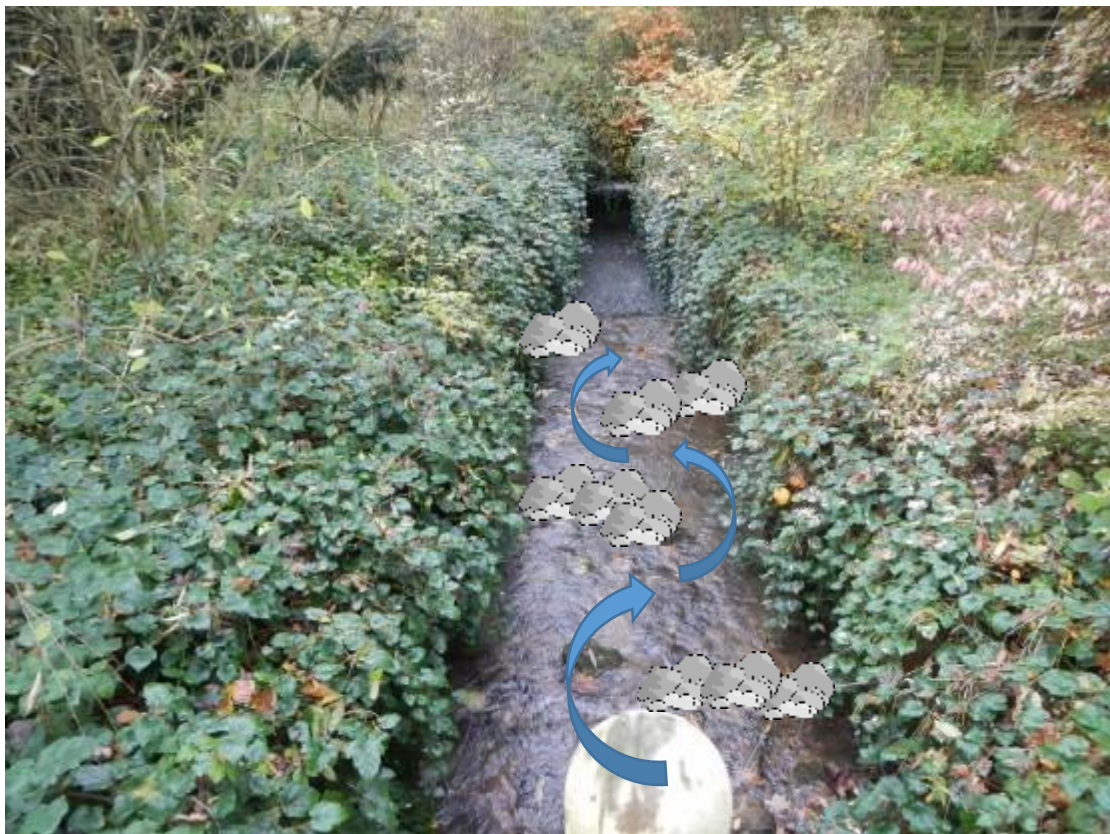
Figure 51. Boulders placed in channel to assist fish passage. The blue arrows indicate the direction of flow.

The issue of fluming flows through the uniform, artificial channel section could be reduced through the installation of flow baffles. This technique is often undertaken within culverts using concrete baffles (often kerb stones). However, in this case it may be more in-keeping with the garden and more acceptable to the owner to use rock/boulder clusters within the channel to create resting areas for fish in a more aesthetically pleasing manner (see Fig. 51 below). The rock clusters could be employed to meander the flows within the channel and create areas of slower water where fish can rest as they attempt to ascend the channel.

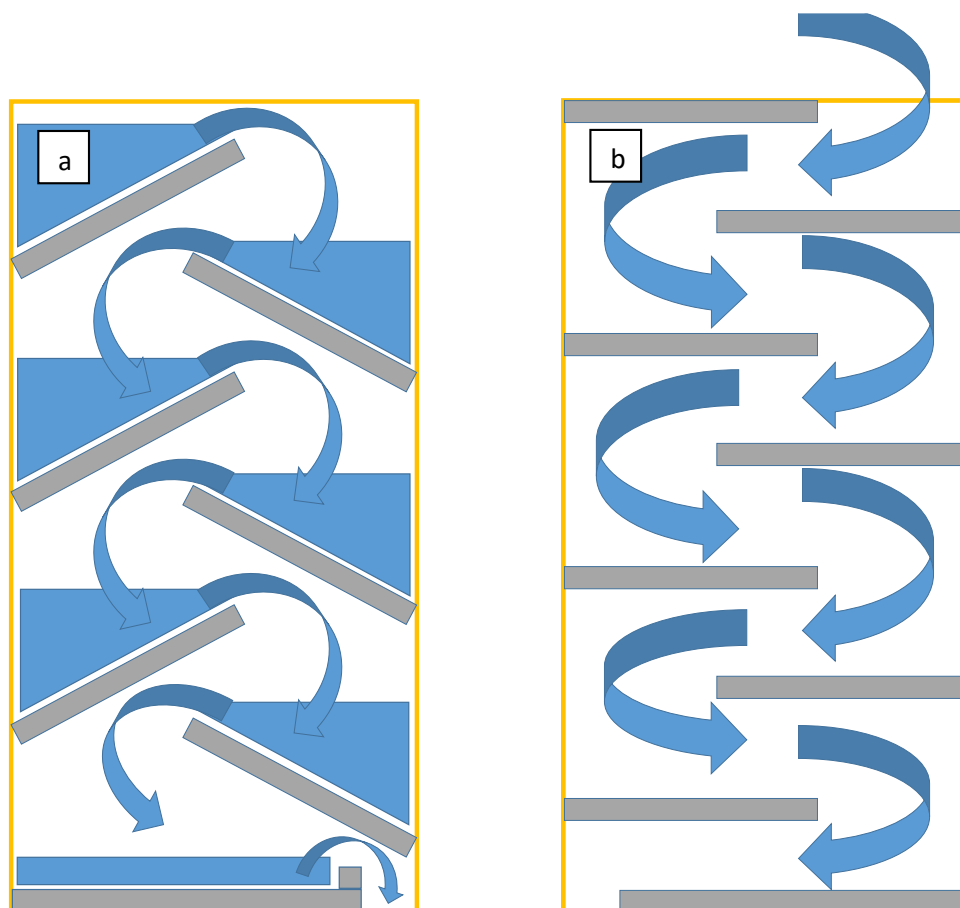
Figure 52a & b. Possible designs for the concrete baffles within the culvert.

Within the actual road and railway culverts, a simple concrete baffle array could be employed using kerb stones or similar, as shown in Fig. 52a & b. This would create increased deposition within the channel, slow the flow making it easier to ascend, and create slack water where fish can rest as they pass through.
