Advisory Visit

Shelf Brook, Glossop, Derbyshire

March 2019

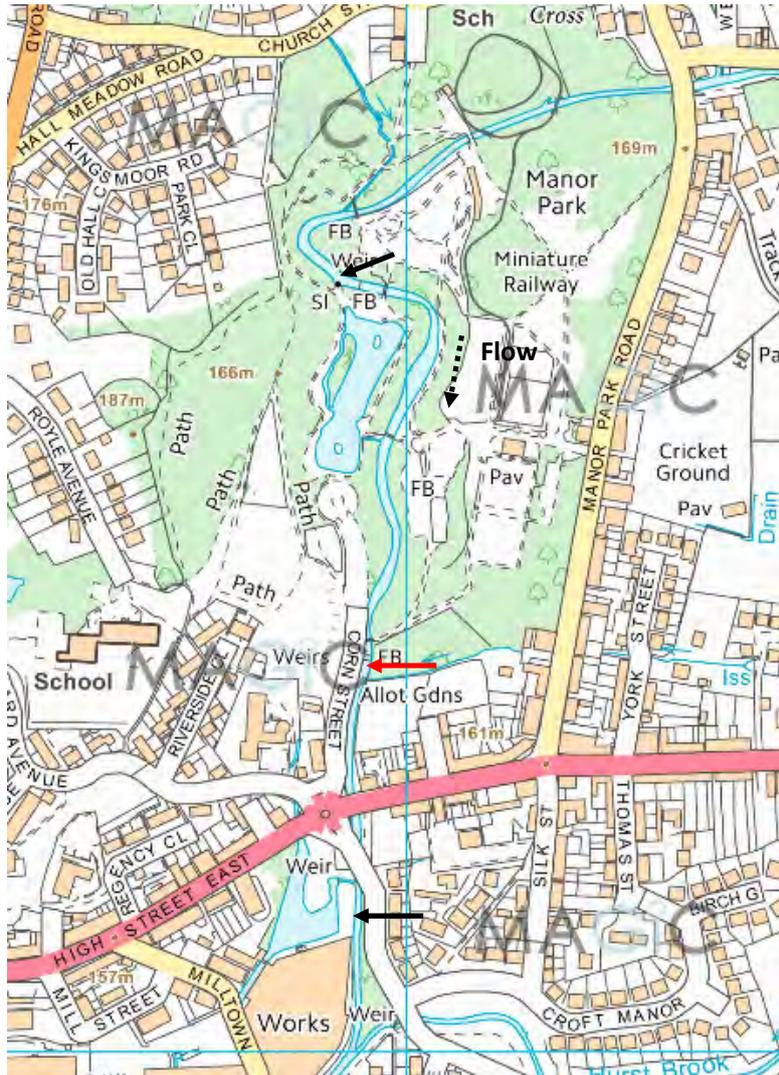
Figure 1 Site location, Manor Park, Glossop. Black arrows denote upstream and downstream extent of reach inspected, red arrow is the location of the weir and in-channel works.
