Advisory Visit
River Aire, Skipton Angling Association
August 2016

1.0 Introduction

This report is the output of several site visits to the River Aire, N. Yorkshire, undertaken by Jon Grey of the Wild Trout Trust. The visit was requested by Graeme Waterfall (Chairman) of Skipton Angling Association (SAA), who accompanied Jon (with Dave Martin, Bailiff) on the initial walkover in June, 2016. Jon re-walked further sections in early August, 2016. The main report will deal with those sections visited that are exclusively fished by SAA; an appendix covers additional waters shared with Bradford City Angling Association – see Fig 1.

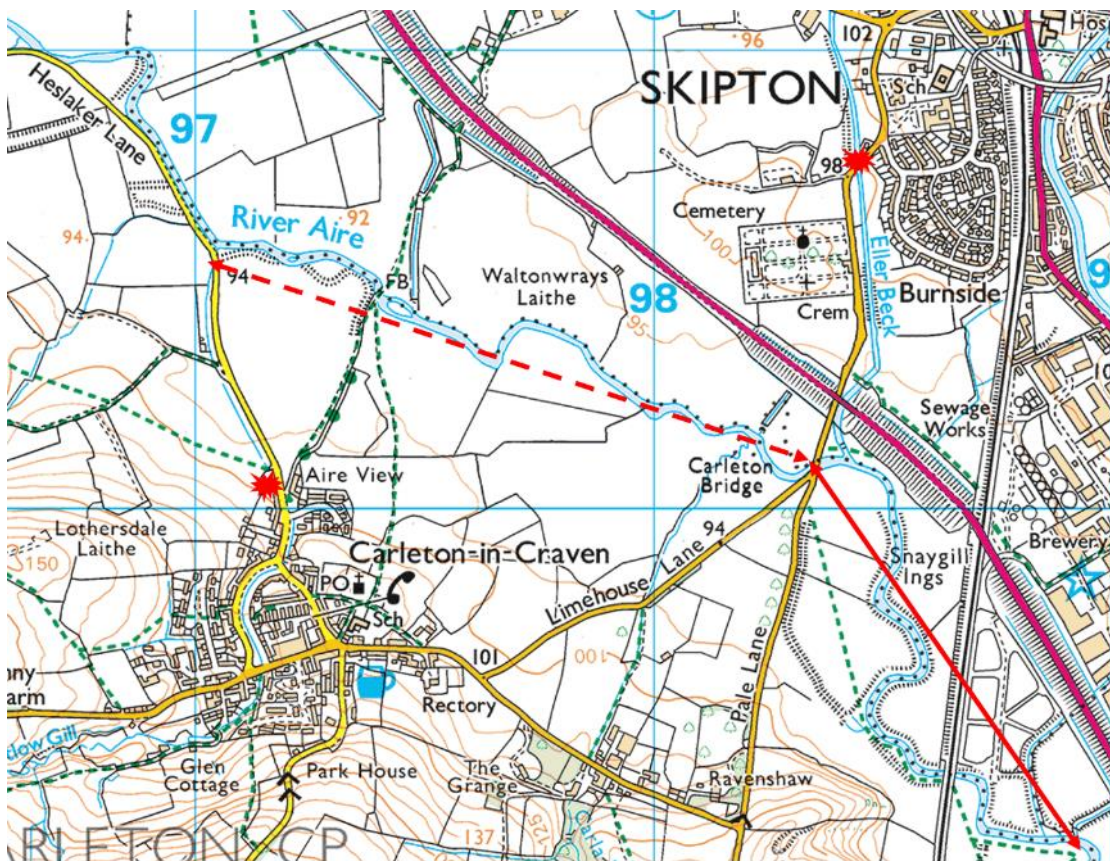
Fig 1. Map of River Aire sections walked: solid red line – Skipton AA only; dashed red line – shared waters with Bradford City AA. Red asterisks denote upstream extent of point searches of tributaries: Catlow Gill running through Carleton, and Eller Beck through Skipton. Note the severe bunding on the river banks below Carleton Bridge (lower right); see also Fig 2.

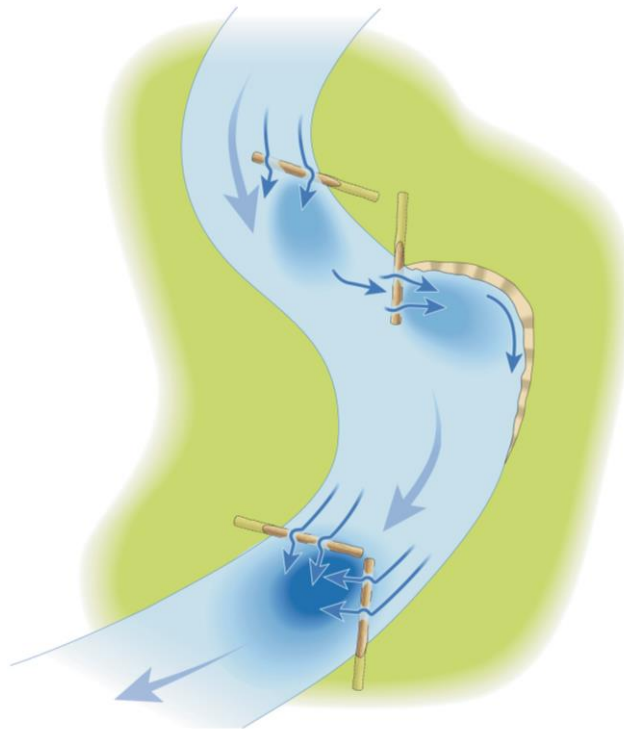
Fig 11. Conceptual diagram of use of woody material as deflectors. From the top of the figure:

Upstream angled – diverts flow to the centre of the watercourse, and creates localised scour; locating deflectors on opposite banks of a straightened section, but off-set in position can create sinuosity of flow without eroding the banks.

To emulate natural pinch-points and treefall where there is no living wood available, paired deflectors or individual stub deflectors could be installed on the straight, wide, shallow, trapezoidal reaches: short (<2m), well anchored / pinned trunks of wood (<400mm diameter); see Fig 11. The purpose of such installations would be to cause small-scale, localised scour and 'hummocking' of the bed, thereby focussing and retaining smaller gravels in their lee (see WTT video, here: <https://vimeo.com/32317564>). They might also introduce an element of sinuosity to the flow under low-flow conditions. Angling the deflectors u/s focuses flow toward the middle of the channel (i.e. away from the bank and hence reduces erosion risk there), when they

are overtopped. In terms of perceived flood risk, because these structures are relatively small (<5% of bank height) and occupy <50% of the cross-sectional channel width, they are completely overtopped during high spate flow.
