## Advisory Visit

River Slea, Sleaford, Lincolnshire

February 2015

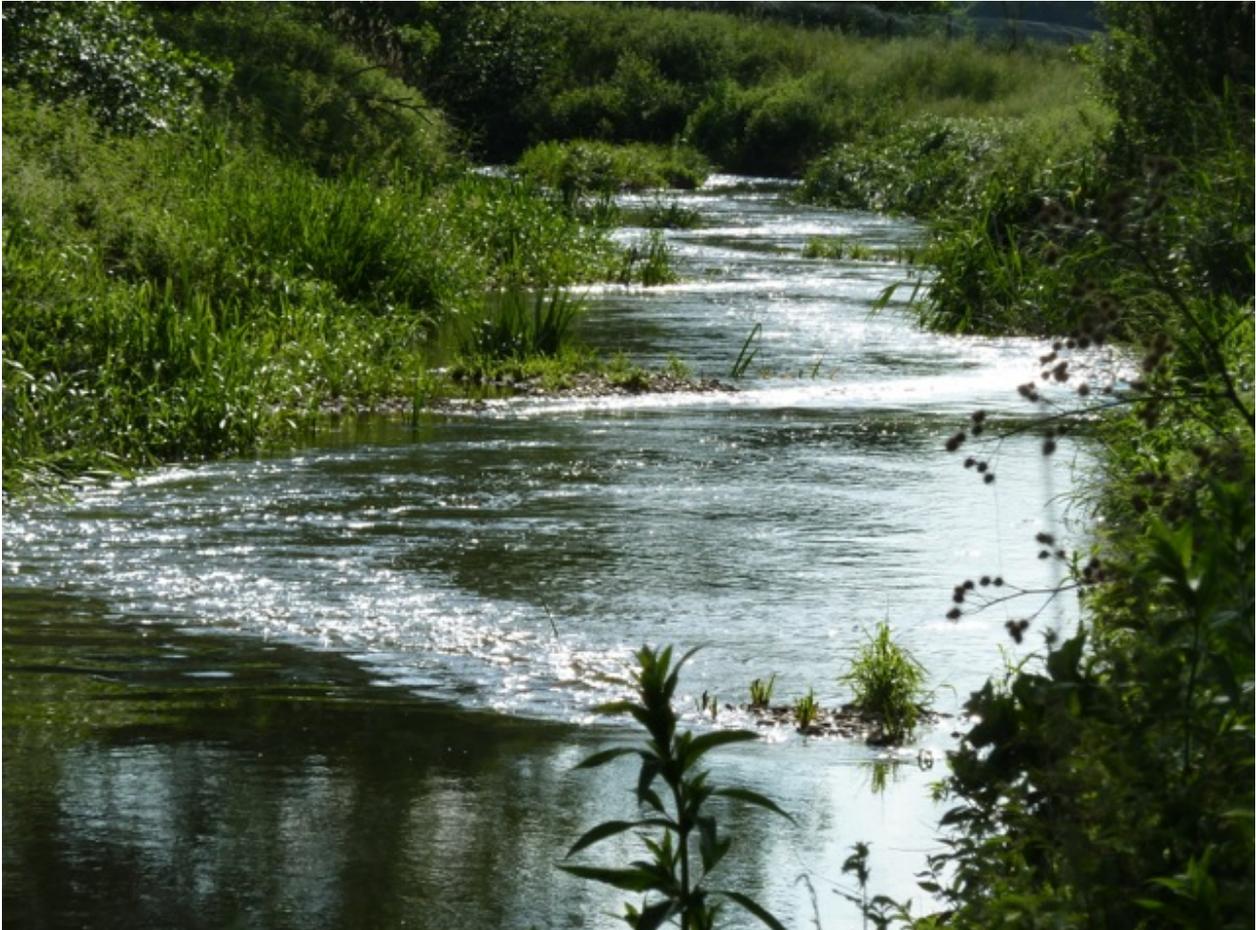
**Photo 19 River Lark, Suffolk following river bed re-shaping**

Use an excavator to re-shape the river bed, a technique pioneered by the late Nigel Holmes. A thalweg (continuous deep line of flow) is excavated in the river bed and the arising material used to form berms (benches) in the margins of the river. An example is shown in Photo 19.

The cost of this work is approximately £10/linear metre of channel and the section between Drove Lane and the railway bridge is approximately 500 metres, so a budget of £5,000 should be allowed. Tree planting with low-growing willows (*Salix caprea*, *S. cinerea*) would also be beneficial here and could be done with volunteers and a budget of £500 for materials.

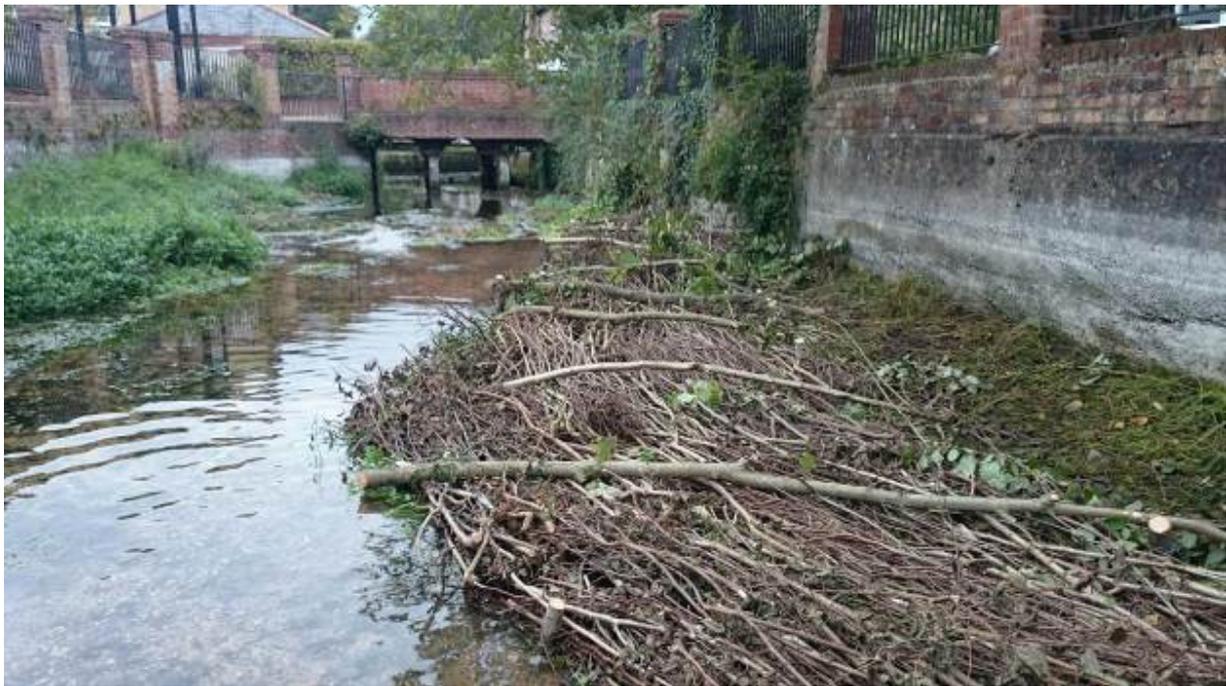
**Photo 20** Brushwood mattress installed on an over-wide chalkstream

A similar approach to the above section could be adopted, assuming access for an excavator is possible in this more restricted environment. This is a section of approximately 700m, so a budget of £7000 should be allowed, plus £1500 for consents and project supervision. If excavator access is a problem, then use of brushwood mattress berms would be an alternative (Photo 20).

A potential issue in this section is shading (from the houses and wall on the south bank) which appears to have limited in-stream vegetation growth. Both the described techniques rely on colonisation of vegetation (on the berms) in the longer term. Concentrating structures against the north bank is advisable here.
