Advisory Visit

River Stour, Warwickshire

August 2016

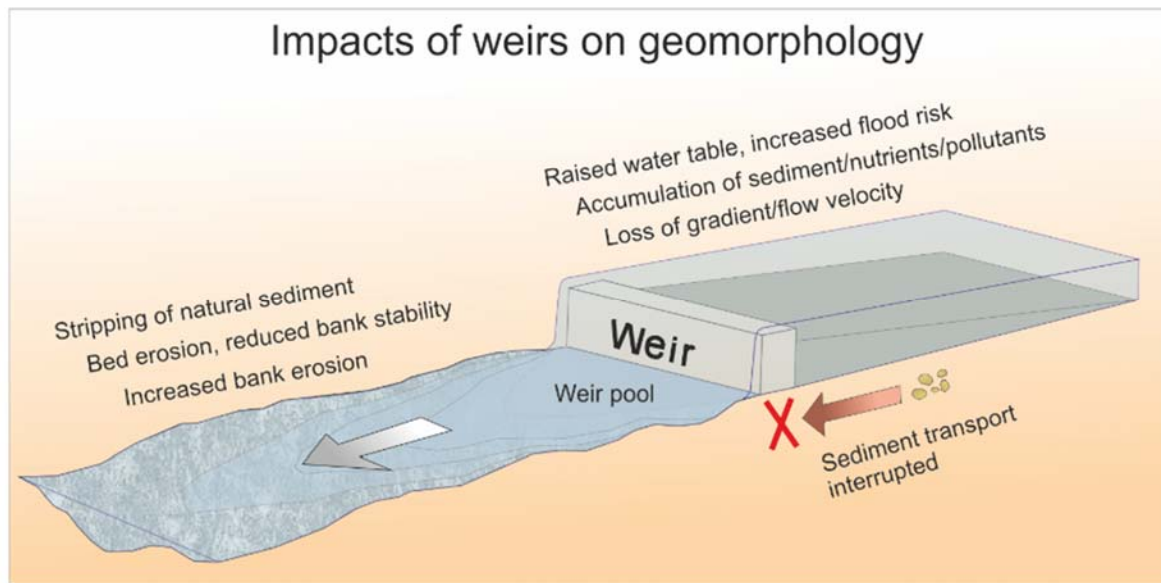
Figure 2 Weirs interrupt sediment transport, trapping it upstream whilst it continues to be transported away downstream of the weir, leading to a net loss of smaller particles (gravels) there.

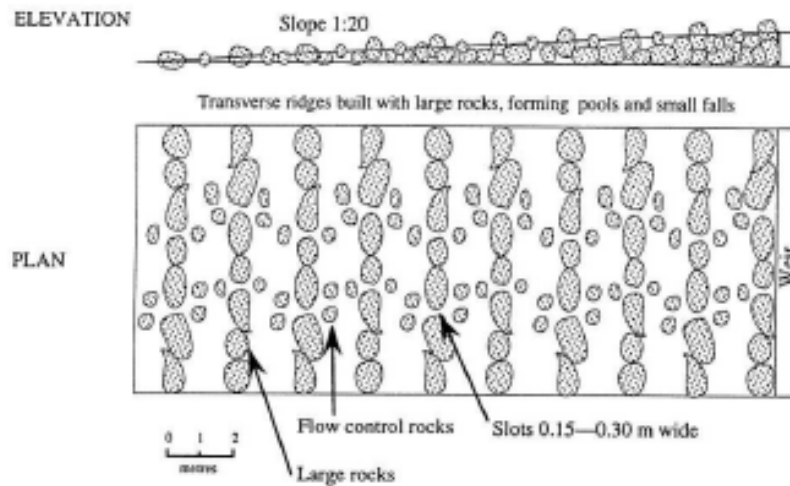
Figure 3 The general design layout of experimental rock-ramp fishways in New South Wales, Australia (after Harris et al, 1998) – from Environment Agency Fish Pass Manual, pp 156-159. (https://www.gov.uk/government/uploads/system/uploads/attachment_data/file/298053/geho0910bthp-e-e.pdf).

would be the easiest way to achieve this. Rock ramps consist of a low gradient (between 1% and 5%) constructed from rows of coarse boulders, infilled with cobbles and coarse gravel. Slots within the rows of boulders provide pathways for fish passage (Figure 1, Photo 9).

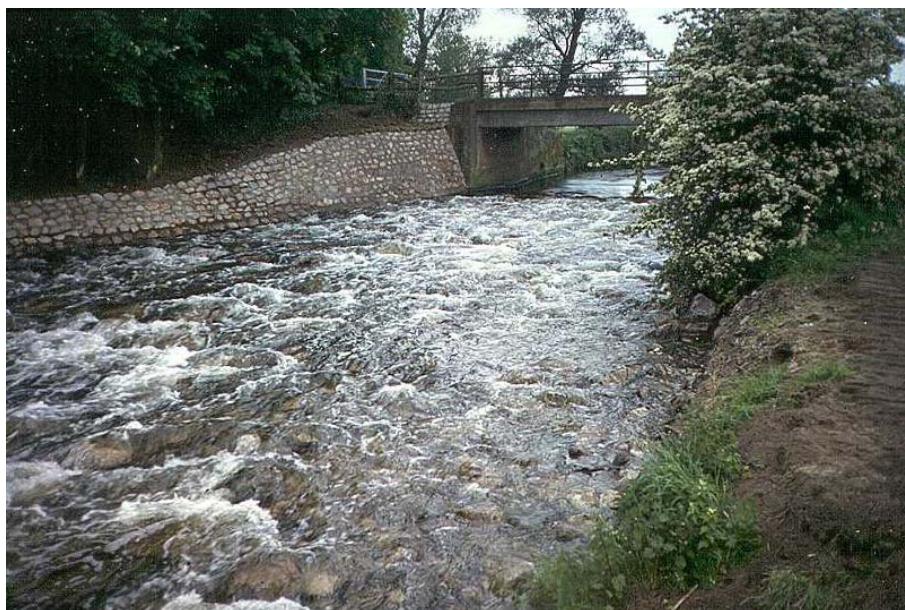
Photo 9 Rock ramp installed downstream of a pre-existing weir, River Trent, Staffordshire.

Keying-in the downstream end of the rock ramp, well below existing bed level, is very important to prevent it becoming undermined and leading to the disintegration of the ramp.

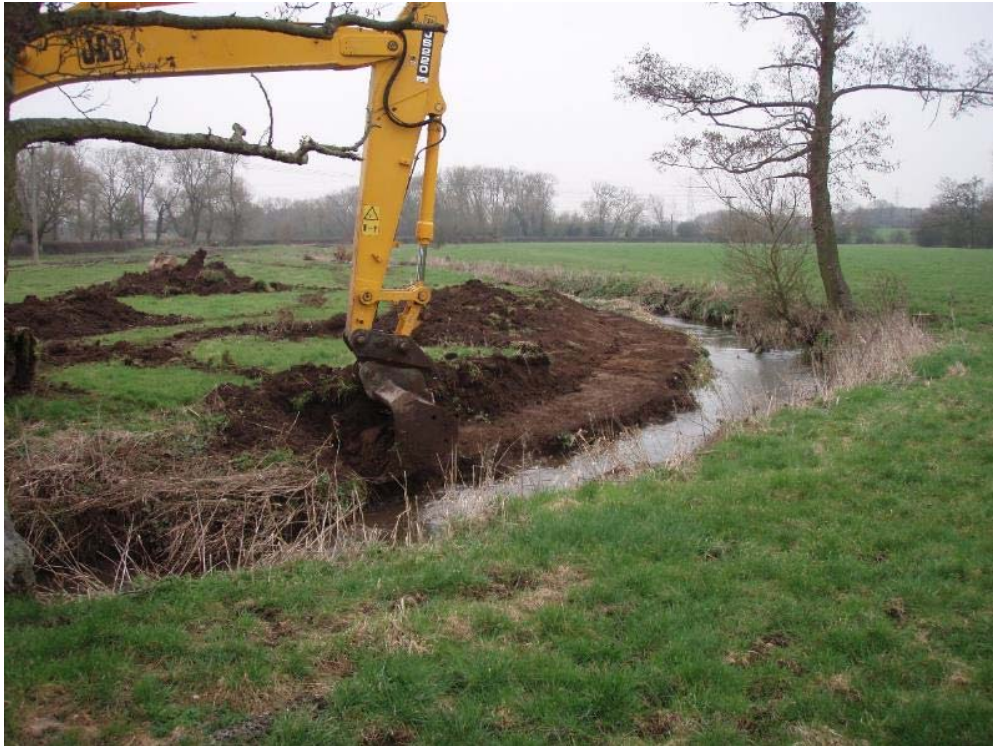
Photo 11 Bank reprofiling on the inside of a bend.

- If the opportunity arises during construction works at the mill property, or during pond construction, the banks of the river on the inside of bends could be re-profiled to a shallower angle (Photo 11).
