Advisory Visit to Torver Beck – River Crake Catchment
South Cumbria
February 2014

1.0 Introduction

This report is the output of a site visit undertaken by Gareth Pedley of the Wild Trout Trust to Torver Beck on the 20th February, 2014. Comments in this report are based on observations on the day of the visit and discussions with Jen Aldous and Pete Evoy of South Cumbria Rivers Trust (SCRT).

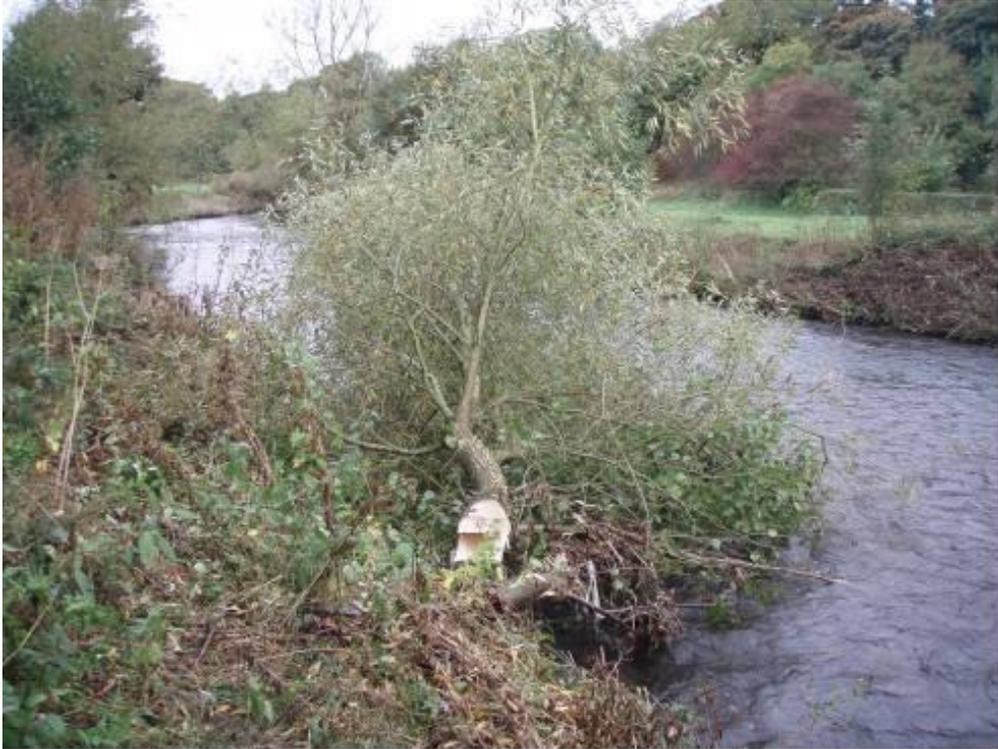
Figure 17. Hinged willow.

Hinging some of the tree material into the channel would also be beneficial in creating cover and refuge habitat, and diffusion flow. The ideal species for this are willow and hazel as they are supple, but thin willow and ash can be treated in this way, if done very carefully. Tethering LWD in to increase structure within the channel (Figures 17 and 18) would also help.

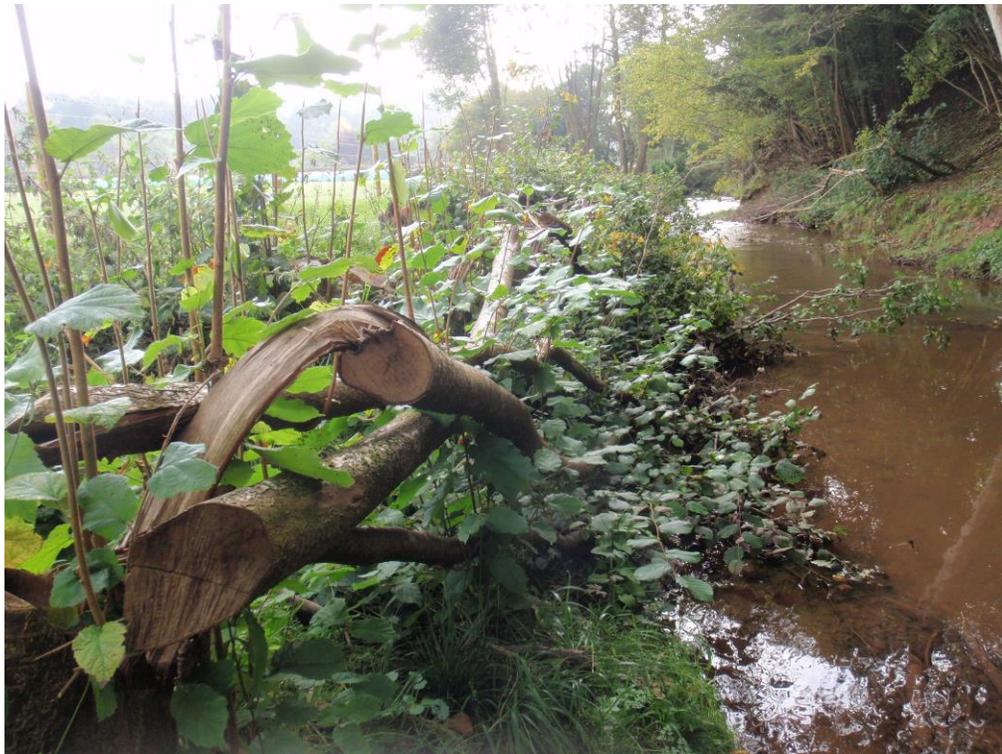
Figure 18. Hinged Hazel.

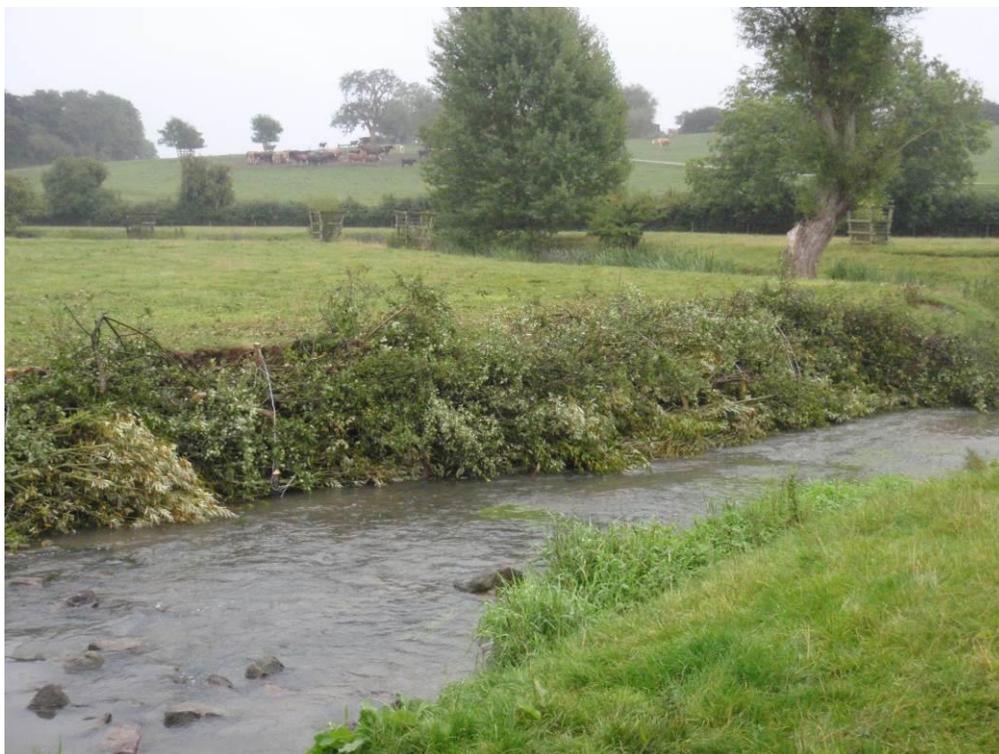
Figure 19. Mixed brush bank revetment (mainly hawthorn and willow).

The overlapping brash technique is demonstrated on a larger scale with a mixture of willow and other species in Figure 17. This method diffuses flows along the bank, increasing deposition in areas that were subject to excess erosion. The benefit of using living willow being that, if at least some of the branch is in contact with the water and bank, it should start to root. This technique would be particularly beneficial in areas such as that depicted in Figure 4, and along the erosion in Figure 6 where clearance of the central channel would also be beneficial to relieve pressure from the bank.

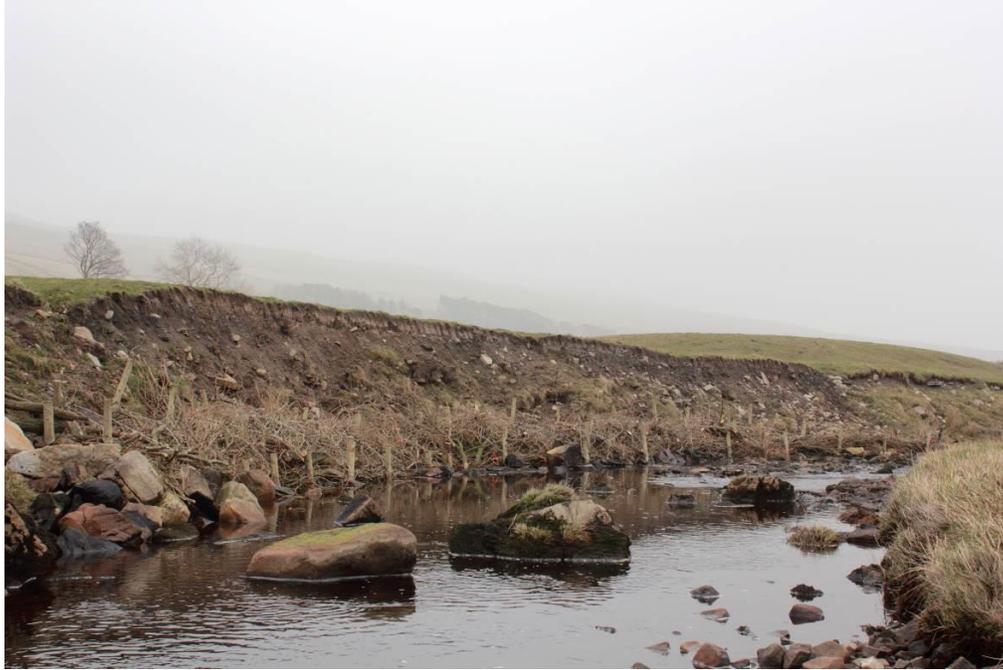
Figure 21. Wired willow brush installed by Yorkshire Dales Rivers Trust resulting from the advice of a previous WTT advisory visit.

In a similar way, brash bundles/wired brash (ideally live willow) can be installed in a line along the base of the river bank to create a toe (Figure 20). This method works by creating a stable base to the bank that can colonise with vegetation and will catch any material that slumps from the bank above. The benefit of using live willow for this being that if it is in contact with the water the branches are likely to take root and grow, rapidly providing bushes along the bank that will stabilise it and create high quality habitat.

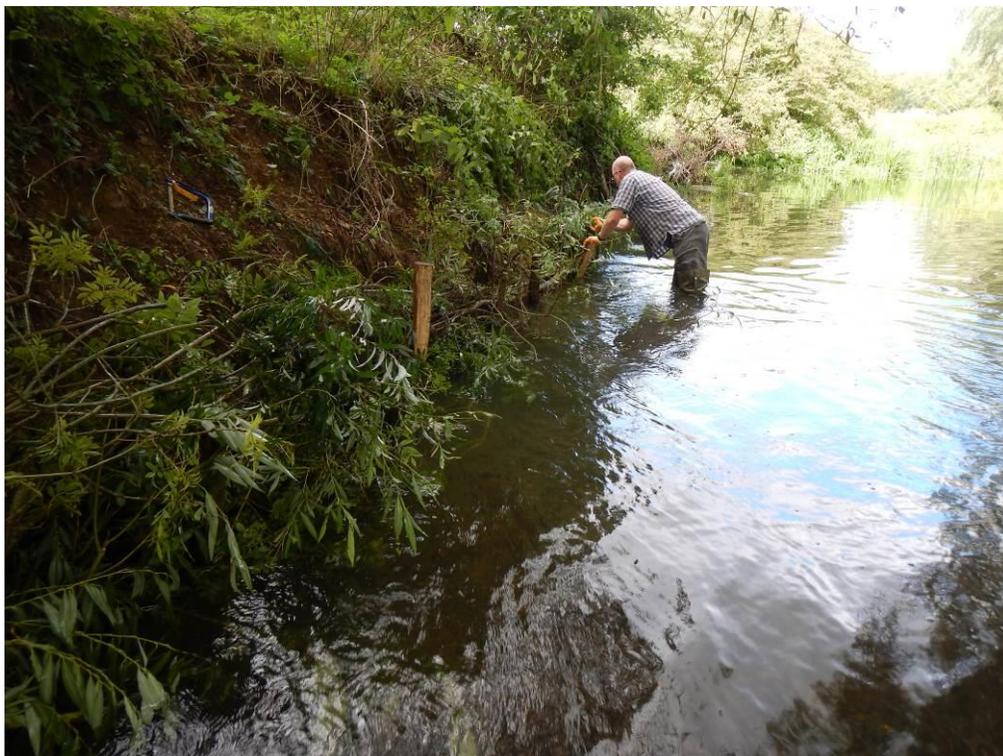
Figure 22. Living willow bundle toe being installed during a previous WTT workshop.
