Advisory Visit
River Trent, Stoke-on-Trent
October 2014

Introduction

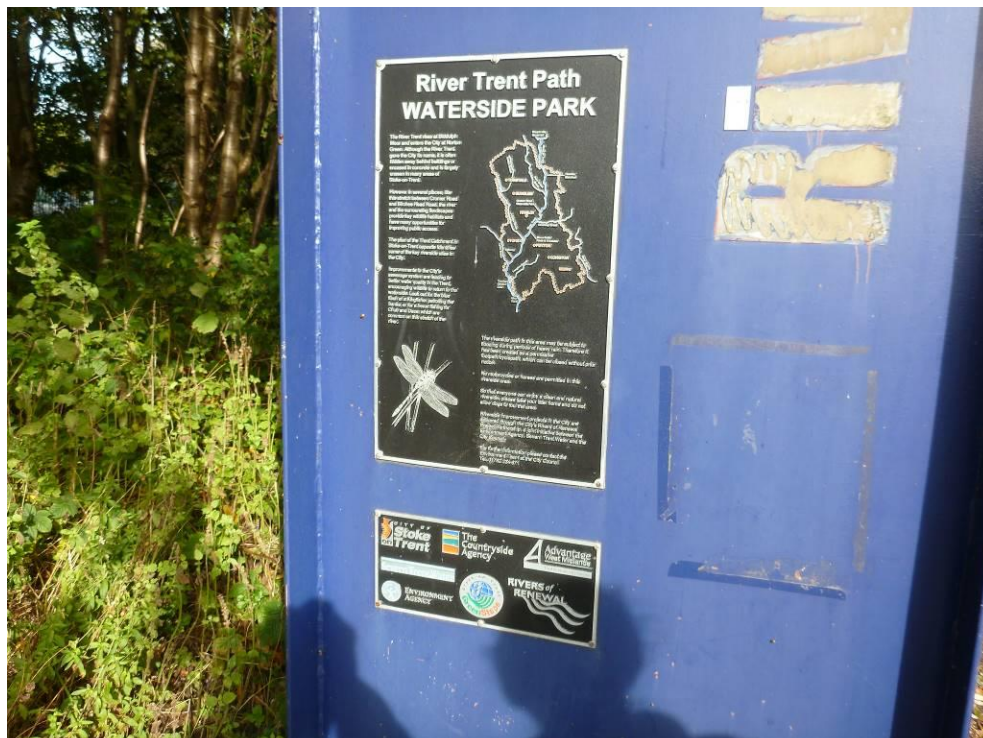
Photo 24 Interpretation board

Further upstream there is a footpath through Waterside Park (Photo 24) alongside the river and up towards the Caldon Canal. The river is more open here and as a result has tall herbage alongside it, creating good marginal habitat. The river occupies a wide corridor which has some nice wet, scrubby habitat (Photo 25). The quality of in-stream habitat of the river here is moderate; it has obviously been modified in the past, but appears to have narrowed itself considerably. As at the University and Milton sites there is scope for re-meandering here, or the use of flow deflectors and woody debris.
