Upper Avon, France Farm

An Advisory Visit carried out by The Wild Trout Trust August 2012

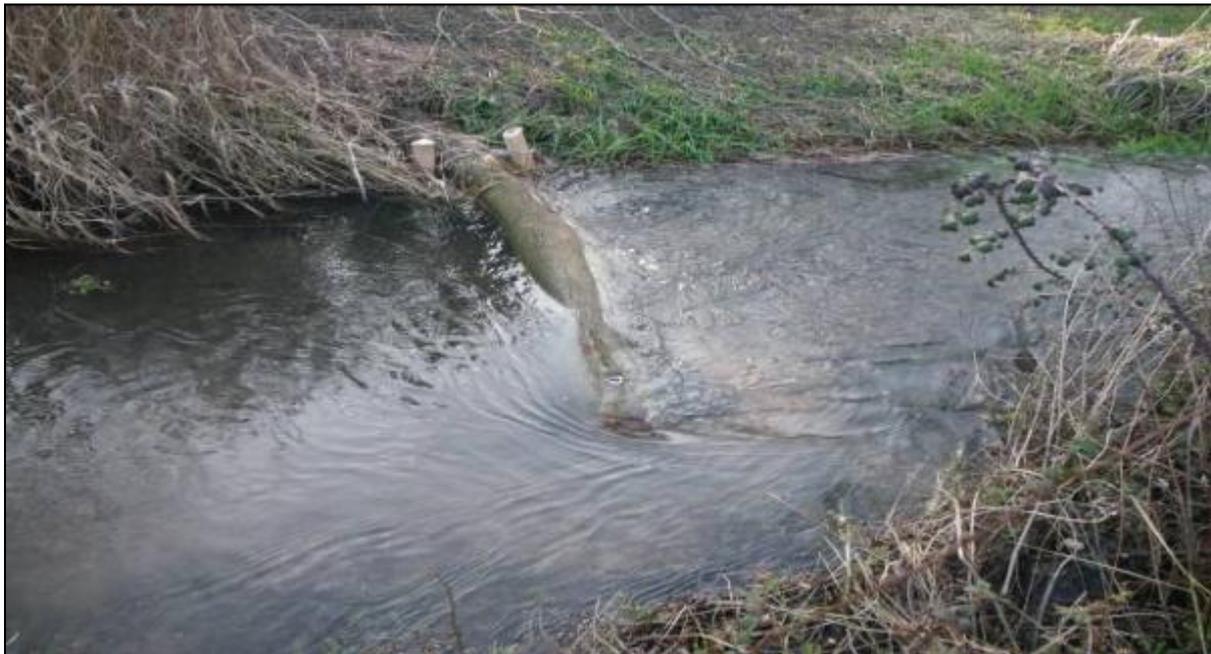
Figure 16: An example of an LWD groyne installed to diversify in-stream flow patterns

Once the weir has been removed, the channel between the hatches and the weir will need some adjustment to the new flow regime. LWD sourced from the wooded area on the left bank could be utilised to achieve this aim and also introduce some extra flow diversity.

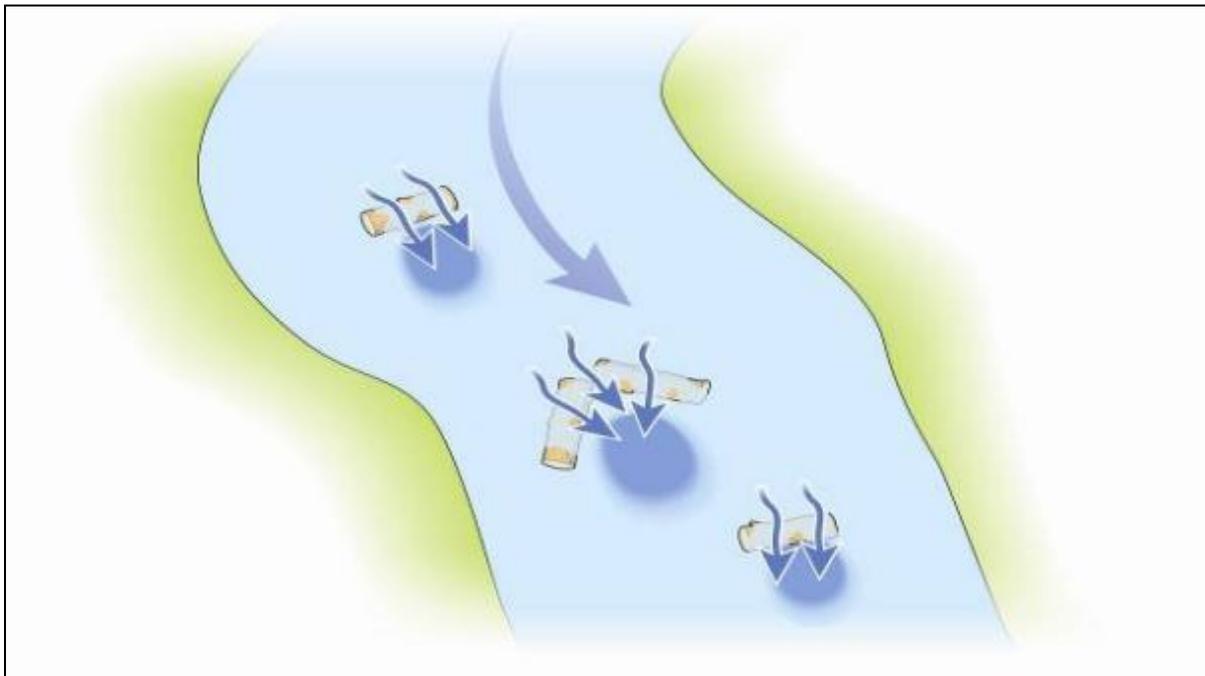
Figure 17: Log deflectors secured to the river bed promoting localised scour and improving gravel riffle habitat

LWD flow deflectors secured to the river bed to promote localised scour and accentuate flows over existing riffles will help loosen gravels and to 'sort' bed material into various sizes. This will make it easier for trout to create productive redds (spawning nests) and will ensure that eggs are kept free of silt and provided with a fast flow of well-oxygenated water.

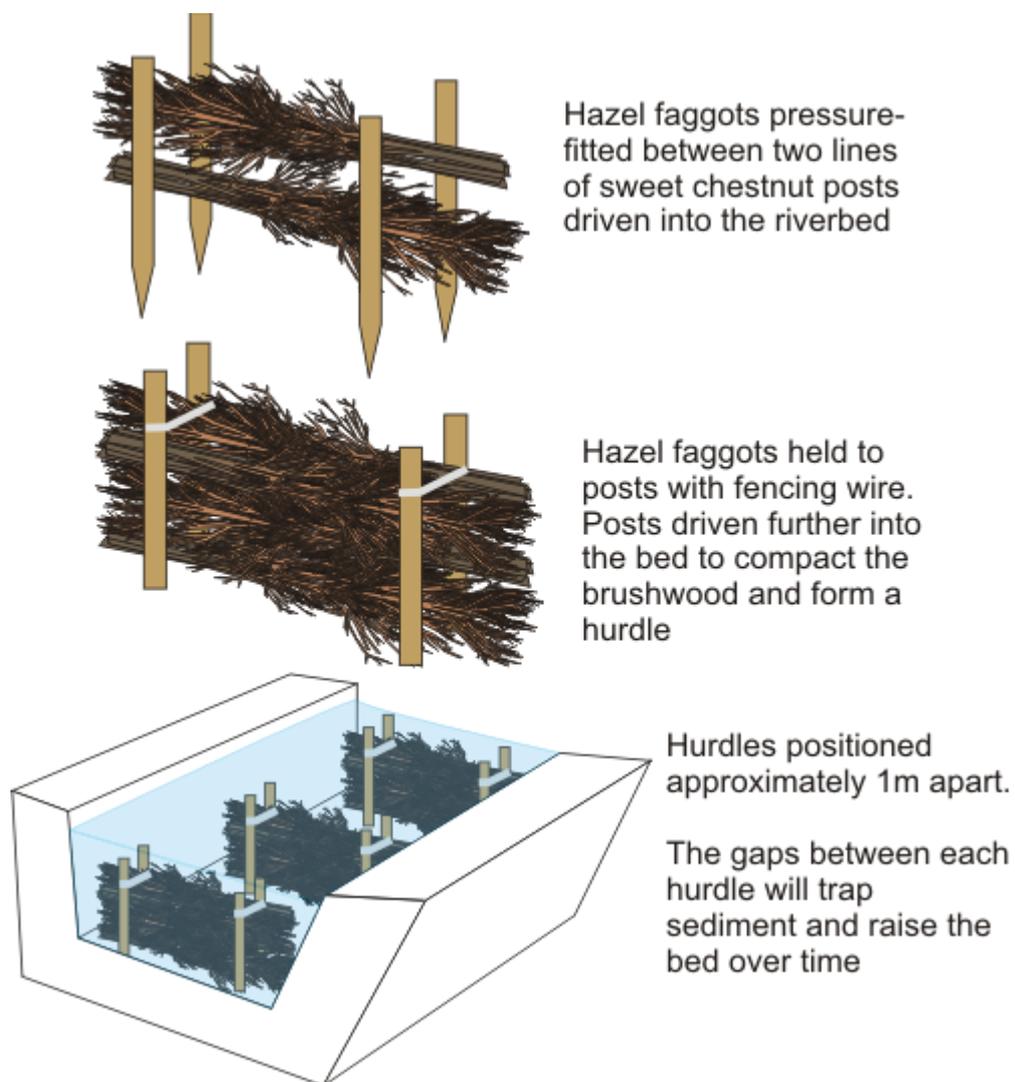
Figure 18: Brushwood hurdle sediment traps used to raise bed-level

One such technique involves the use of hazel faggots to create hurdle-like structures across the bed. These hurdles are positioned approximately 1-2 metres apart and consist of hazel faggots secured between lines of sweet chestnut posts driven into the bed. The hurdles act to trap sediment between them and raise the bed level over time.

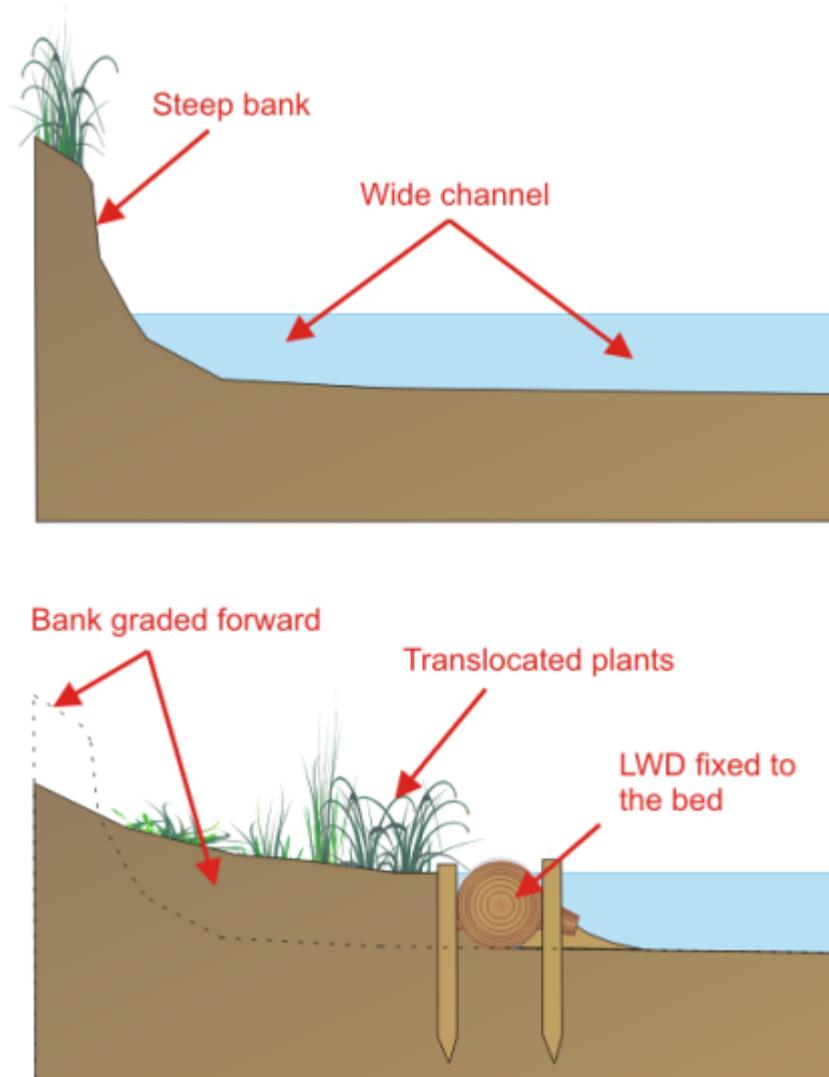
Figure 19: Example bank re-grading works to narrow the channel and provide better angling access

This can be achieved by creating berms that protrude out from the banks to narrow and re-shape the channel. These berms will also improve angler access by reducing the height of the bank.

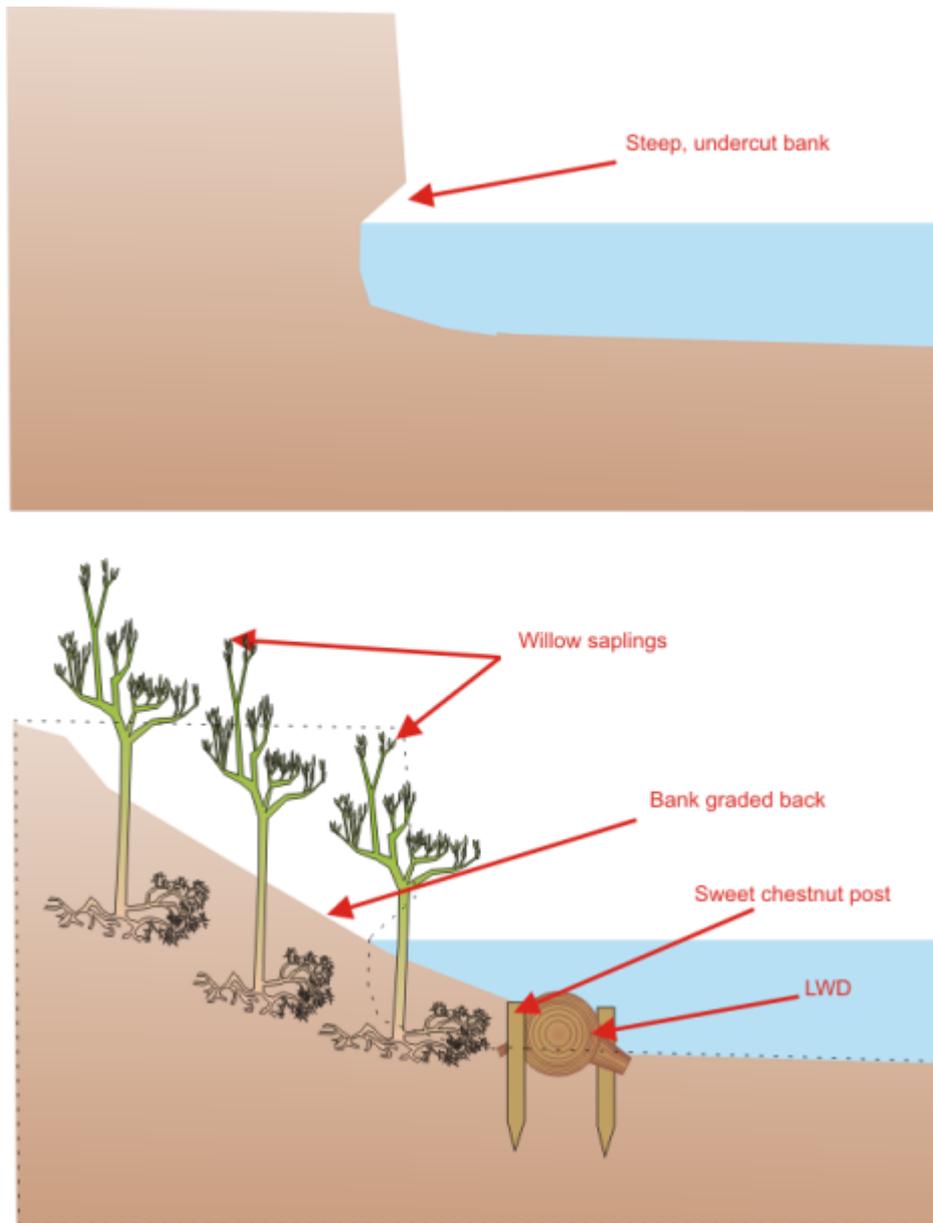
- Where the bank is perched high above the river, the rate of erosion should be monitored and an assessment made as to whether or not the bank should be stabilised. The potential habitat value of the bank for kingfishers and sand martins should be taken into consideration even if no nesting burrows are observed.

Figure 21: An example bank stabilisation using LWD and live willow

Ideally, natural processes should be allowed to continue but if action is required, the bank could be re-profiled back and planted with live willow stakes to help stabilise the soil. This is a cost-effective and environmentally friendly alternative to hard engineering and will become stronger with time as willow roots spread through the bank.

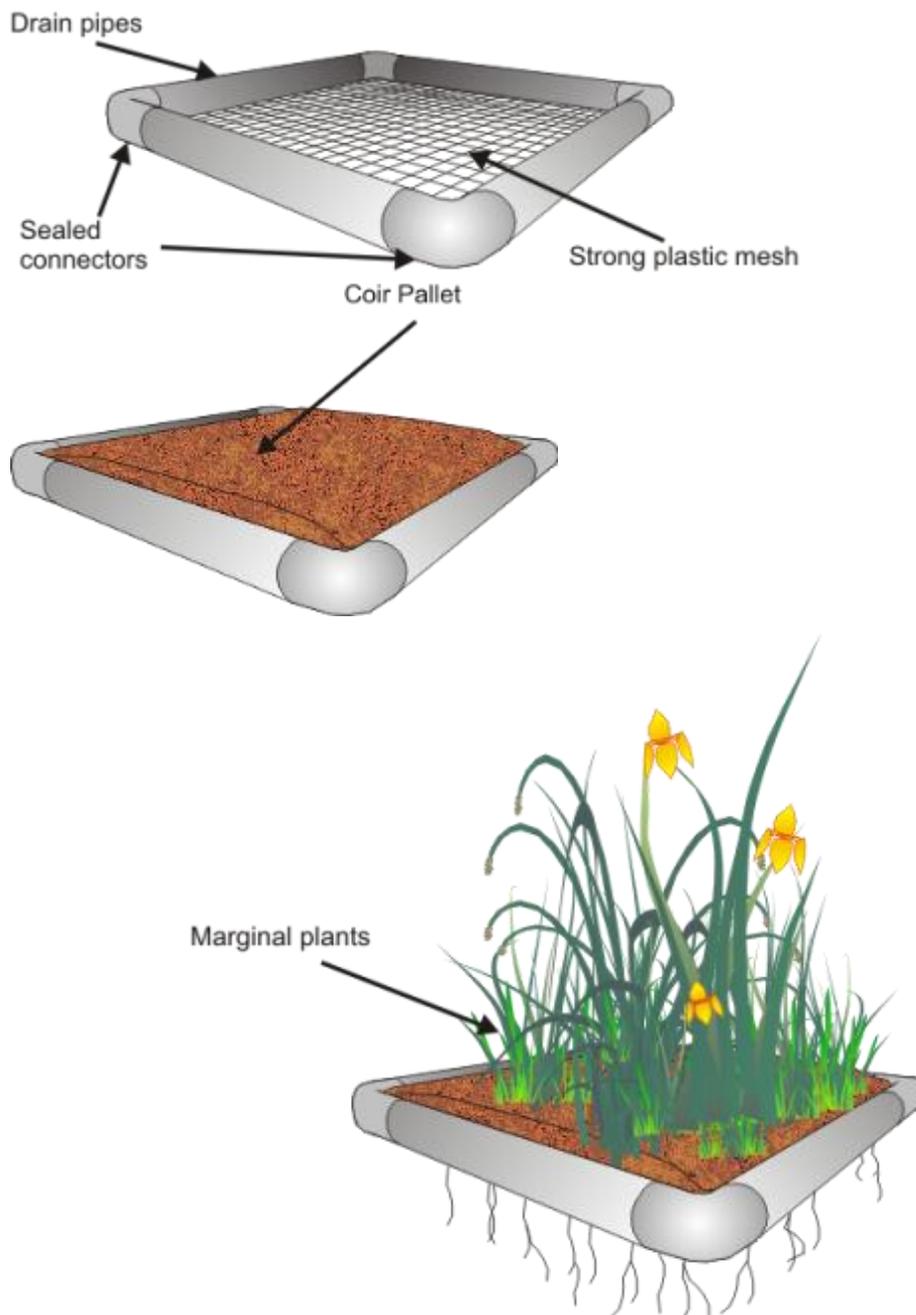
- Algal blooms within the ponds could be the result of slightly elevated nutrient levels in the river feeding the ponds combined with stocked fish preying on the zooplankton that would normally control phytoplankton levels. Blooms can be controlled by the introduction of barley straw as a growth suppressant or the construction of some simple floating islands as a zooplankton refuge. These can be purchased as individual modular units or home-made (see below).

Figure 22: An example of a simple floating island to provide refuge for zooplankton that can help control algal blooms
