Advisory Visit

R. Ure, Middleham

Leeds & District Amalgamated Society of Anglers

June 2019

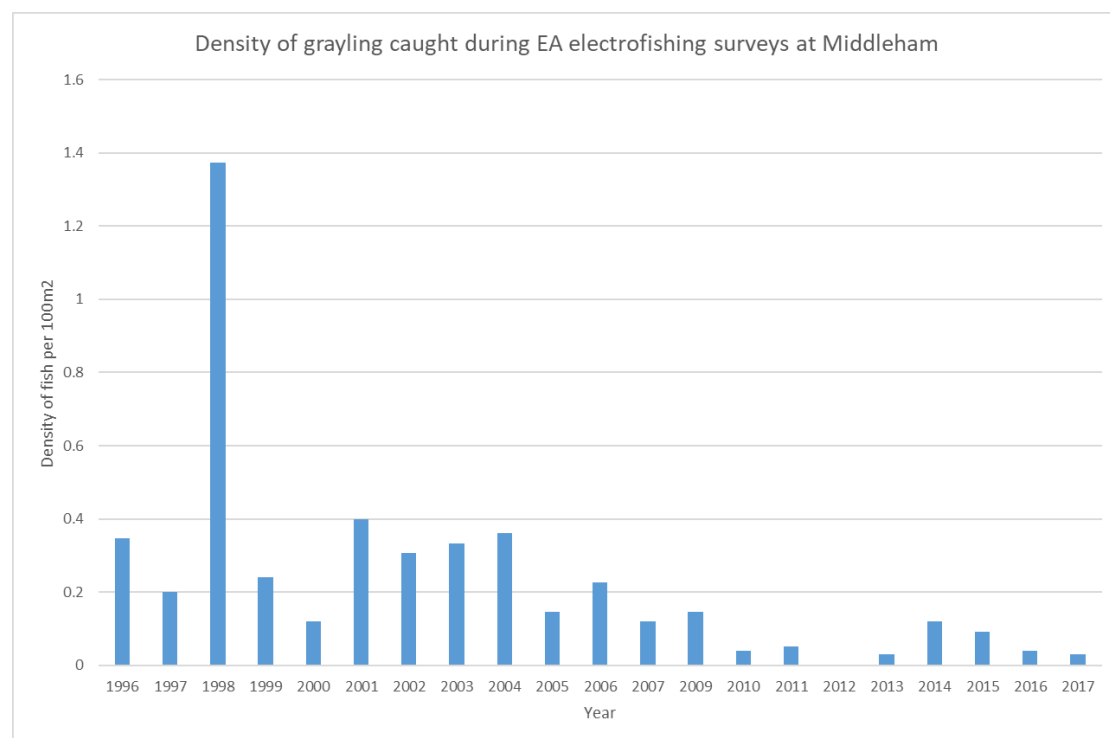
Environment Agency data hint at a decline in grayling density in the period 1996 to 2017 (Fig 2), although densities were typically low throughout (<0.4 fish per 100m^2) and look to have declined further in the last 10 years (<0.1 fish per 100m^2). These are data derived from single anode equipment in a broad, deep river and the actual site may also have changed over the period, hence it is difficult to interpret the results with any certainty. Interestingly, the EA removed 31 fish for broodstock collection in 2013 which coincided with the lowest ever recorded density; further broodstock fish were removed in 2014 & 2015, thereby preventing these fish from undertaking mate selection and also removing their contribution to natural production. Despite between 5k-10k advanced larvae being returned to the river in those years as 'compensation', it appears from the data that stocking with farm-raised fish had no discernible impact on grayling densities in the river. Chub have also declined over the same period.

Fig 2. Grayling density at Middleham (R Ure) derived from Environment Agency electrofishing surveys (supplied by David Morley)

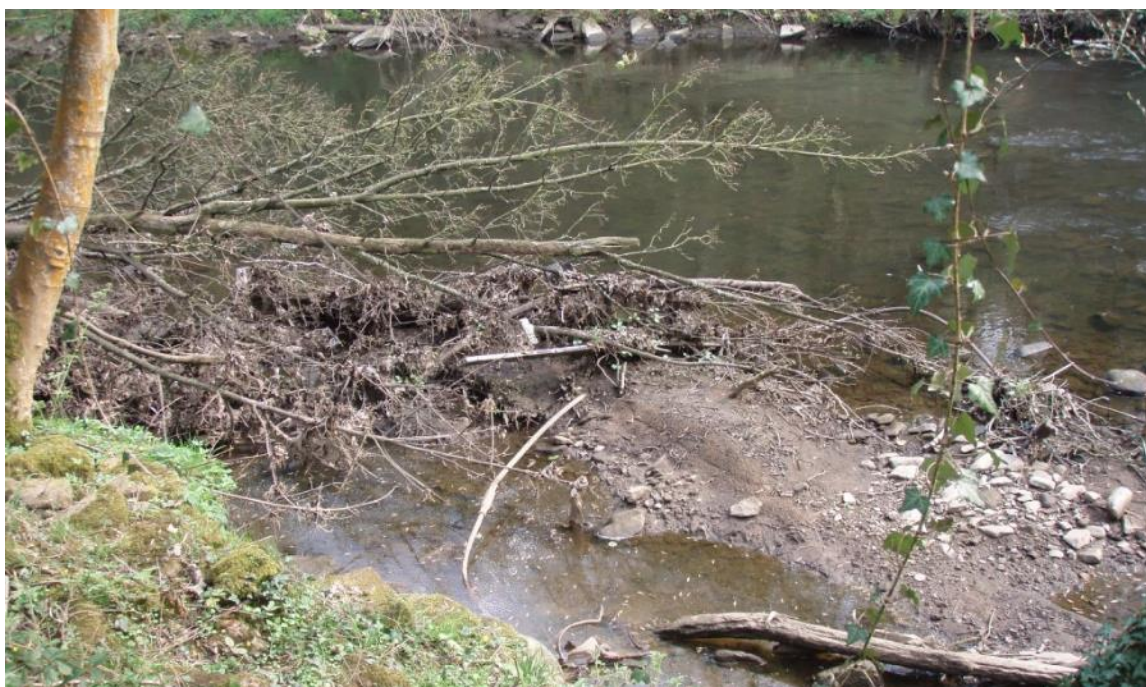
Fig 16. A tree kicker causes flow to be deflected away from the bank resulting in deposition along the protected, nearside margin.

A larger scale solution is to use a tree-kicker, to increase flow diversity by creating narrower pinch points where bed scouring and sorting will occur and create areas of slack water immediately d/s to encourage more deposition. A tree kicker secured within a river margin (Fig 16) has accumulated sediment within the crown and in its lee d/s, providing beneficial channel narrowing.

A tree kicker is created by felling a tree to lay in the margins almost parallel to the bank and preferably already in an area of modest deposition to encourage stability of the ensuing structure. However, it must be cabled securely to an appropriate anchor point (usually its own living stump or another trunk if the tree has been previously coppiced) to prevent any risk of future mobilisation and transport d/s. Installation of tree kickers requires consent under the EA environmental permitting regulations. WTT has produced a video on secure tree kicker installation:
