**Advisory Visit**

**R. Burn, R. Ure tributary**

**Northern Fishing School**

**July 2019**

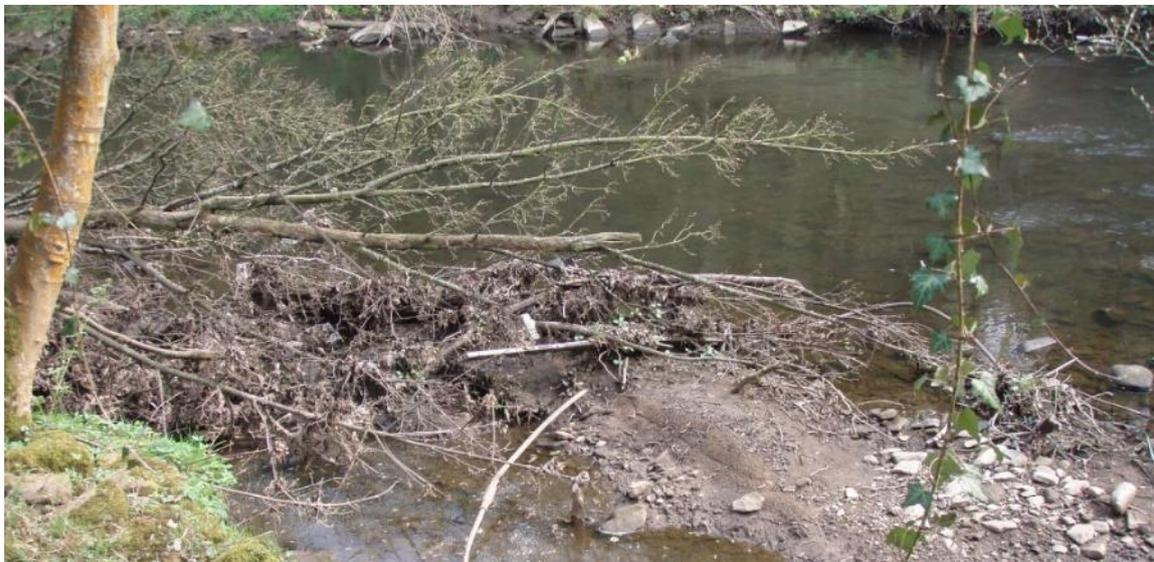
A larger scale solution is to use a tree-kicker, simulating natural tree fall but limiting any perceived flood risk by tethering it *in situ*. A tree kicker secured within a river margin (Fig 22) has accumulated sediment within the crown and in its lee d/s, providing beneficial channel narrowing.

Fig 22. The impacts of a tree kicker.

A tree kicker is created by felling a tree to lay in the margins almost parallel to the bank and preferably already in an area of modest deposition to encourage stability of the ensuing structure. However, it must be cabled securely to an appropriate anchor point (usually its own living stump) to prevent any risk of mobilisation and transport. Depending upon the local situation, it is also possible to wedge or
