River Culm, Culm Fly Fishing Club

An advisory visit by the Wild Trout Trust September 2012

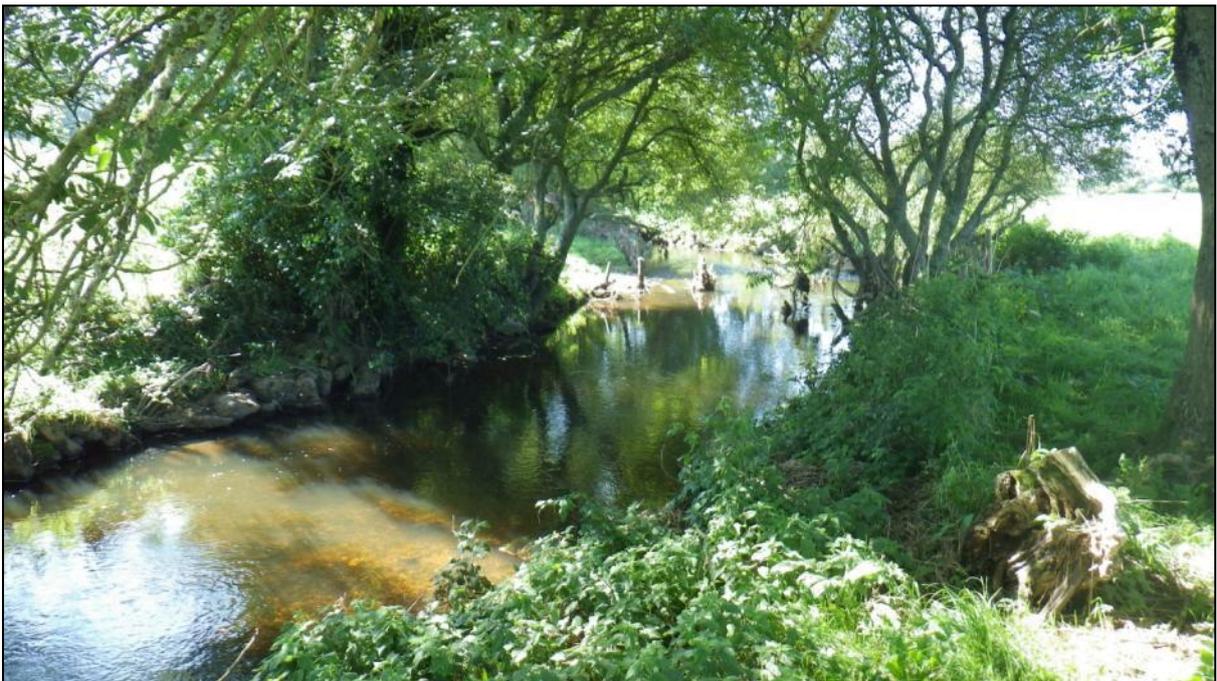
Tree cover varies from dense and dark shade, to open sunlight. Where the river is more heavily shaded, the bankside vegetation is sparser and the river is more accessible to anglers.

Figure 5: Dappled light conditions under bankside trees

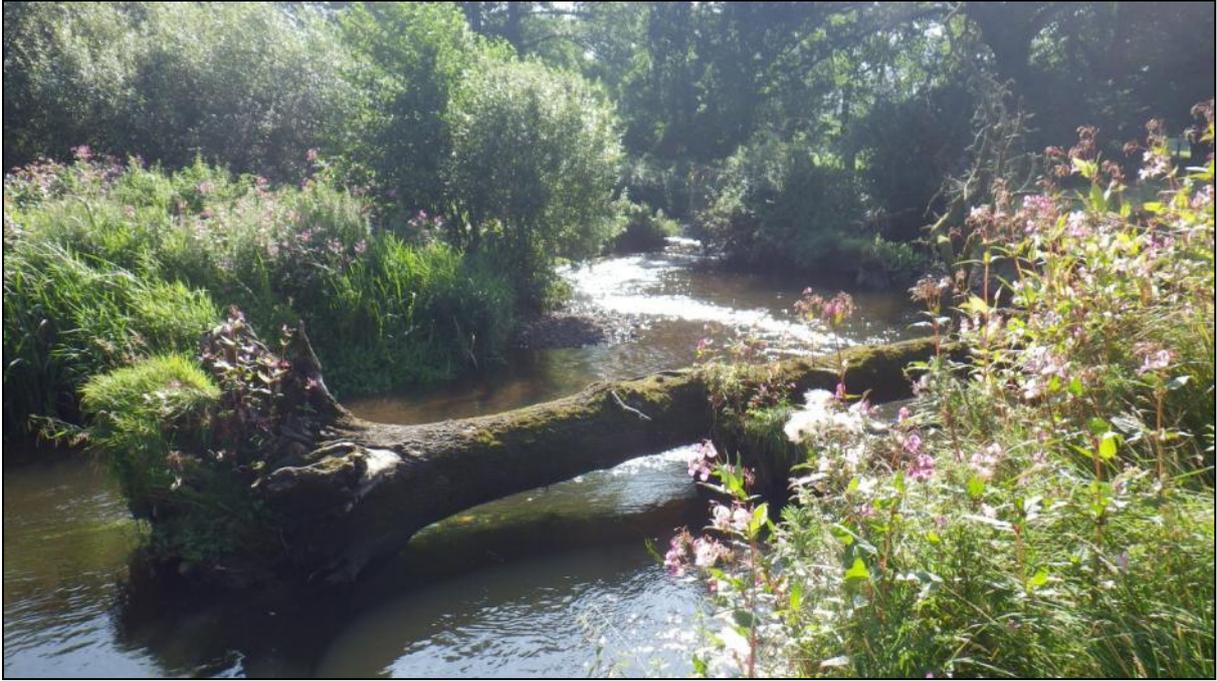
Rapid erosion and deposition has shaped this section into a diverse wild habitat with a broad range of features. Sharp meanders and distinctive pool-riffle sequences are clearly visible and gravel shoals mark the path of braided flood channels. LWD is littered throughout, helping to further diversify flow patterns and shape the complex channel form. The result is an idyllic wild-looking river that should be considered an enviable asset to the fishery. Fishing at locations such as this is likely to be particularly challenging but an extremely enjoyable and rewarding experience for wild fishing enthusiasts.

Figure 14: A wild and varied reach offering a broad range of habitat niches

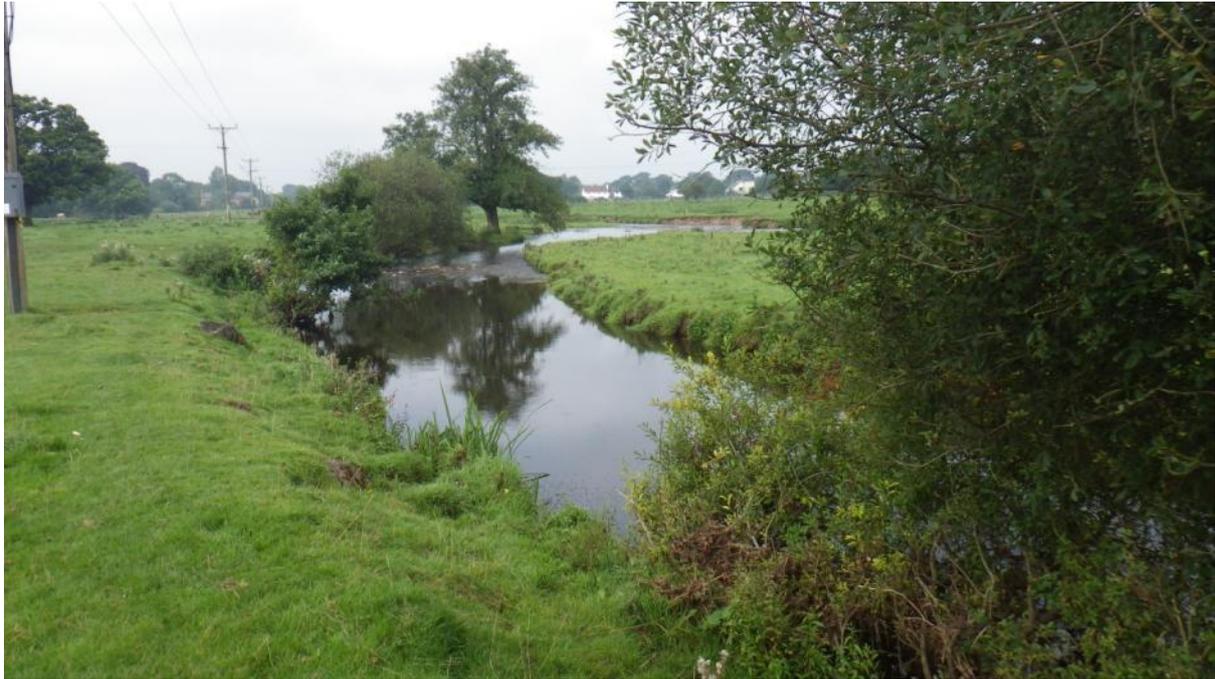
Observing the reach flowing southwest towards Culmstock in the present day, it is hard to imagine that the river was ever artificially straightened. The Culm's recovery from a straightened channel to naturally meandering river illustrates the energy in the river during spate conditions.

Figure 17: The once straightened course of the river now follows a naturally meandering path across the floodplain

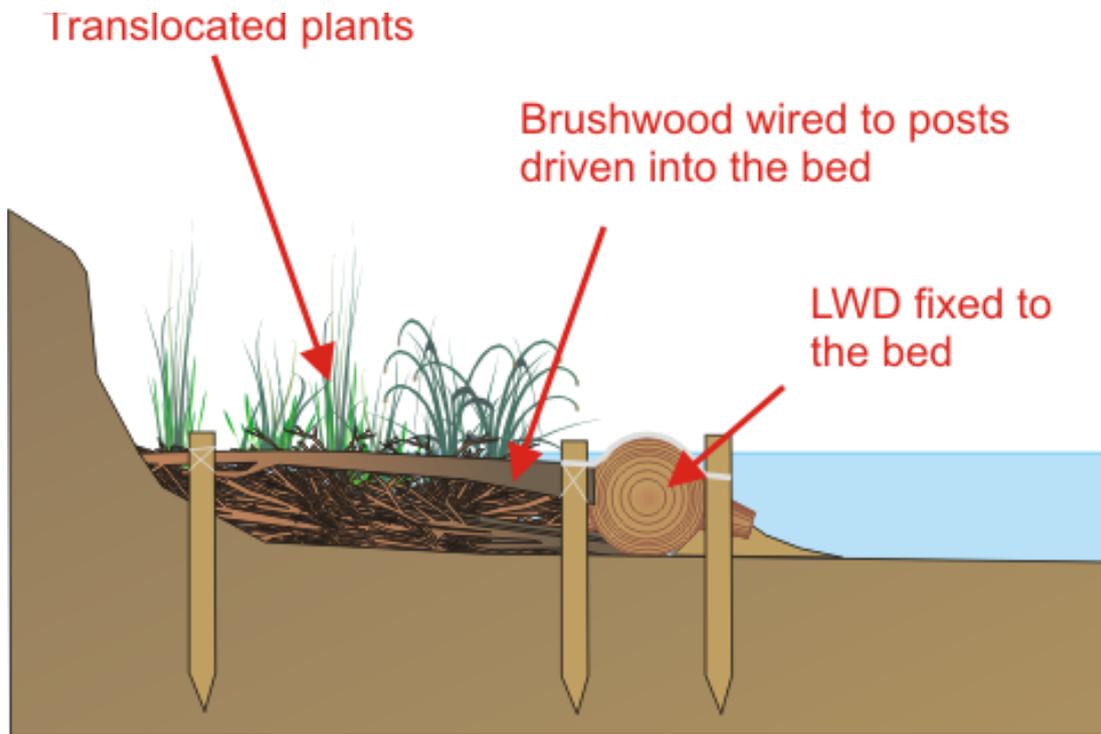
Figure 19: Coarse Woody Debris (CWD) marginal mattress

Brashy material left-over from such works could be used to create dense marginal mattresses that could be planted up with marginal species translocated from elsewhere on the river. This type of structure secured to the bed in depositional areas (such as on the inside bend of meanders) will trap sediment and quickly develop into a dense bed of marginal plants.

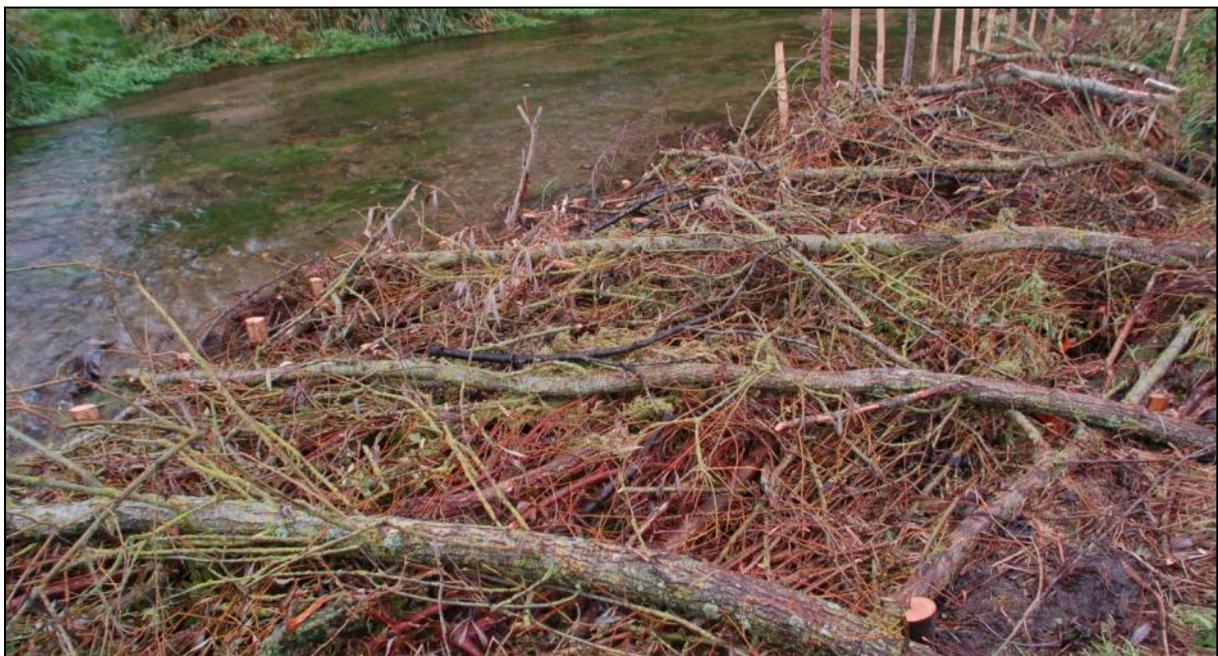
Figure 20: An example marginal mattress made with live willow

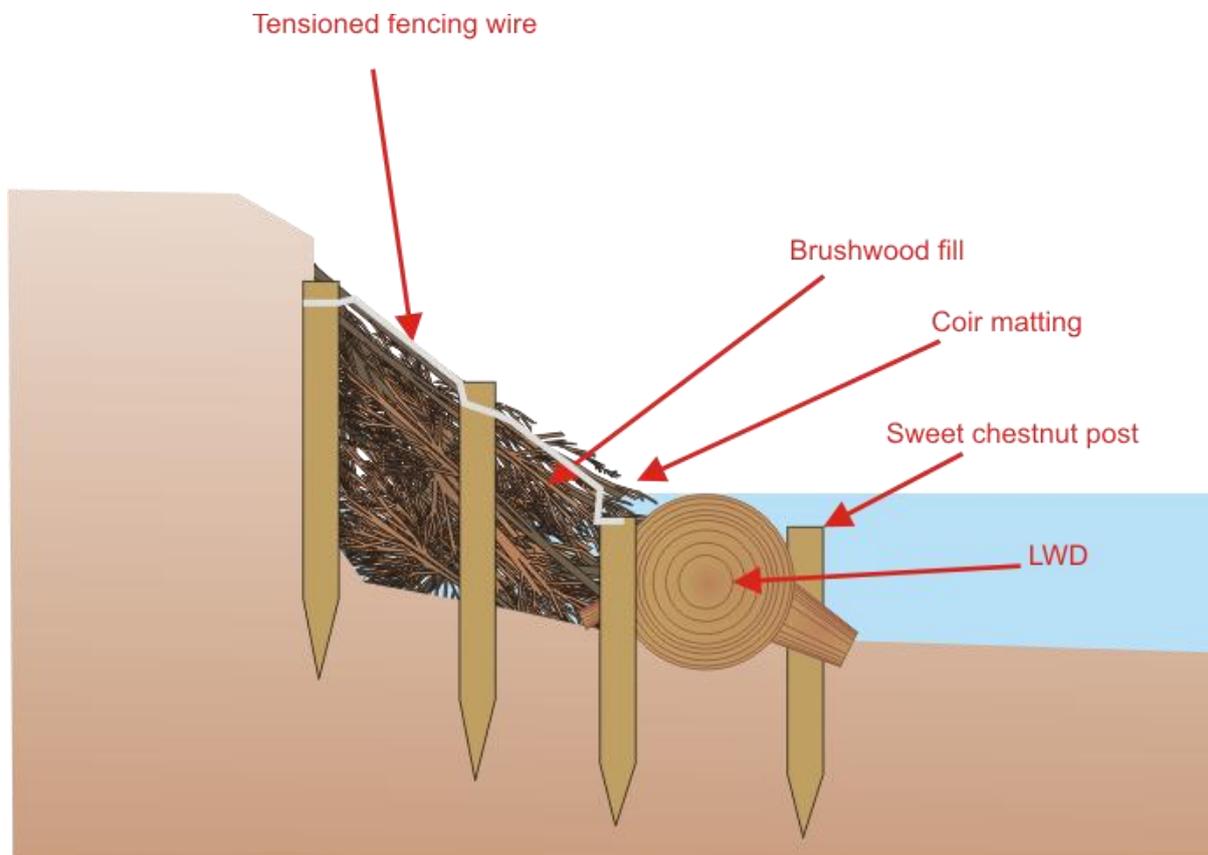
Figure 21: A LWD and brushwood sloping revetment

- The club has already done a sterling job of utilising LWD to create anti-erosion revetments. This type of work is warmly encouraged as a means of introducing more woody habitat into the river and repairing erosion problems

without resorting to environmentally unfriendly 'hard engineering' techniques. The design previously used by the club could be improved by incorporating a sloping cross section. This will make the structure more resistant to flood flows by presenting a smoother face to the flood flows and limiting the hydraulic pressure within the structure that could otherwise lead to revetments being dismantled under turbulent conditions.

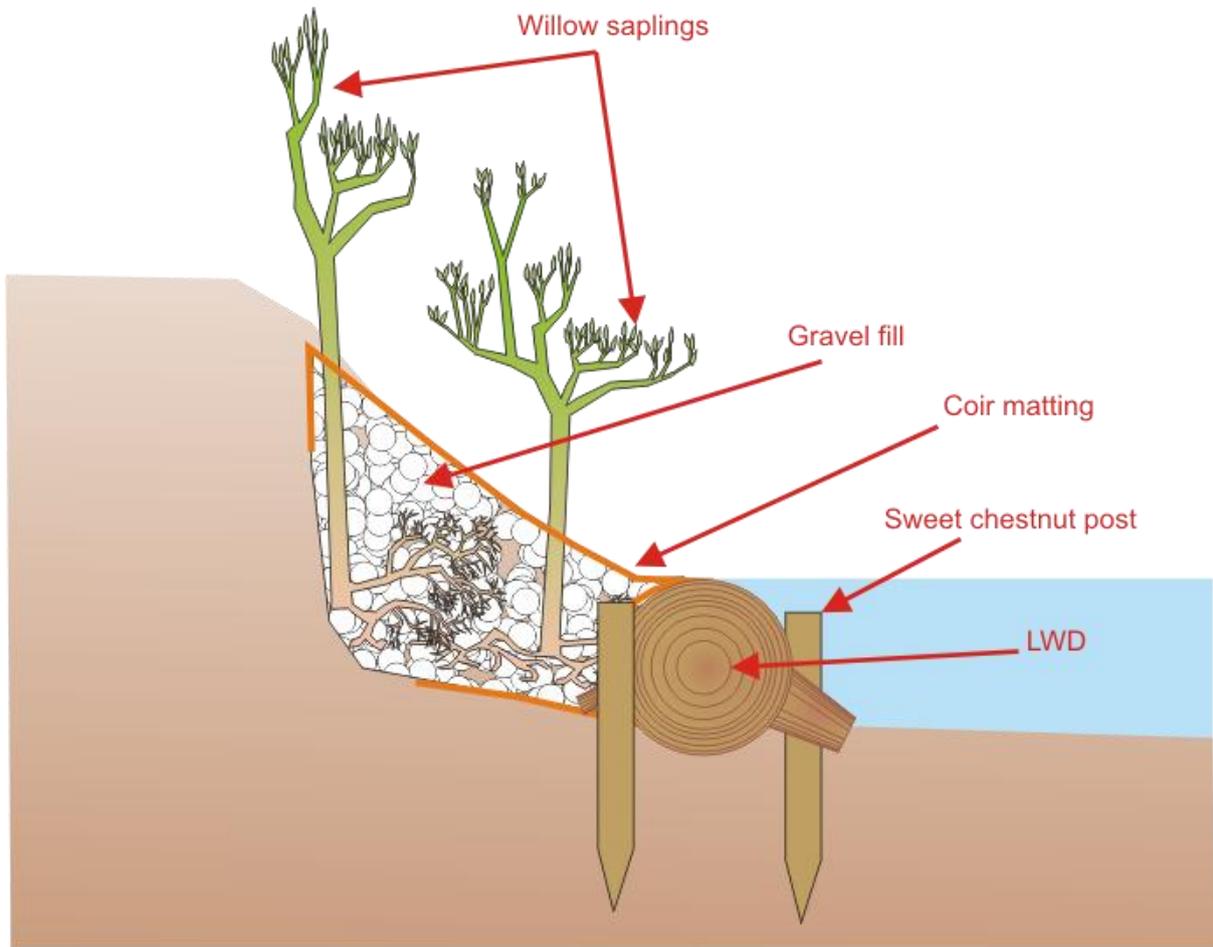
Figure 22: A gravel-filled alternative with live willow saplings

Another option could be to use some imported gravel. Coir matting (an inexpensive biodegradable geotextile made from woven coconut husk) can be used to create an enclosed cell that can be back-filled with gravel. Live willow stakes could then be driven through the structure to help anchor the revetment. By the time the coir has rotted away, a dense willow root system will be holding the structure together and growing stronger every year.
