**Advisory Visit**  
**River Mimram, Hertfordshire**  
**April 2019**

## **1.0 Introduction**

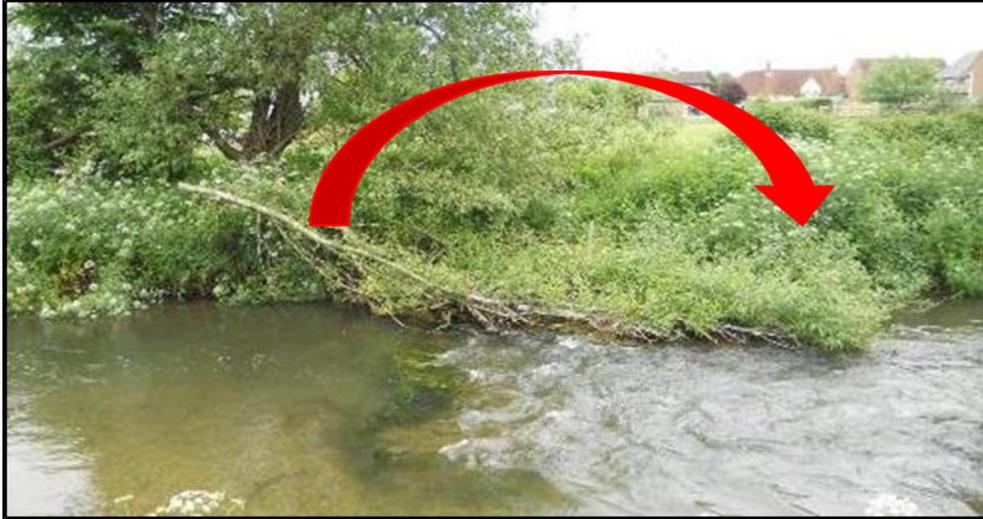
Pic 27 - An example of tree hinging, a simple and effective technique for increasing cover in a river

- Tree-hinging would be a simple first approach to managing the tree stock whilst providing cover at water level (pic 27). The process and benefits of tree-hinging has already been discussed on page 7.

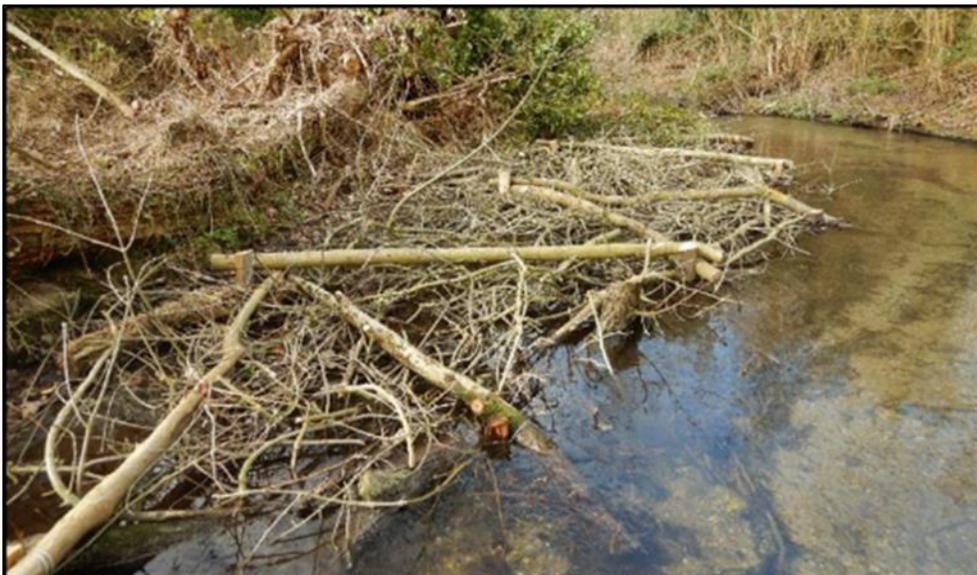
Pic 28 - A low-level brushwood ledge created on the River Misbourne following tree thinning work. Brushwood can be used to protect banks from erosion, to create in-channel sinuosity and to entrain silt and sand. They are particularly effective for enhancing low flow rivers.

- Brushwood ledges: these features can be created following tree works. A brushwood ledge provides complex cover at, and below, water level. Brush from tree thinning is pinned against the bank in alternating directions or increasing stem thickness, and is securely wired down or held with battens. The brushwood lattice provides niches for invertebrates and small fish, aids silt entrapment and provides a rooting substrate for plants to establish. In time (~3yrs) the brushwood ledge will become a vegetated berm if exposed to full sunlight.

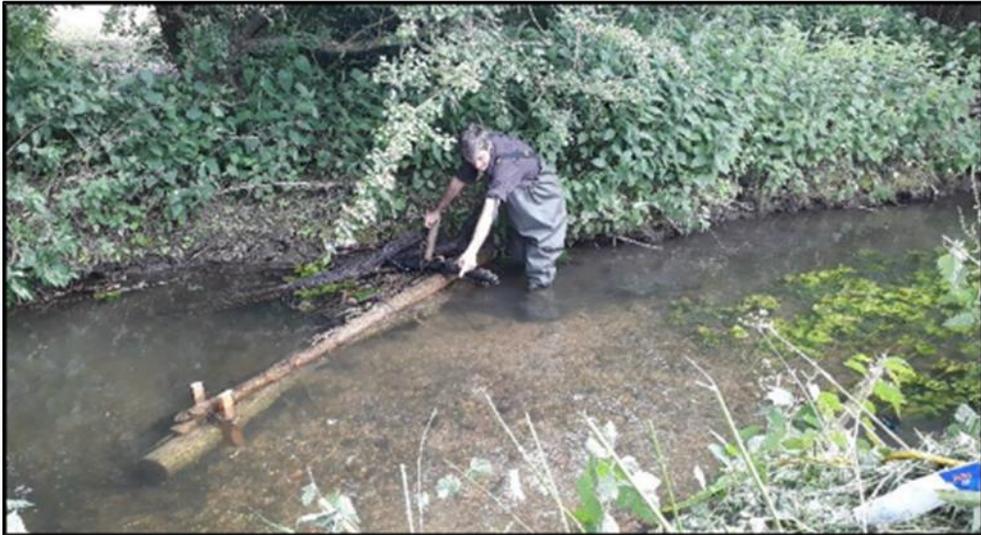
Pic 29 - A flow deflector used to focus flow and scour into the centre of the channel.

- Flow deflectors: these features can be used to increase flow diversity and bed scour. They can be simple log deflectors or tethered tree stems. The complex flow that arises results in depth cover and sediment sorting and transport.

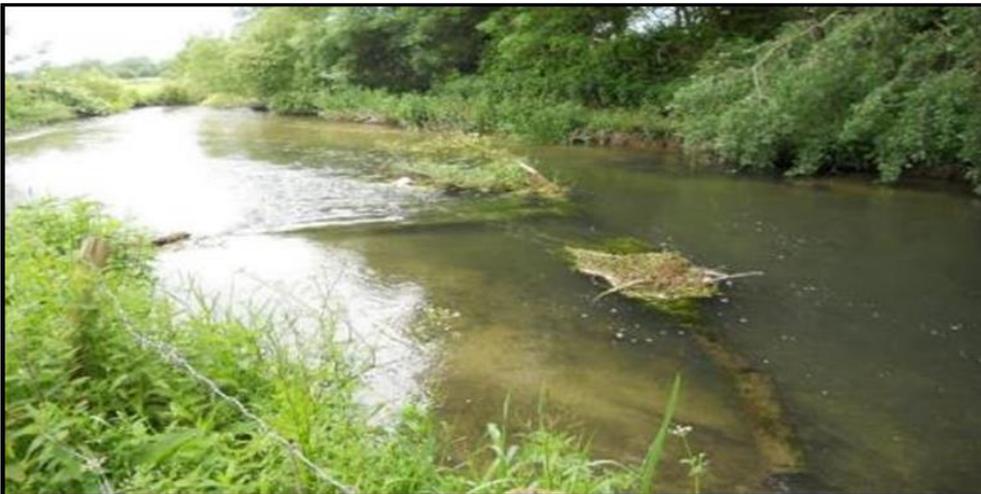
Pic 30 – LWM fixed to the bed on the Wyllye. Large pieces of timber create both underwater scour to sort sediments and a broken water surface providing cover and oxygenation.

- Fixing LWM to the riverbed: this is a means of increasing flow diversity and in-channel cover. In gravel-rich rivers such as the Mimram, the positioning of LWM mid-channel is likely to increase bedform diversity, through scour and deposition of gravel. This could result in a highly diversified channel with complex flow patterns and a greater level of habitat diversity.
