River Wey – Bishops Meadow Trust

An Advisory visit by the Wild Trout Trust – August 2012

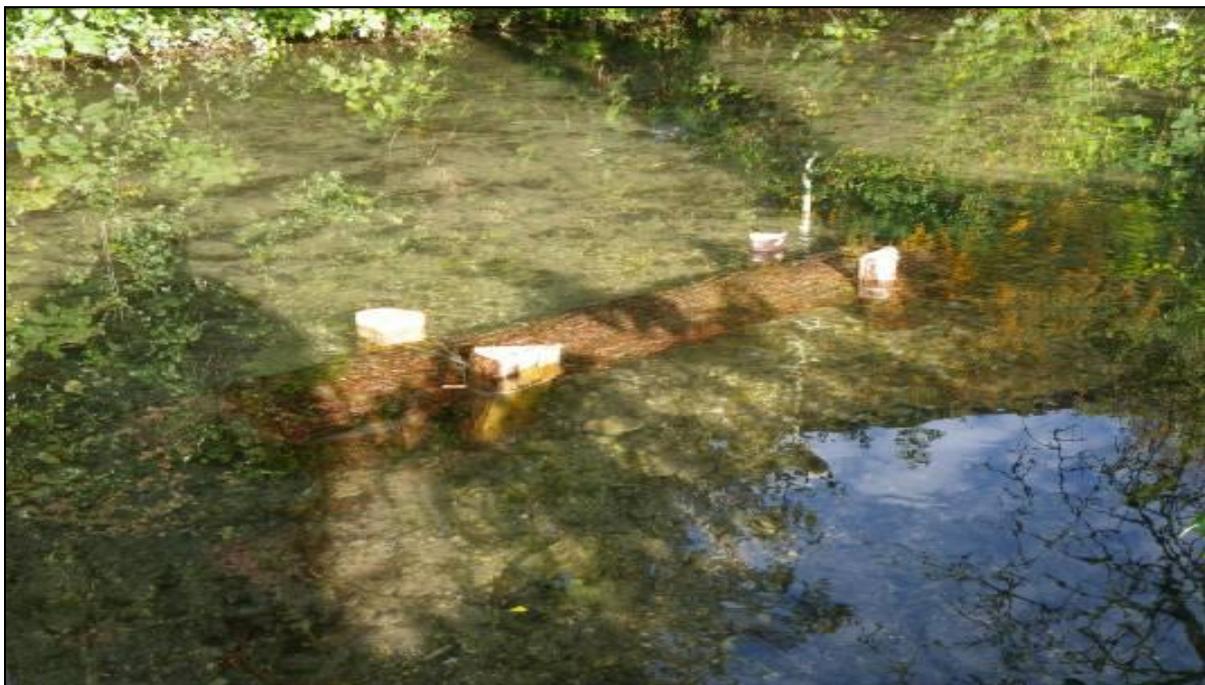
Figure 14: An example of a very simple LWD deflector fixed to the bed with posts and wire

The habitat from the gauging weir towards the downstream boundary of Bishops Meadow would benefit from some simple habitat improvement works. The installation of a few large woody debris (LWD) deflectors fixed to the bed in key locations could help to deepen existing pools and gently 'sort' gravels – keeping them clean of sediment and enhancing spawning habitat.

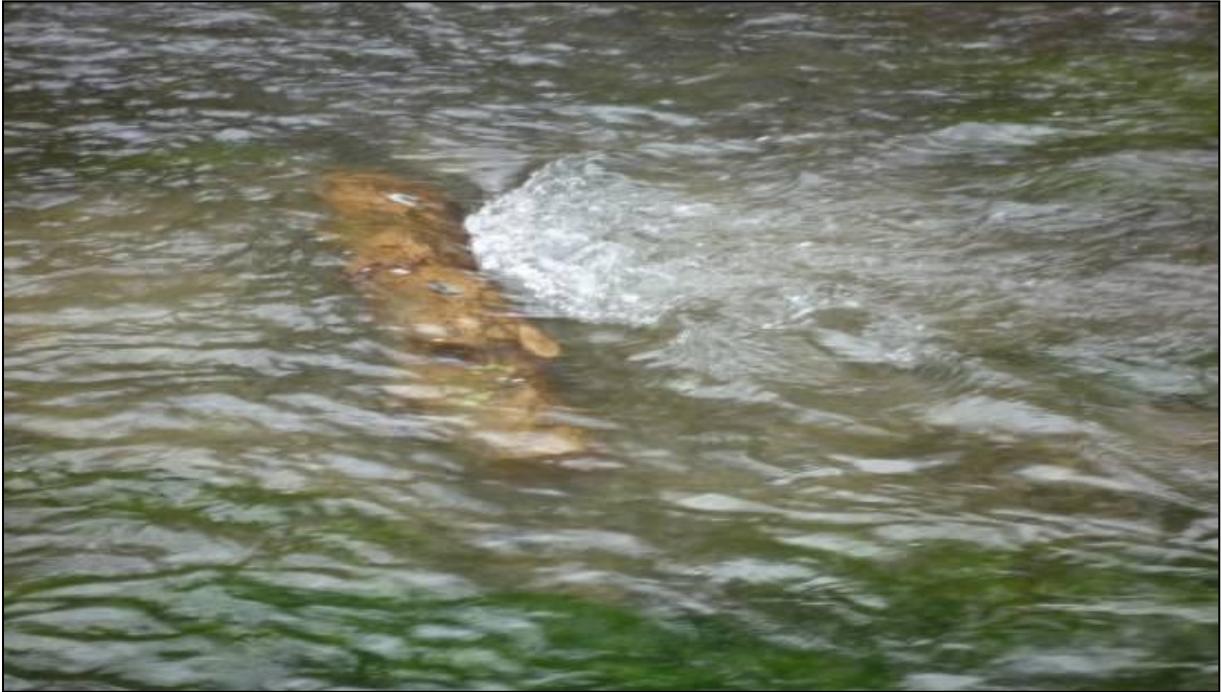
Figure 15: A small LWD log deflector fixed over a shallow riffle to promote localised scour and sort gravels for spawning habitat

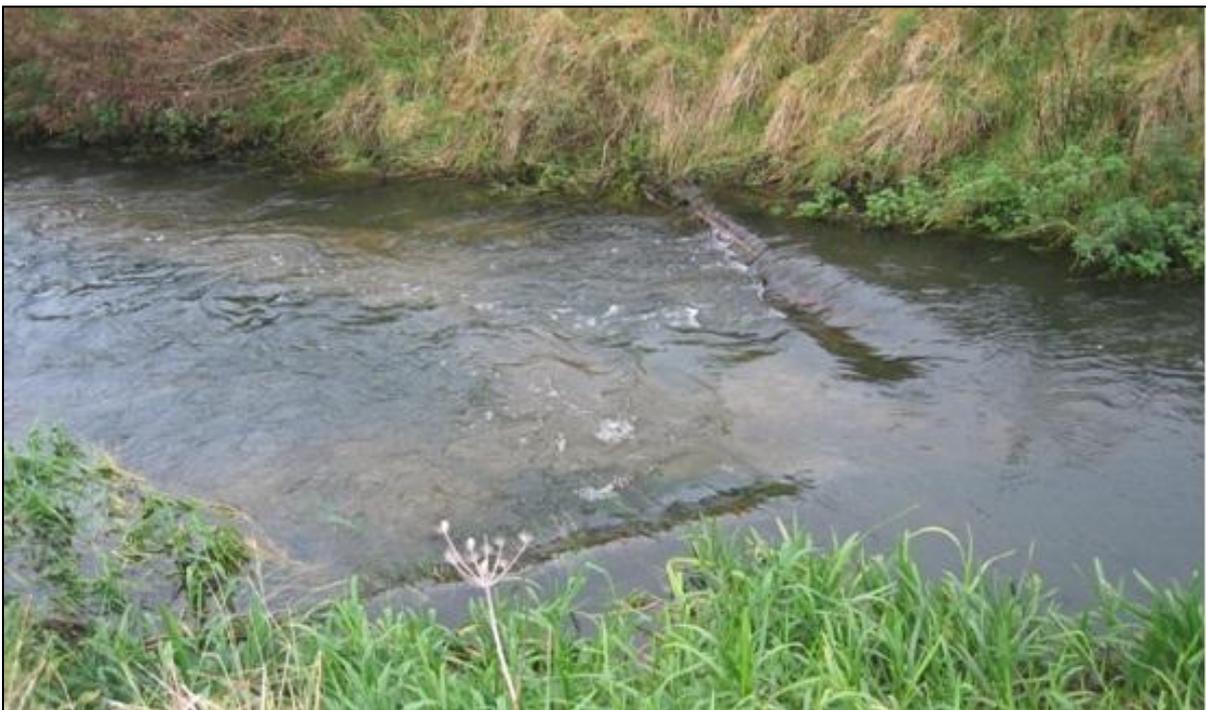
Figure 16: LWD in an upstream 'V' formation. Flows are focussed into the centre of the channel – scouring a pool and lifting gravels from the bed.

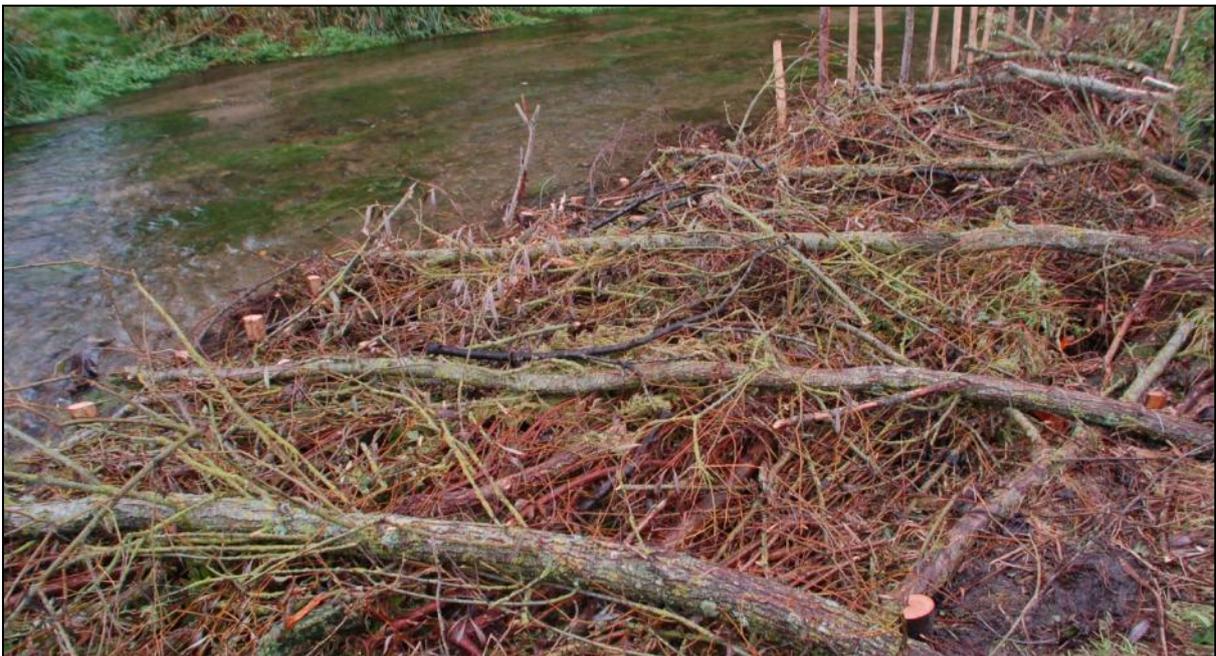
Figure 17: A live willow CWD (brushwood) marginal mattress installed as a habitat feature. This will narrow the channel whilst also trapping sediment and developing into a dense stand of marginal plants and willow scrub.

CWD mattresses can be created from branches or brushwood bundles packed tightly together at or just below the surface and fixed in place with sweet-chestnut posts and fencing wire. These act as sediment traps that develop into good habitat for marginal plants and facilitate natural channel narrowing.

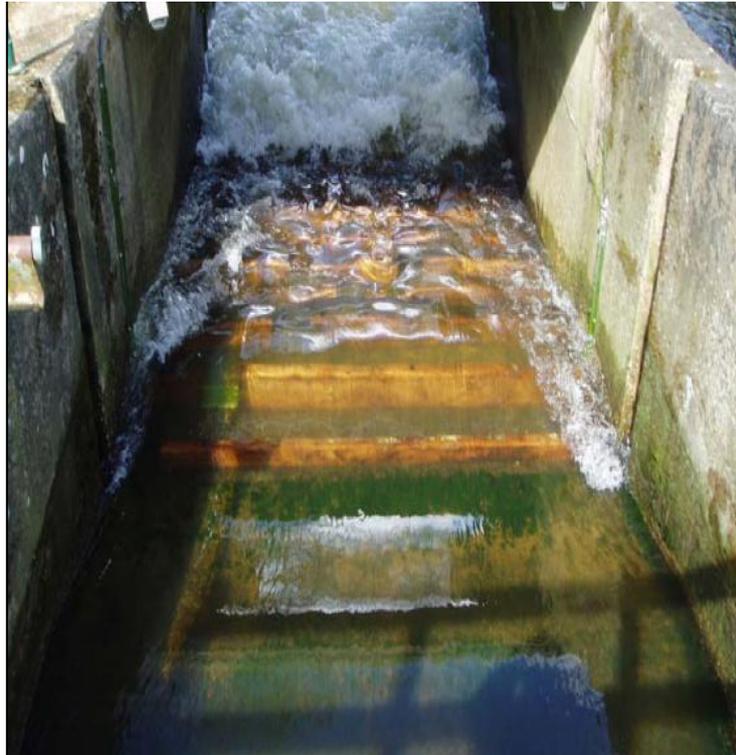
Figure 18: An example timber baulk easement fixed to a crump weir

The gauging weir is potentially a complete barrier to upstream migration. It is recommended that a dialogue is opened with the Environment Agency with regards to easing fish passage over the structure. Ideally, the structure could be completely removed in favour of a more modern gauging station that does not require a crump weir. Alternatively, a project could be designed to ease fish passage without removing the weir or affecting the performance of the gauging station. An example easement project using timber baulks to baffle flow and raise water levels over the downstream face of a crump weir is shown in **Figure 18** below:
