**Water Framework Directive Habitat Survey
Upper River Yare and Blackwater, Norfolk
February 2012**

1.0 Introduction

This report is the output of a site visit undertaken by Tim Jacklin of the Wild Trout Trust to the upper River Yare and Blackwater, near Reymerston, Norfolk on 1st and 2nd February, 2012. Comments in this report are based on observations on the day of the site visit and discussions with Jez Wood, Biodiversity Officer with the Environment Agency, Anglian Region.

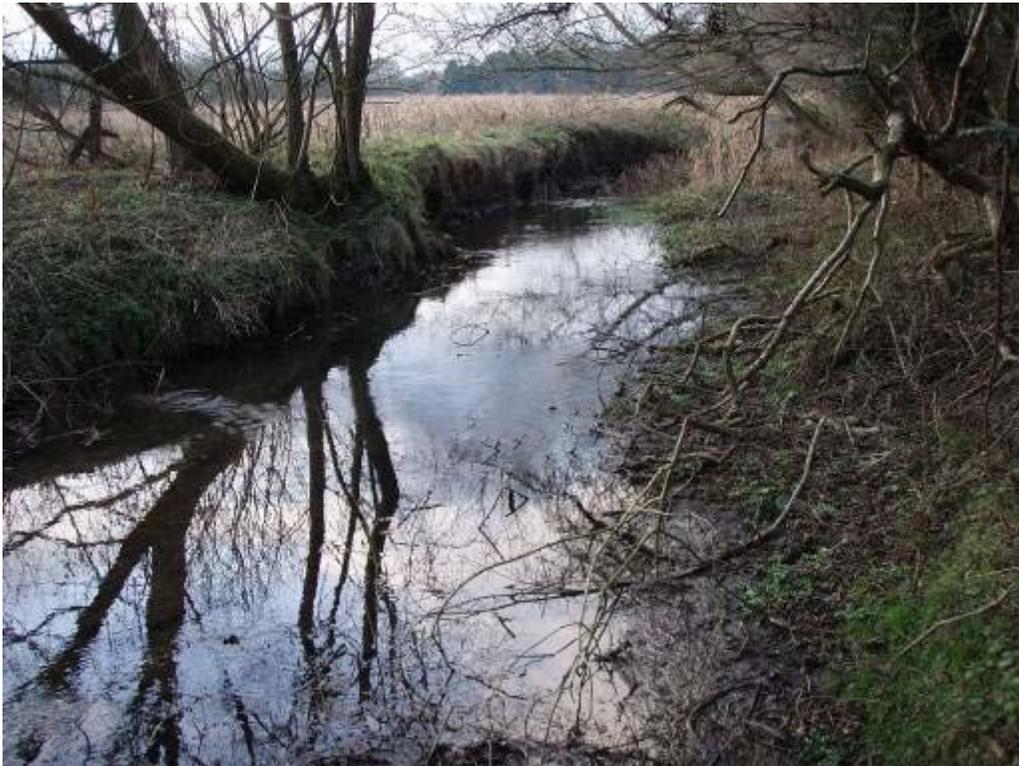
Photo 13 Upstream view, Blackwater TG012047

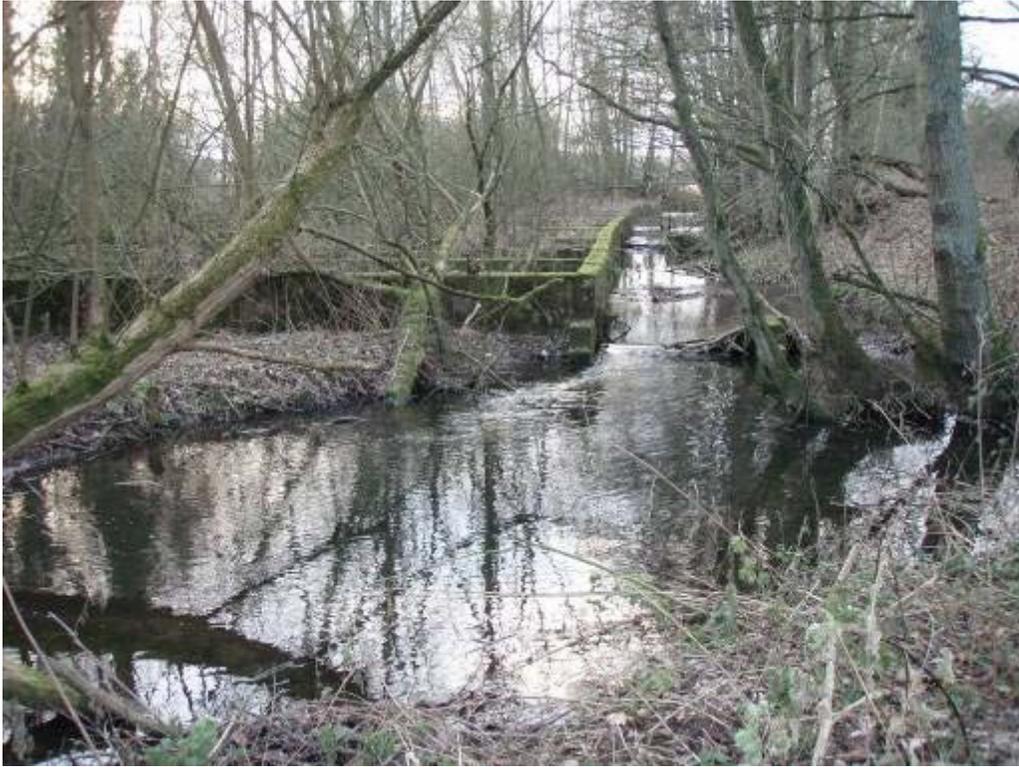
Photo 14 Upstream view showing disused trout rearing tanks, Blackwater TG013047

Photo 15 Blackwater immediately downstream of Photo 14 – some excellent in-stream habitat with large woody debris, scour pools, a good depth variety and well-sorted gravel substrate
