Upper East Stour, Monks Priory, Kent

Advisory visit May 2016

This report is the output of a site visit to a headwater stream making up one arm of the East Stour River at Monks Priory, near Sellindge in Kent carried out by Andy Thomas of the Wild Trout Trust. The request for the visit came from Mr. Adrian Birth who has been contracted by the land owner to undertake environmental and aesthetic enhancements to the various waterbodies located within the estate boundary.

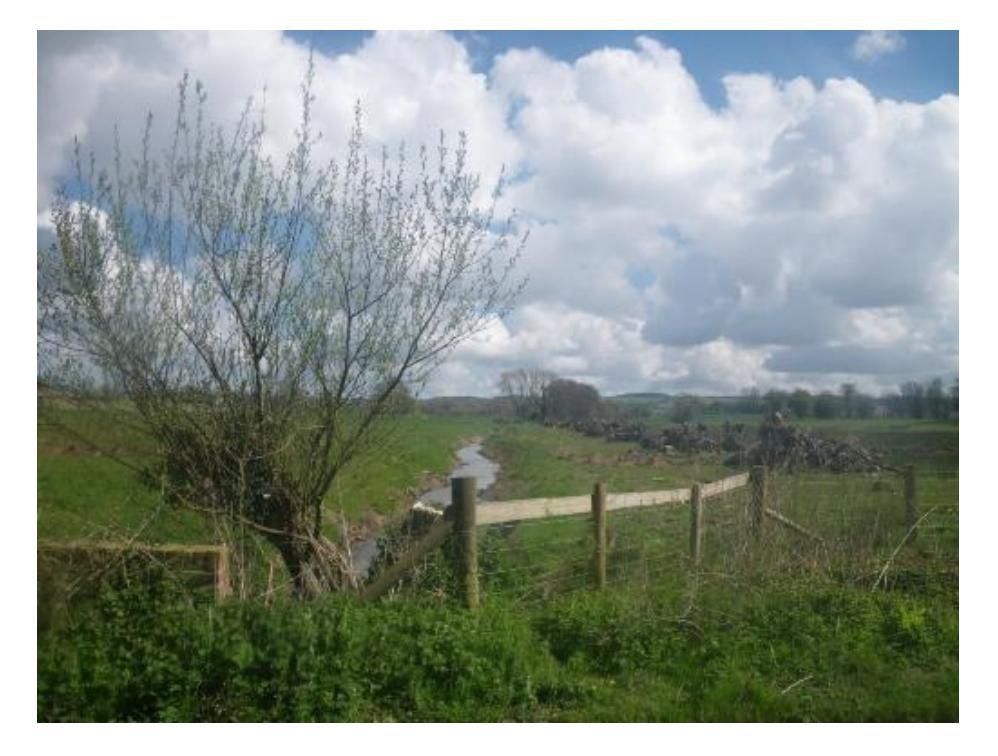
In the reach immediately upstream of the Monks Priory water there has been some recent in-channel dredging work which has included the removal of large numbers of trees, including their root systems (photo 1). Presumably this work was undertaken by the neighbouring land owner, or tenant in an attempt to improve local land drainage. This potentially damaging work will have resulted in notable destabilisation of the banks and large quantities of fine sediment being mobilised which will impact upon habitat quality within the Monks Priory reach. Any mobilised sediment that then settles onto shallow gravel runs can catastrophically impact on fish spawning success by filling the gravel matrix with fine sediment and potentially smothering fish eggs, resulting in poor egg to fry survival rates and degrading invertebrate and plant habitats. Hopefully any damage incurred as a result of the redistribution of fine sediment at Monks Priory will be temporary as silt is gradually moved on by natural river processes; however, any long-term bank destabilisation could create an ongoing issue.

Unfortunately, the work undertaken upstream will also be resulting in the stream warming up. Tree shading is very important for small streams and is particularly important for species like brown trout that require cool, well oxygenated water. Research carried out by the Forest Commission and others has clearly identified how even comparatively short sections of tree shading can help to moderate water temperatures in flowing streams. Conversely, wholesale tree removal can result in a warming effect, especially under low flow conditions, with the stream less able to retain the high levels of dissolved oxygen required to sustain a trout population.

Photo 1. The section upstream has been badly degraded by the wholesale removal of all tree cover, including root systems.

- Engage with your upstream neighbour over methods for managing the stream and banks.
- Coppice occasional stands of mature alder to preserve the life of long, leggy trees, particularly those with exposed root systems.

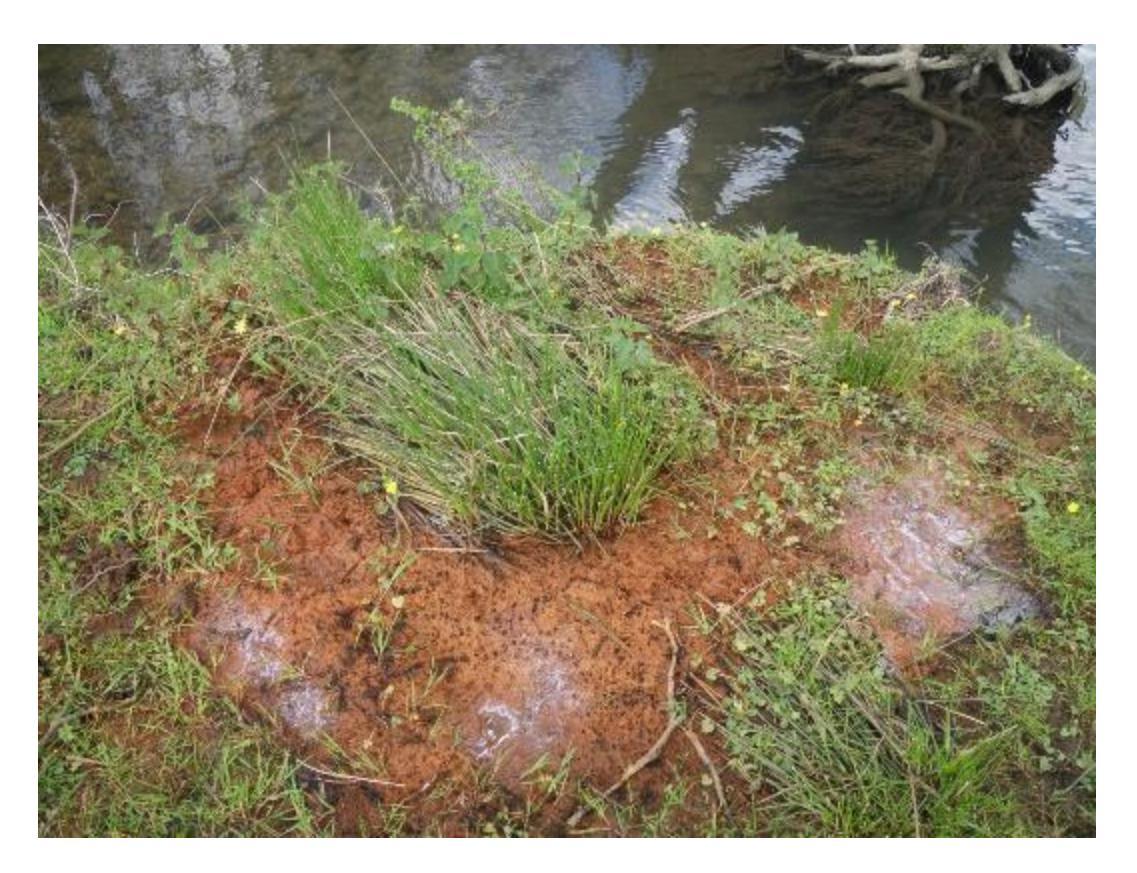
Photo 2. Iron rich groundwater source adjacent to the stream.

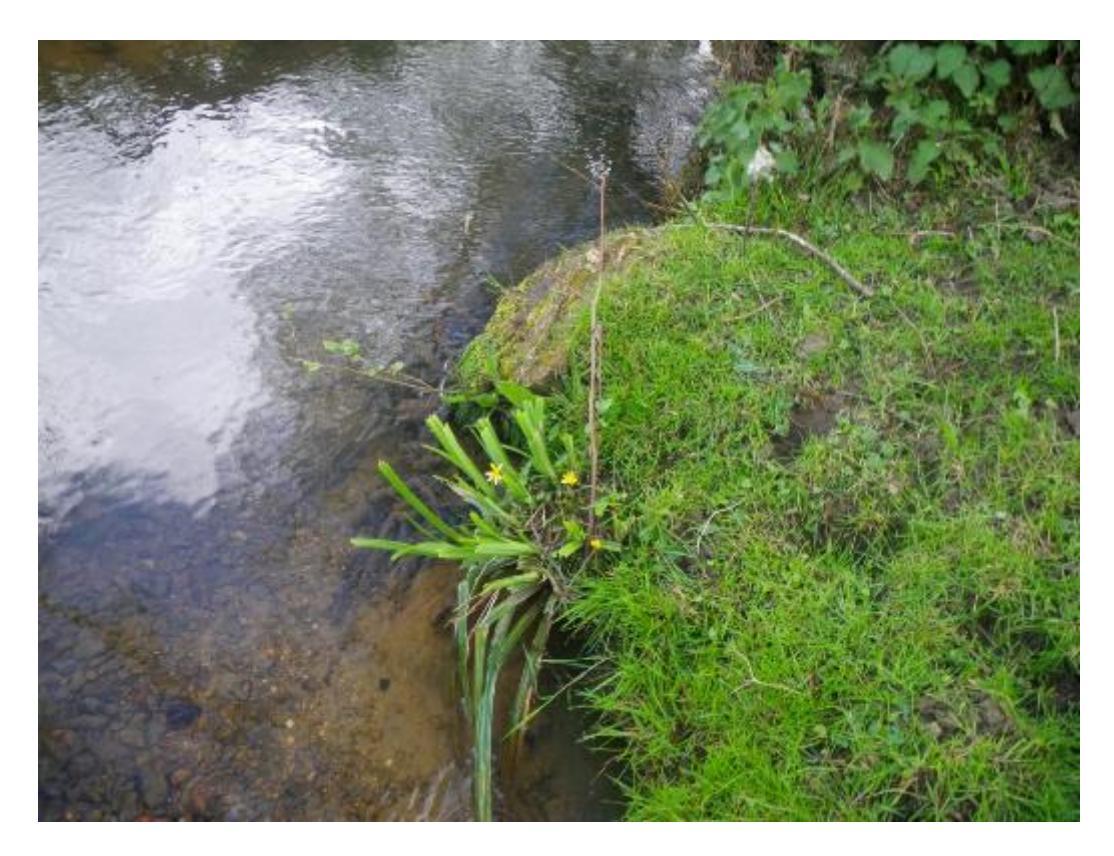
Meadows adjacent to the left bank are being used for grazing livestock. There was evidence of excessive grazing pressures (photo 3) which is impacting on bank-side plants, reducing their capacity to provide a biologically rich river margin, as well as leaving the banks more vulnerable to increased river erosion pressures. Excluding grazing animals from selected sections of sensitive river bank via targeted stock fencing will help the margins to develop a more diverse and healthy range of plants. This in turn will provide improved habitats for invertebrates and ultimately more food for fish, while also stabilising the bank.

Photo 3. Marginal sedges are considered to be very good for bank protection and providing habitat for invertebrates. Less nibbling will result in a thicker fringe developing.

- Encourage rougher, more naturalistic river margins to develop by reducing bankside grazing pressures. This can be achieved via permanent or temporary fencing and will help to protect the banks and provide habitat for fish and the food of fish. It must be ensured that any subsequent grazing does not compromise the establishment of herbaceous vegetation and shrubs.

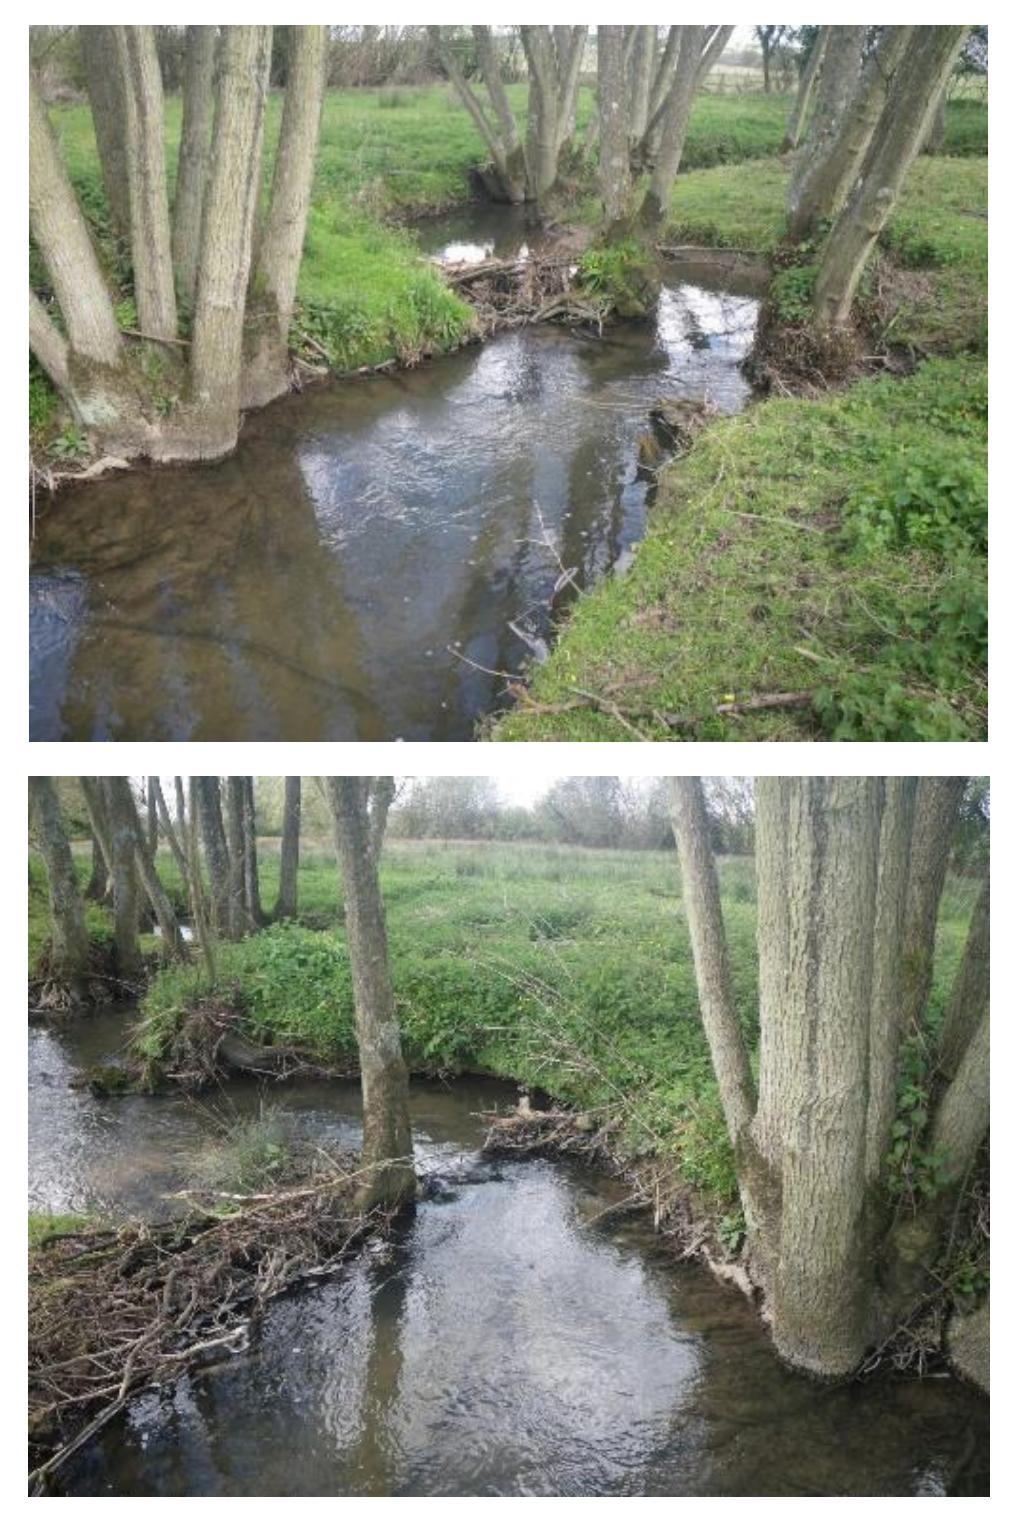
In some areas, there is evidence that marginal alder trees have been previously coppiced. Consideration should be given to carrying some further light coppicing work to introduce some variety into the height of the tree canopy and also to preserve the life of some of the stands. A good example is where a tree is in danger of being washed out and the root system exposed (photo 4 & 5). Coppicing the tree on the mini island will reduce the risks of this particular tree falling over and causing a full-width debris dam from forming. Again, this should only be undertaken after exclusion of livestock, otherwise you will simply lower the canopy into their reach.

Photo 4 & 5. The alders in the centre of the channel should be coppiced to preserve the tree and root systems.

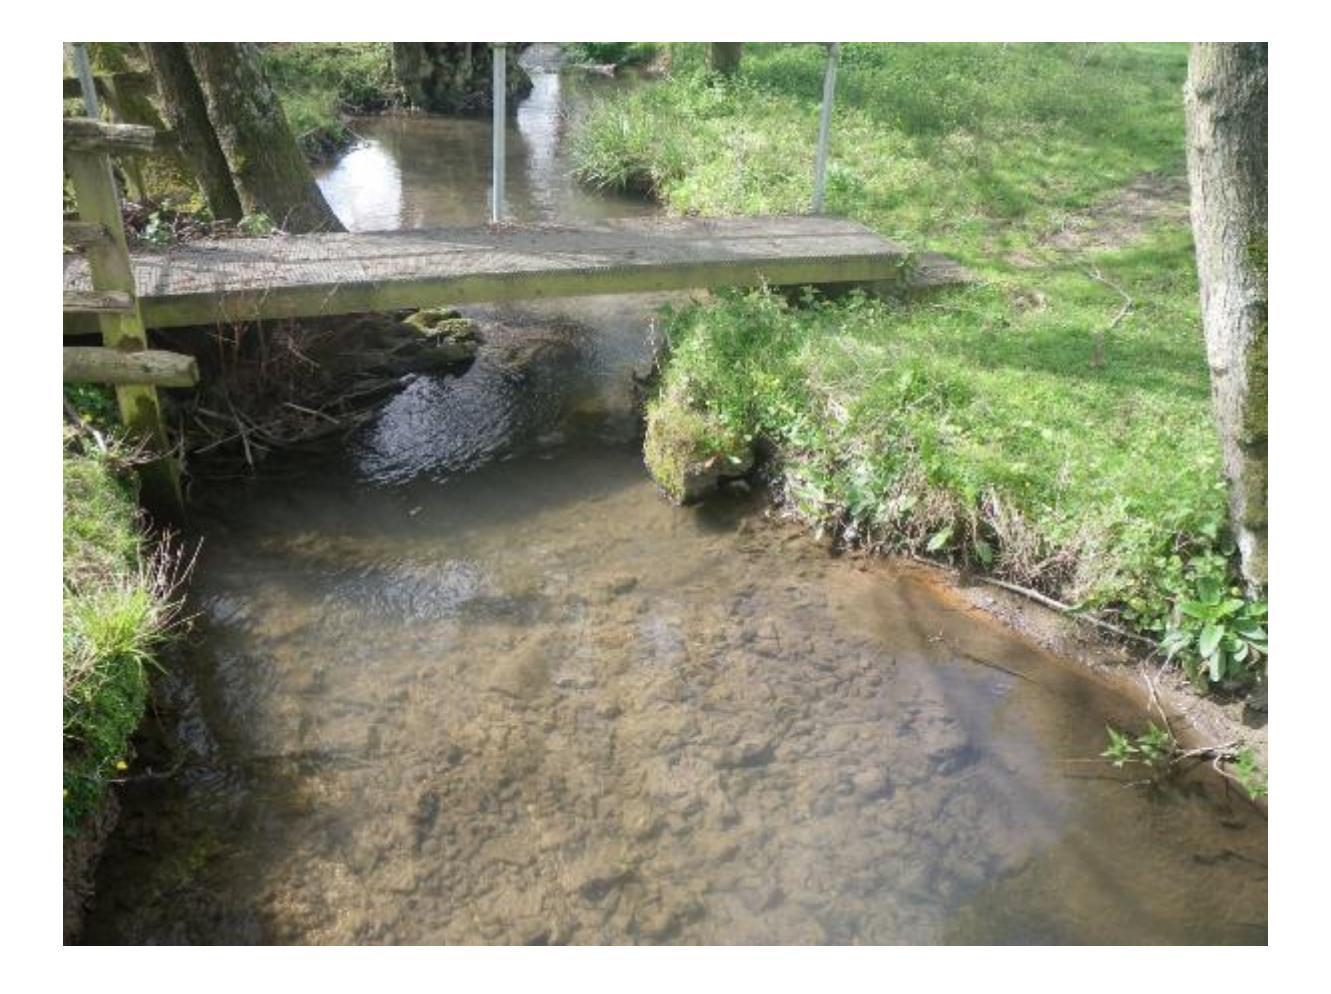
There were some good examples of shallow, gravel-lined runs, which potentially can provide high quality spawning opportunities for a range of fish species, including trout. Much of the gravel appeared to be covered in a thin layer of fine sediment and as previously discussed, this may be due, in-part, to issues further upstream. Trout spawning success can be enhanced on sites like this with a few hours of work undertaken just prior to trout spawning season in the November to January period. Raking the gravels to reduce the fine sediment loads can significantly help to boost spawning success.

Photo 6. A potential spawning site coated in fine sediments.

Further information on exactly how and where to undertake gravel cleaning can be found on the Wild Trout Trust website, including instructional videos. <u>http://www.wildtrout.org/search/node/Gravel%20cleaning</u>

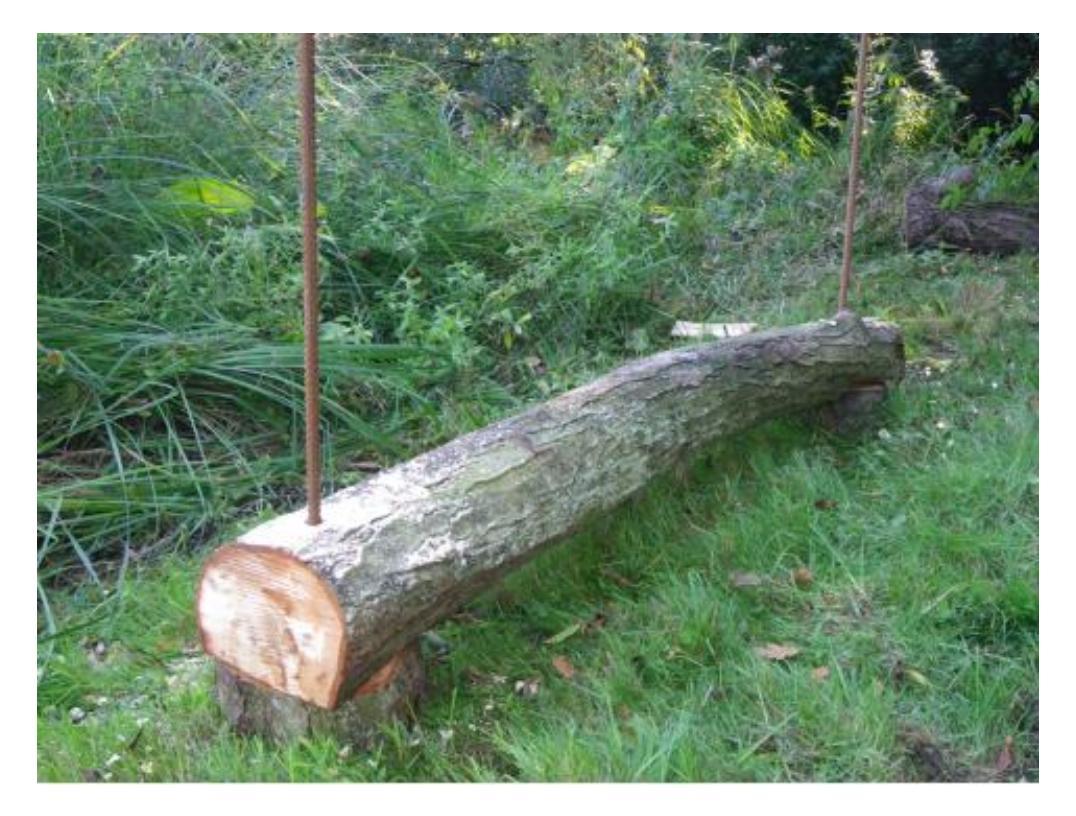
Photo 8. Cover log sat up on two woody rings cut from the end of the log, drilled and ready to be pinned to the bed with steel re-bar.

On sections where in-channel cover is scarce, consider introducing woody material to create cover and promote bed scour. 'Cover' logs popped in parallel to the flow and adjacent to the toe of the bank can also encourage trout to take up residence in open, shallow environments. The principle of the cover log is that there is a gap underneath where trout can safely hide from predators but also safely nip out into the flow to intercept passing food items. To be effective they need to be positioned adjacent to the margin that carries the majority of the flow velocity. A cover log is shown up on the bank ready for deployment in photo 7 and how they should look once installed into the channel, mimicking an undercut bank (photo 8). Simple brushwood bundles installed (photo 12) in similar fashion are also hugely effective, especially on sections immediately downstream of known spawning sites.

- Introduce woody material to the channel to promote bed scour/sorting and provide cover. Use large woody material to promote bed scour, parallel cover logs for adult trout cover, and brushwood for enhanced fry and parr cover.

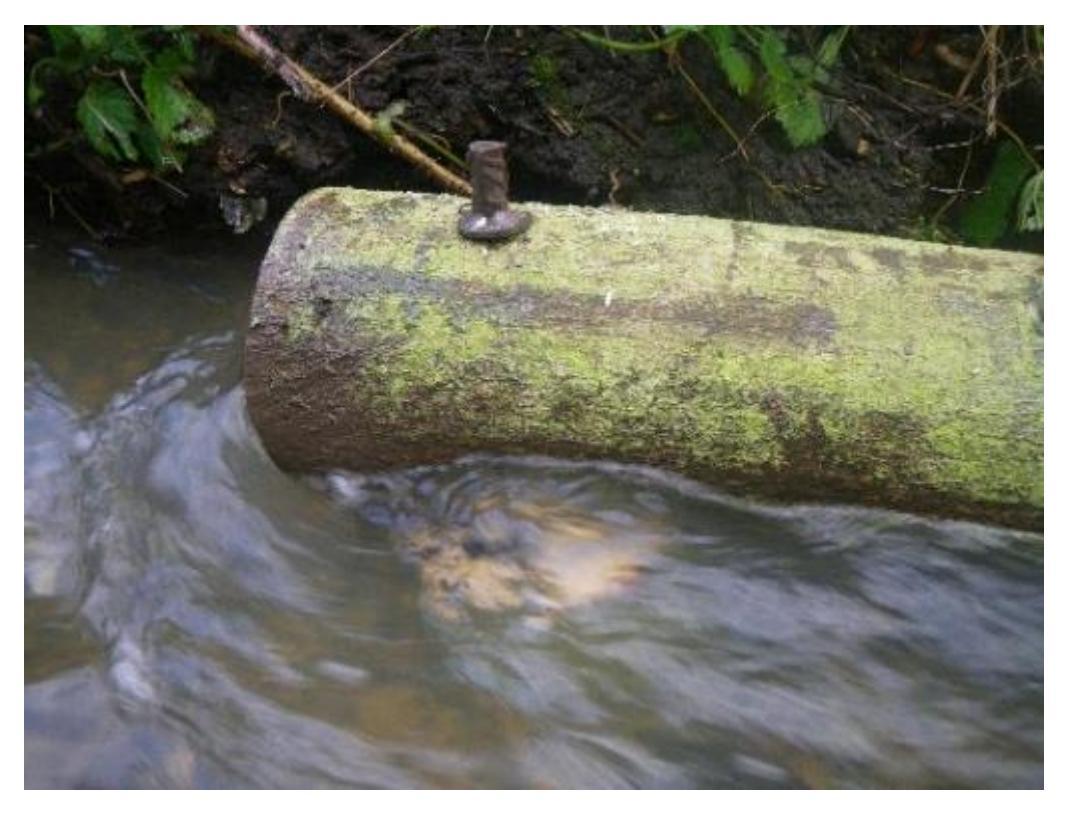
Photo 11. Correctly installed parallel to the flow and tight against the river bank.

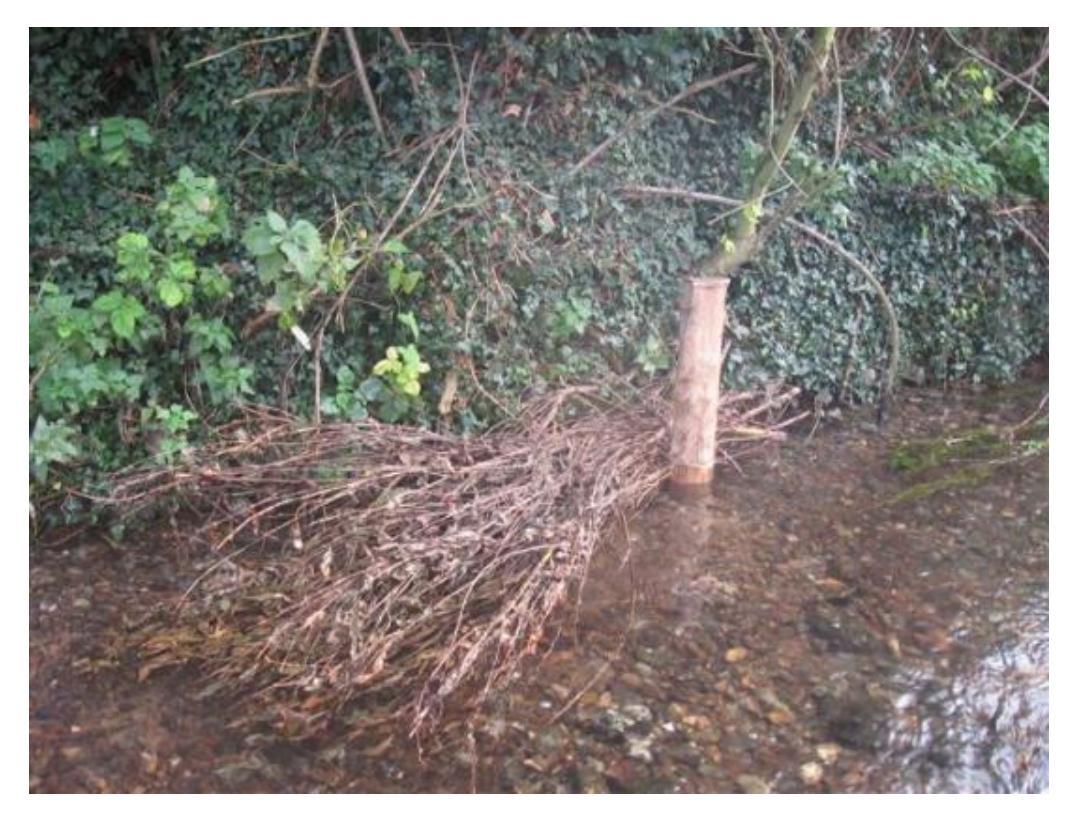
Photo 12. A simple brushwood bundle wired to a driven chestnut post providing cover for newly hatched trout fry in a shallow gravelly margin.
