**THE CANDACRAIG FISHINGS - RIVER DON, STRATHDON,
ABERDEENSHIRE.**

**Advisory Visit Report Undertaken on behalf of
The Wild Trout Trust**

By Ron Holloway MIFM

On 4th October 2002

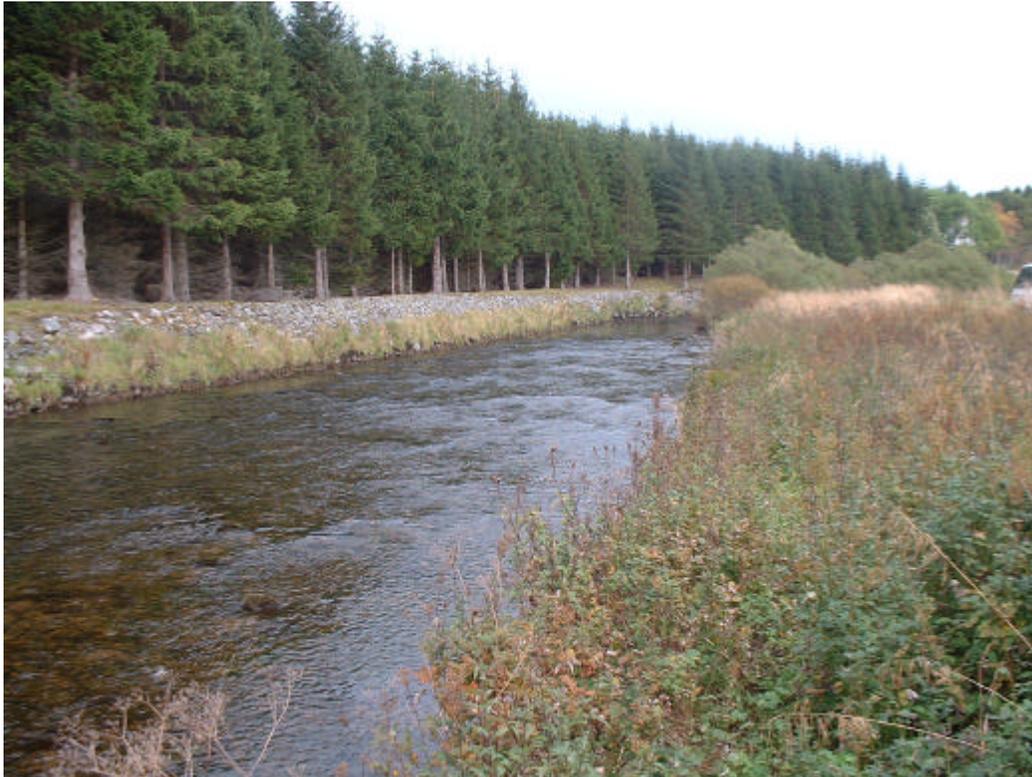
The overall impression from this visit indicates that there is very little wrong with this fishery and there are no major controlling factors which might influence the holding capacity for trout. However, some work could be considered which should improve

and increase the present holding capacity of the river, particularly in some of the flat, featureless stretches of the stream.

Picture One: Featureless stretch of stream.

Of the many areas visited throughout the fishery there are areas that would benefit from the creation of deeper holding pools. An illustration of what can be done by moving some rocks to create a low flow constrictor that will concentrate the flow at all levels to scour a deeper holding pool is illustrated below.

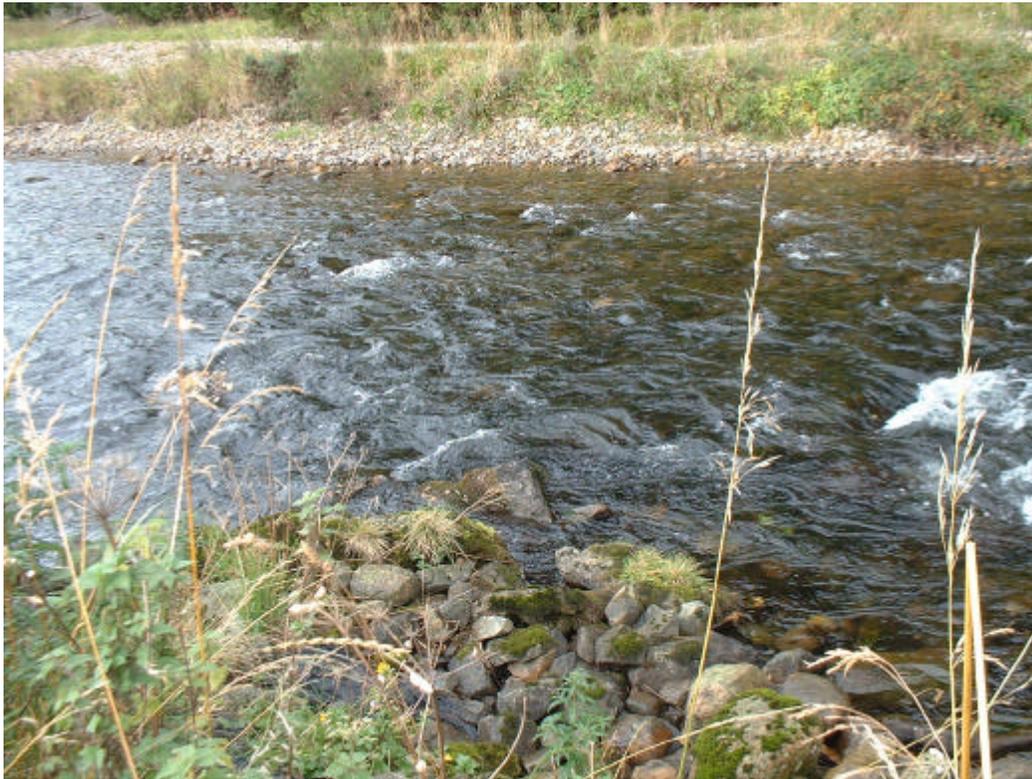
Picture 2. Before Rock Placement.

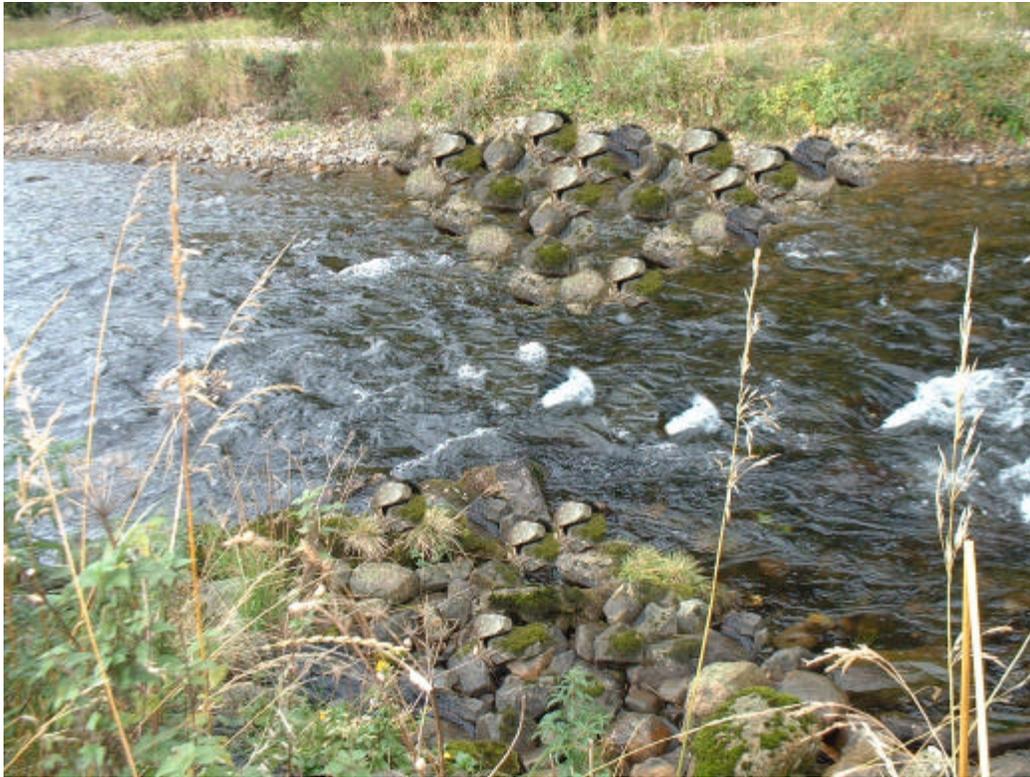
Picture Three: Suggested Rock Constrictor.

These constructions as illustrated should be built from substantial rocks that will remain stable during any flood event. The siting and placement is extremely important and a 45degree triangle format is required with the river bank making one side of this equilateral triangle. The best time to build these constructions is at mean base flow (low summer flow) and when being placed, the rock should be no more than approximately six to twelve inches out of water at summer flow levels. At low flow, the construction will concentrate the flow into the middle and create a scour pool. At higher, and flood, level when the construction is submerged, the shape and stability of the construction will continue to direct the flow to the centre of the river and so continue to scour the pool and not the river banks. Furthermore, these constructions, if built as recommended will have little, or no, impact on increasing the possibility of flooding. To further illustrate how these rock constrictors work, more examples will be included in the Appendix to this report.

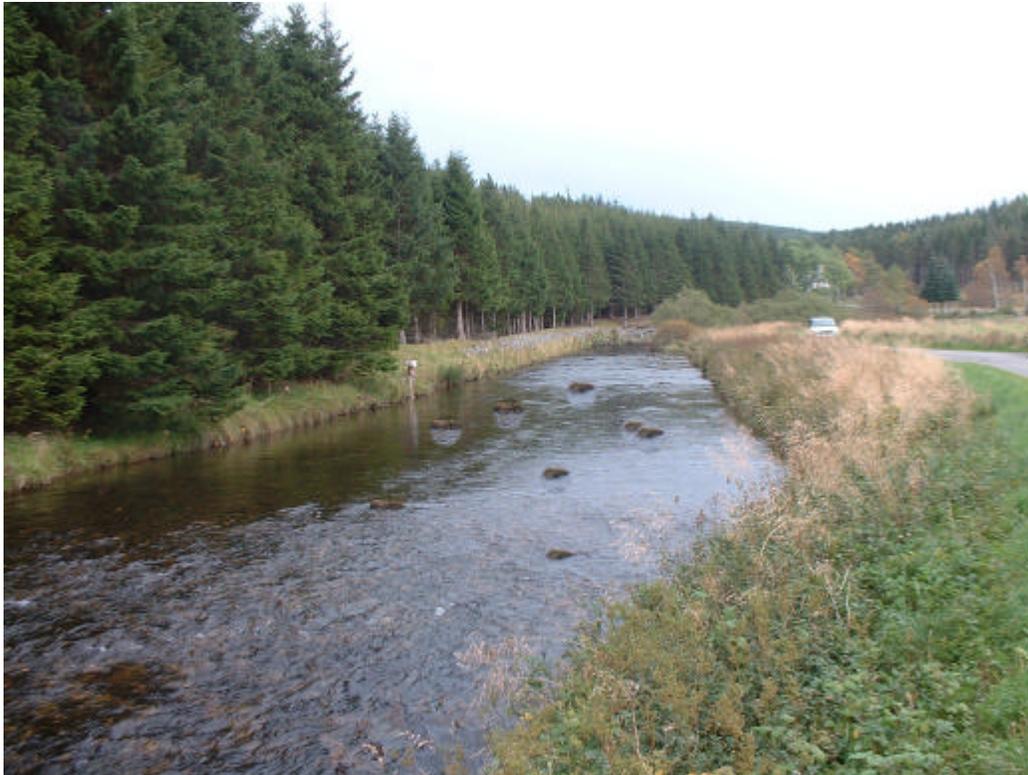
Picture Four – Potential Wheelchair Access Area.

To enable the fishery to attract disabled fly fishermen, the construction of several of these holding pools could be considered, particularly at the convenient and accessible area beside the lane which would make easy access for wheelchairs and where a series of pools could be created for ease of fishing.
