# NAR VALLEY FISHERIES

Advisory Visit Report

## **NAR VALLEY FISHERIES ADVISORY VISIT**

**12<sup>TH</sup> MARCH 2002**

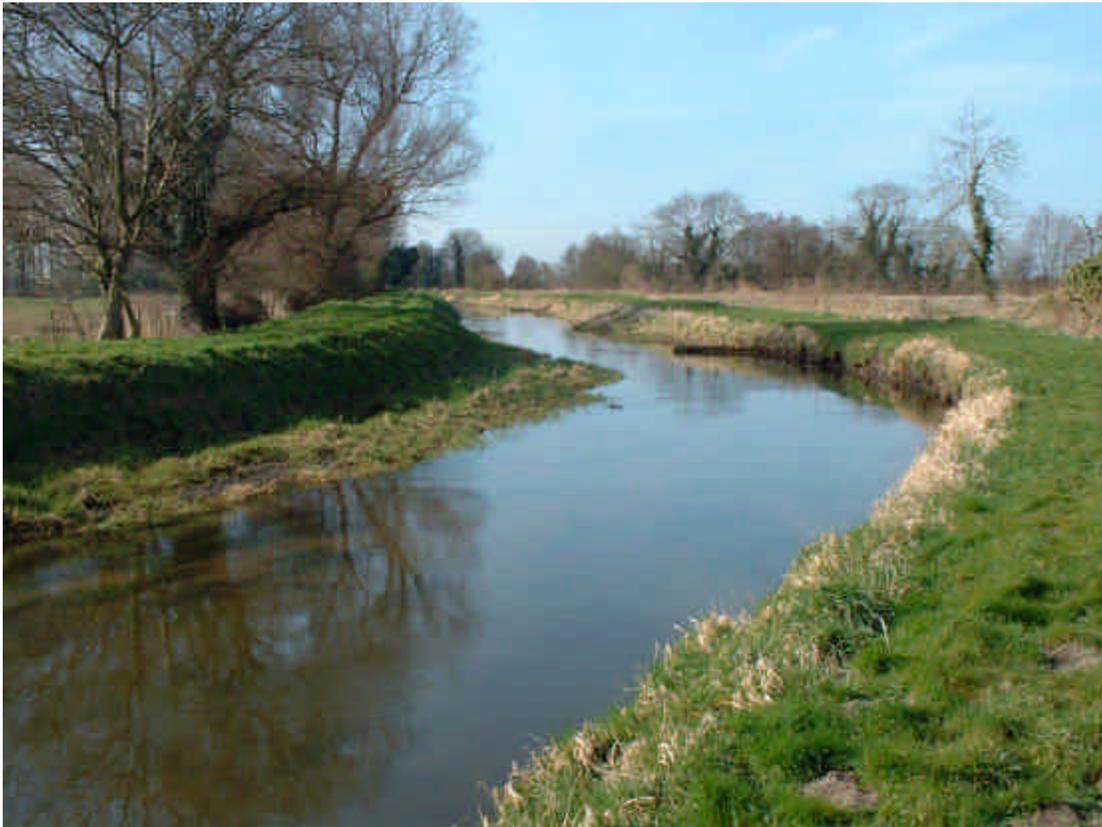
**Fig 1. The River Nar**

The River channel here is overwide and has been overdeepened from historic heavy dredging. This action has reduced flow speeds along this stretch which is now

encouraging large deposits of silt to form on point bars and along stream margins (See Fig. 1 on cover).

Removal of these deposits by further dredging will only compound the present problem as further deposits would soon return. The river now, is naturally indicating its required optimum channel width and to reduce further silt deposits these silt banks could be stabilised by installing a line of willow or hazel faggots (brushwood bundles) along the outside of the silt bank. These faggots to be firmly wired down and fixed with stout stakes, to the bed of the river and to be placed so that they are just out of the water at average river heights. Once in place, the faggots will filter out silt and protect the silt bed behind, thus enabling bankside vegetation to take root and further stabilise the silt bed thus creating a new narrower channel. Wherever silt beds are being created and appear to be becoming permanent features, it is suggested that this faggoting programme be used.

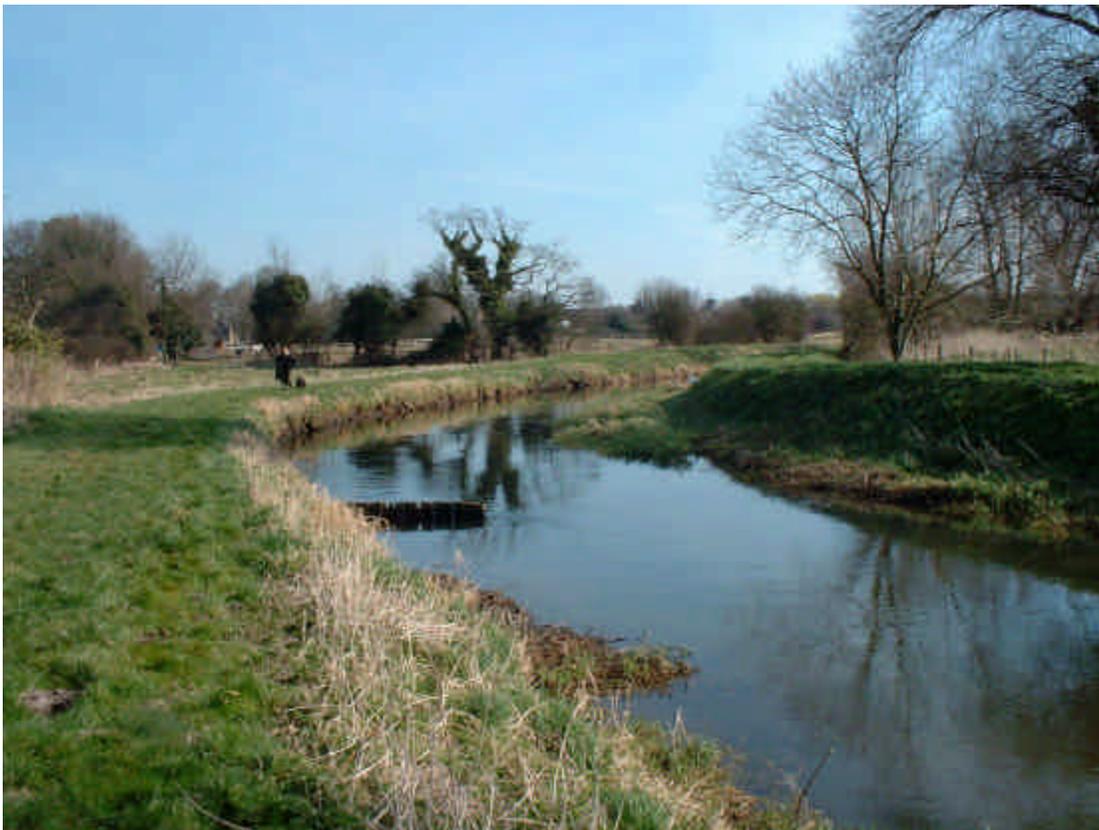
**Fig.2**

The flow deflectors that have been previously installed are now, in most instances, disintegrating and need to be replaced with more substantial triangular groynes, set to

appear just above water level, at normal river height. It is suggested there could be several pairs of these groynes placed opposite each other in the slow deeper stretches and once in place these should speed up water flow and create useful scoured trout holding pools just downstream of each construction. To instil even more energy into the slow flows, a series of alternating triangular groynes would create useful instream meanders by nudging the current to and fro.

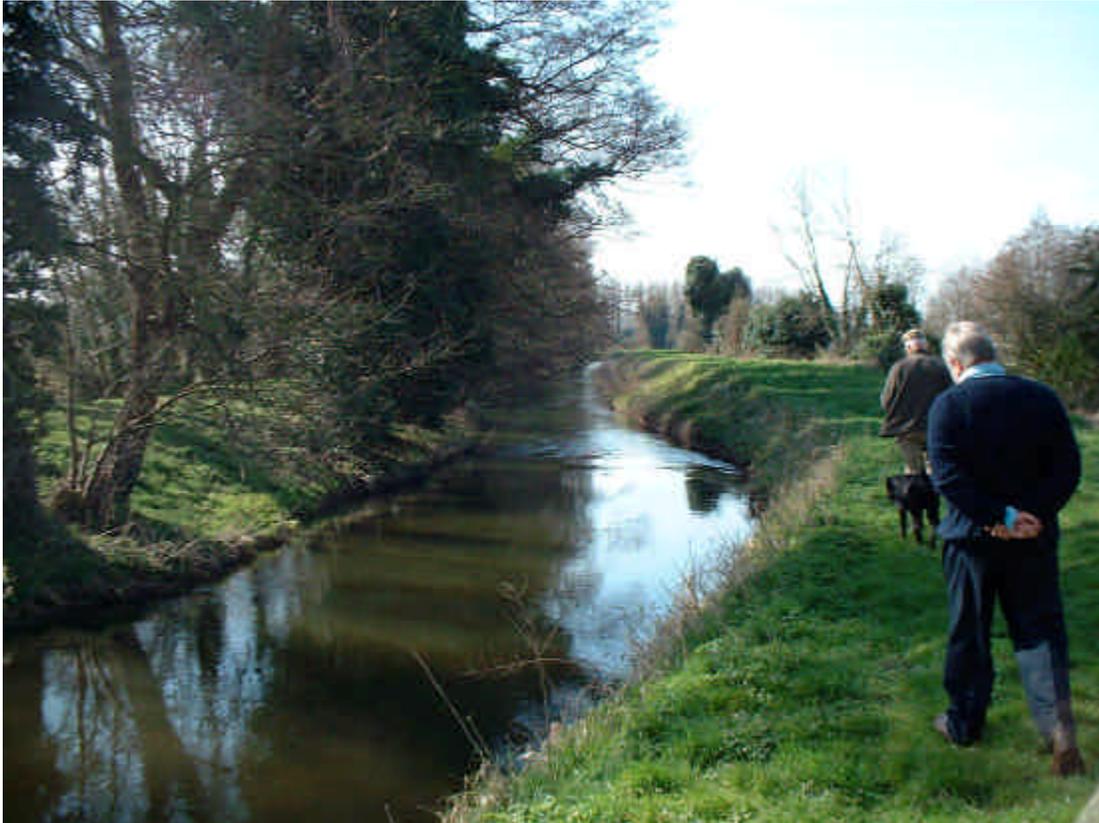
**Fig.4**

This treelined stretch offers excellent habitat and required little attention apart from the removal of the dead trees. Once removed, replanting with suitable species should be considered. Other than some cosmetic pruning of some overhanging “fly snatching” branches, little needs to be done along here.

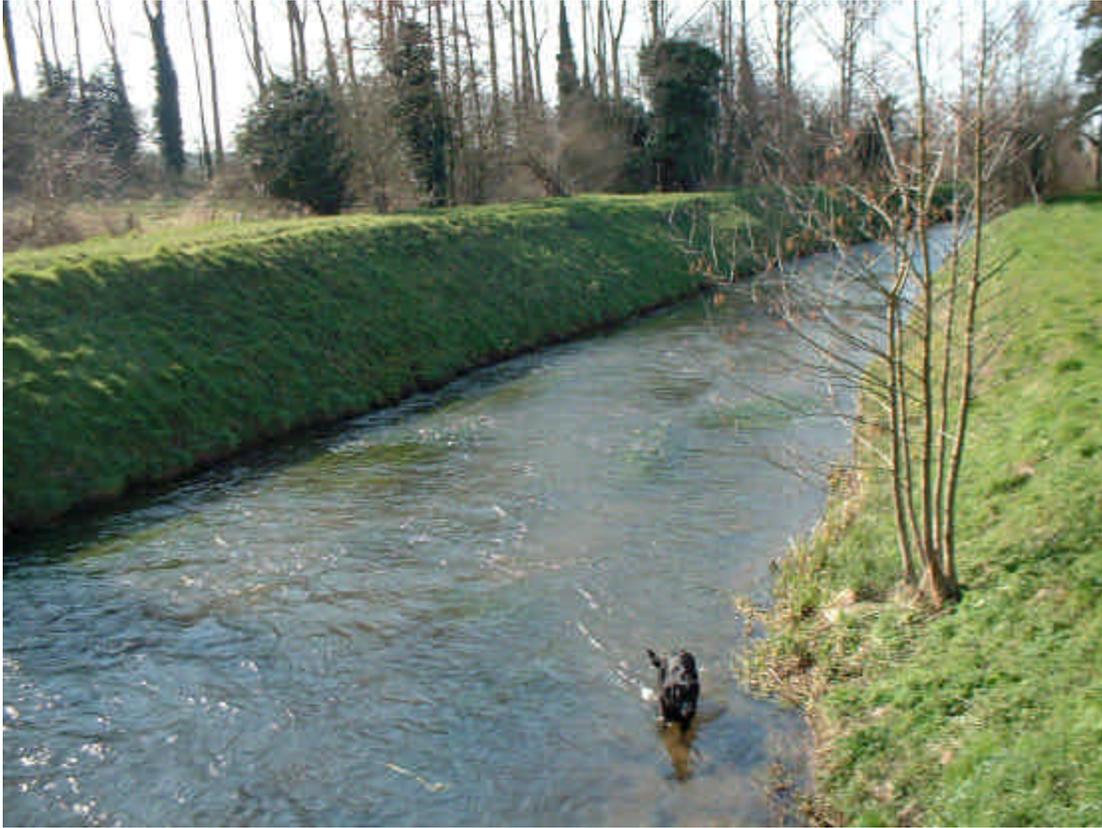
**Fig.5**

This site exhibits excellent chalkstream characteristics which have been created by the increased gradient that speeds flows and keeps the substrate clean and encourages the right type of aquatic weed life. To enhance trout holding capacity, marginal bankside vegetation along the water edge should be encouraged to provide cover for fish and to increase terrestrial insect life. The heavily embanked margins of the stream do create access problems. A series of cut in wooden edge steps that run down to the edge of the river could be considered but may be deemed a hazard to the general public if this is a right of way.
