**HABITAT ADVISORY VISIT, TEISE
ANGLERS' AND OWNERS
ASSOCIATION, RIVER TEISE,
KENT.**

**UNDERTAKEN BY VAUGHAN
LEWIS, WINDRUSH AEC
MAY 2003**

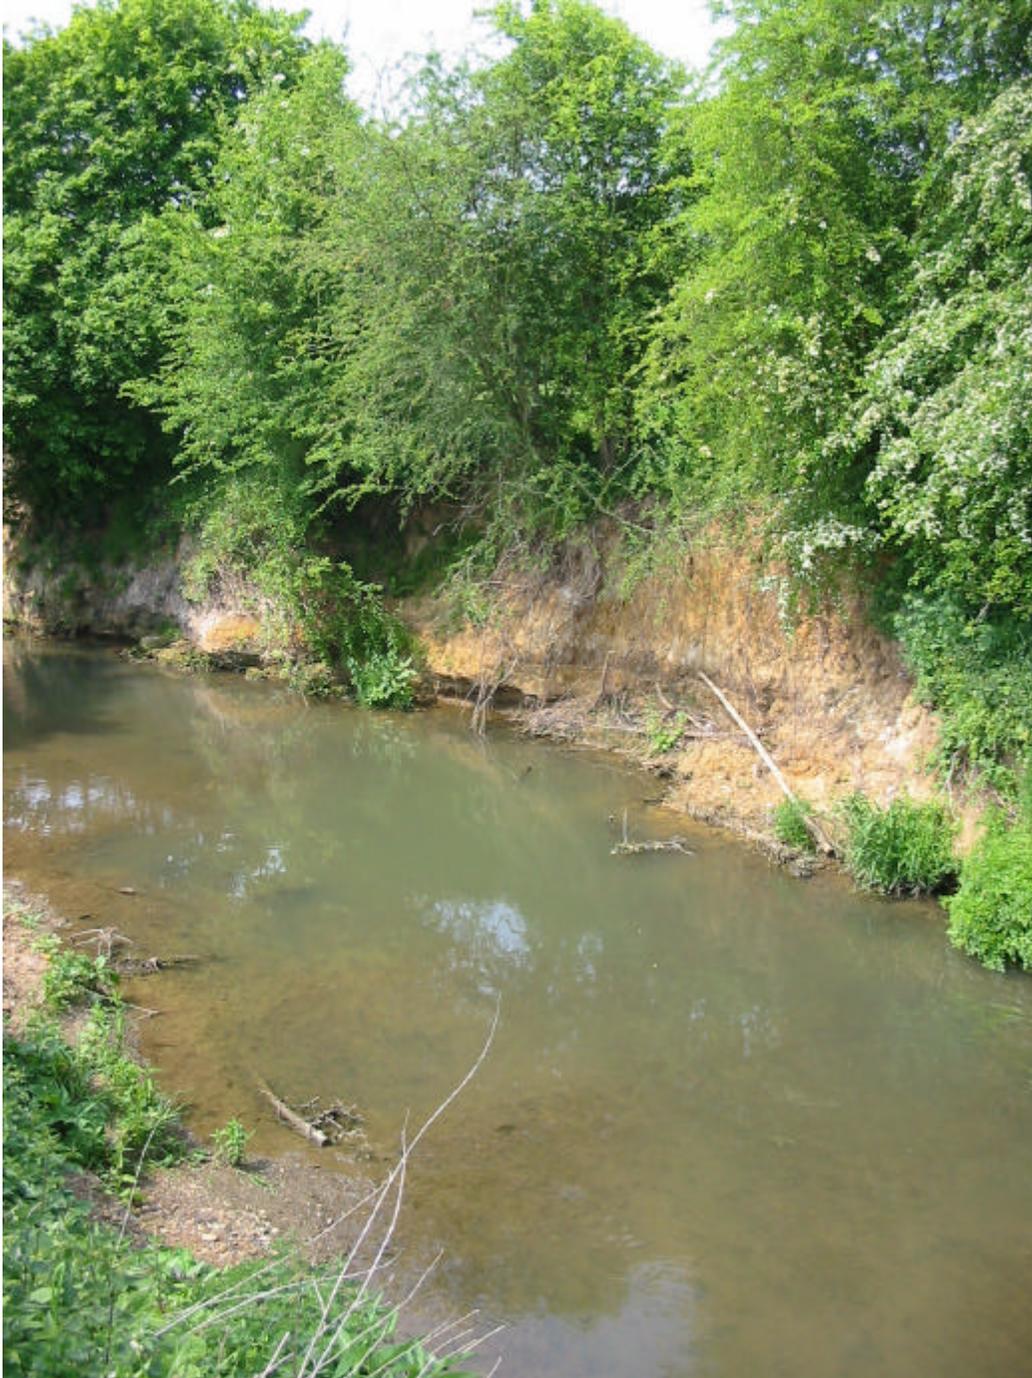
There are two major factors influencing habitat quality and availability in the River Teise. Of primary concern is the extensive modification of the River Teise, particularly during the last 60 years, largely as a result of agricultural drainage activity. As a result, the channel is heavily incised, being more than 4m from water surface to effective bank top in some locations. As a result of this dredging, there is a paucity of gravel/stone bedded riffles, vital for recruitment of brown trout, grayling and rheophilic fish species such as chub and dace. The incised nature of the channel has also resulted in exposed sheer sandstone banks in places. This has inevitably resulted in significant erosion at these locations. Where tree shading is not excessive, some of the fallen bank material has been colonised by marginal aquatic plants, resulting in stable, low level shelves.

Erosion in the heavily incised channel

- The incised nature of the river has a controlling influence on habitat quality. Shading is increased, whilst the reduction in out of bank flows damages both the ecology of the floodplain and also increases bed/bank erosion within the river channel. This issue cannot be addressed by the club alone. A major partnership project would be required that not only tackled the issue of bed raising but examined changes to floodplain ecology, and opportunities for alleviation of peak flows in vulnerable flood locations in the Medway. It is inevitable that such a project would require the input and support of both DEFRA and the EA.

- The creation of low level marginal shelves using fallen timber and/or faggot bundles can be used to both increase valuable vegetation cover and also to protect the toe of the river bank from erosion.

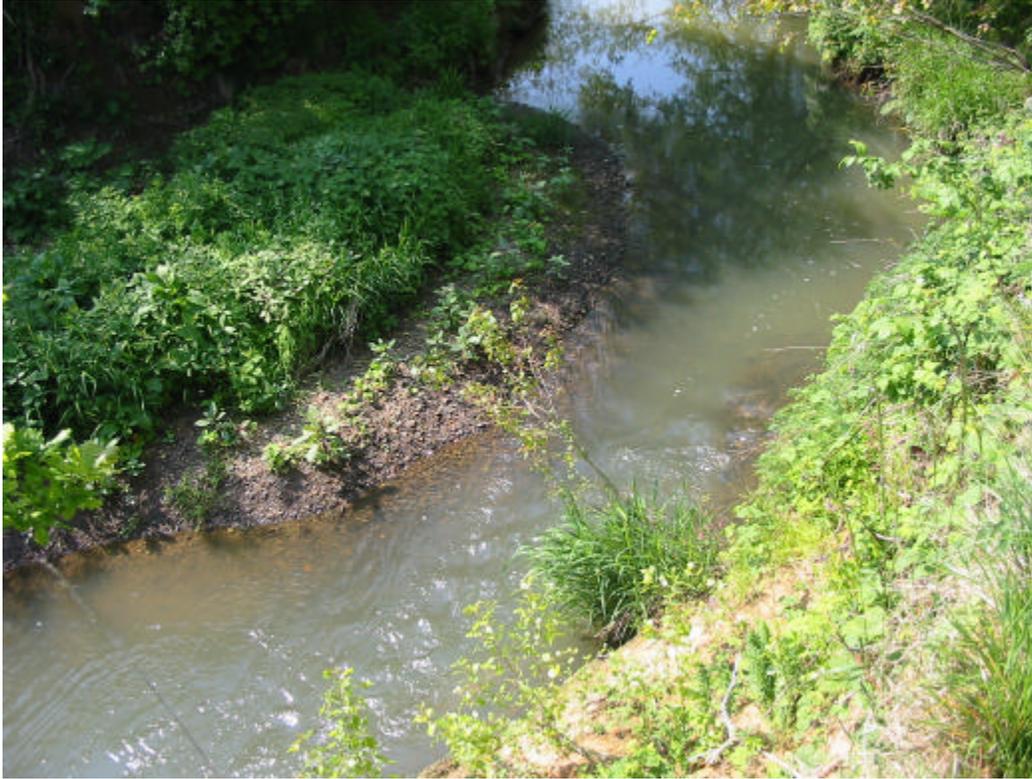
The river here is very heavily incised with significant shading in places. Short lengths of riffle habitat are present where outcrops of harder sandstone remain. A number of small stable point bars have formed on the inside of meanders. A few stands of unbranched bur-reed *Sparganium emersum* are present. The remainder of the channel is rather barren, with no other instream weed and little cover from woody debris.

Vegetated point bar
