Advisory Visit to the River Coln,
Williamstrip Estate, Glos.
Undertaken on behalf of the Wild
Trout Trust, by Vaughan Lewis,
Windrush AEC Ltd

September 2004

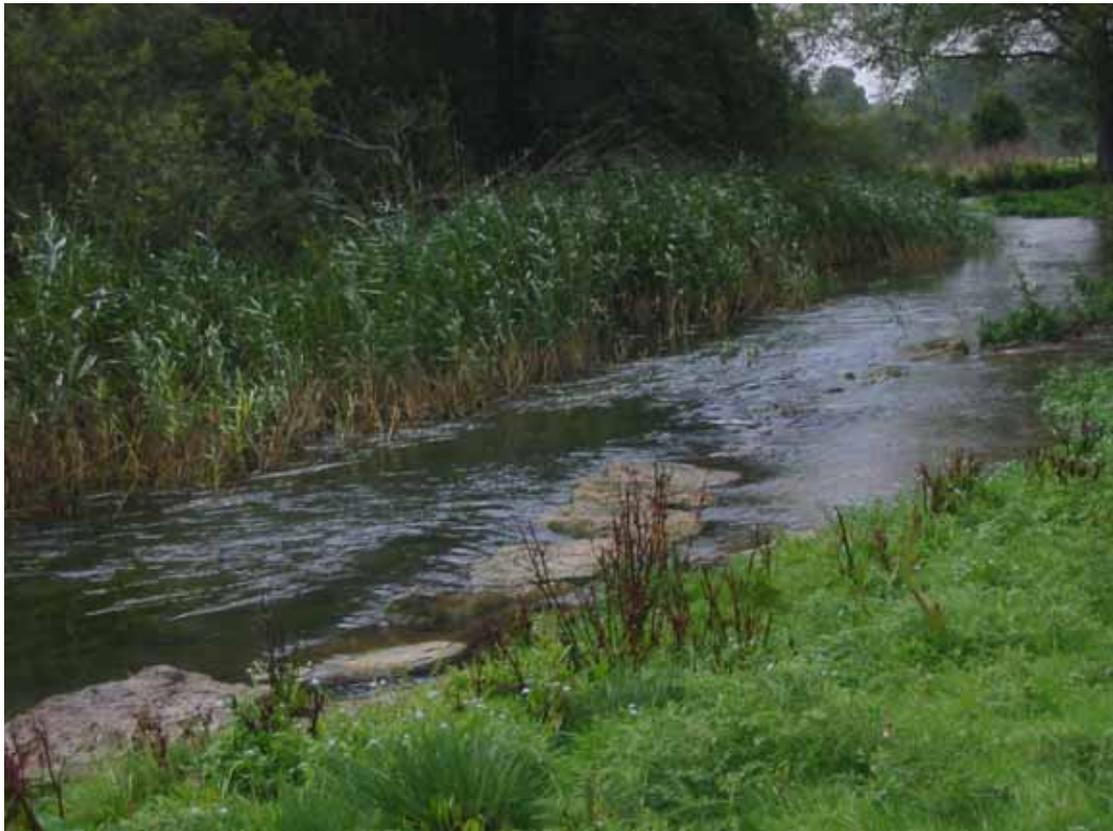
The scheme was largely successful in the first two of these aims, although grazing pressure by large flocks of sheep on the unfenced RB margin of the river has reduced the overall benefits of the scheme. The growth of water crowfoot and other submerged weeds, was in common with the majority of the fishery, poor, with only small stands of unbranched bur-reed *Sparganium emersum*, starwort *Callitriche spp.* and common club rush *Schoenoplectus lacustris* present.

Narrowed channel showing section eroded by sheep behind stone revetment

- The potential benefits of the enhancement work undertaken in the early 1990's are not being optimised, due to grazing pressure on the river banks. It is recommended that a fence (permanent or temporary) should be erected alongside the enhanced reach, and at other locations on the river where intensive grazing takes place, in order to allow the regeneration of valuable emergent vegetation. It is understood that most of the river meadows are registered under the Countryside Stewardship scheme, making them eligible for a fencing grant.

If the presently eroded sections of bank are fenced, it would be of great benefit to carefully re-sculpt the field within the fenced area (using a hydraulic excavator), and use the resulting soil to infill the eroded margins. These could then be planted with sedge *Carex* spp. and reed sweet grass *Glyceria maxima*, transferred from elsewhere on the river.

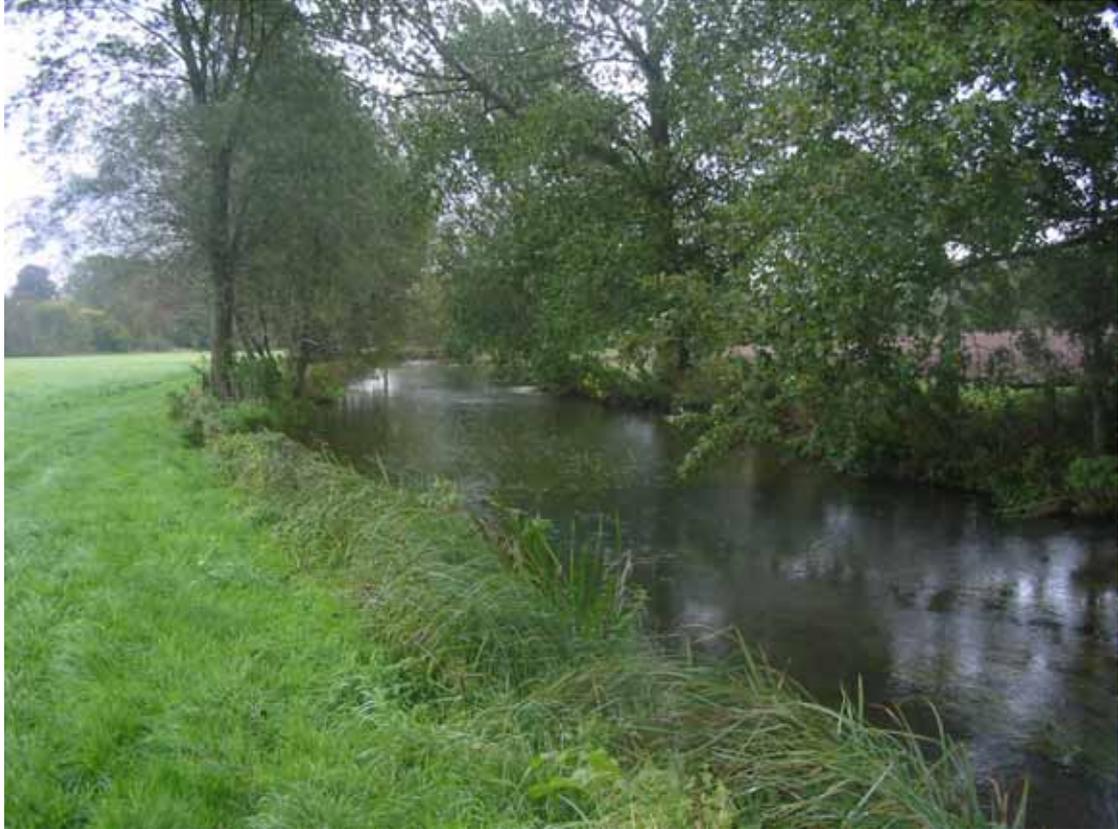
Downstream of the enhanced reach, land use on the RB was arable, with wide, uncultivated margins providing a buffer strip. The river in this reach was over-wide,

with a relatively uniform bed, with little variation in depth or sorting of gravel. Submerged weed was dominated by common club rush.

Over-wide river reach downstream of enhancements

A number of wooden groynes had been introduced to the river in an attempt to increase water velocity locally. However, these had proved largely inadequate given the length and scale of this over-wide reach. Cover boards had also been placed in the river at strategic locations in order to improve deposition and survival of the eggs of Ephemeroidea and Trichoptera species.

- The present limit of the enhancement should be extended downstream in order to address the over-wide nature of the channel. This would be a significant undertaking, with costs running into several tens of thousands of pounds. It would

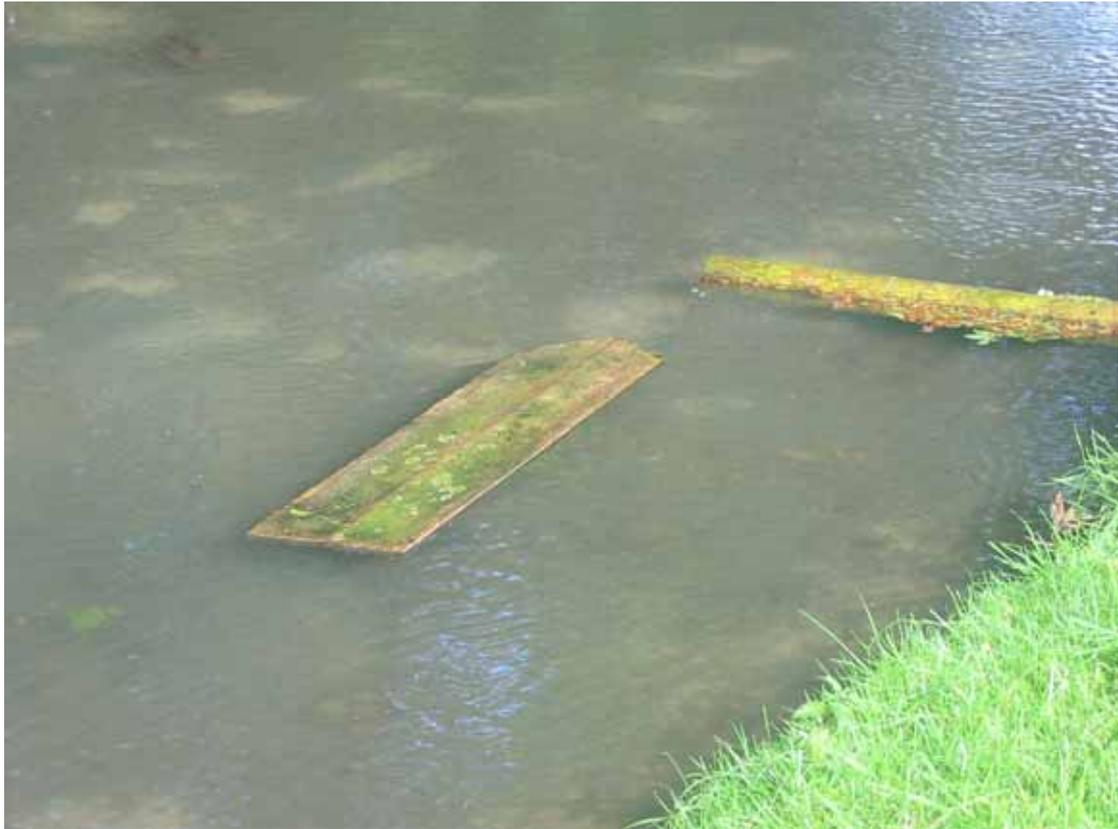
Cover board in river

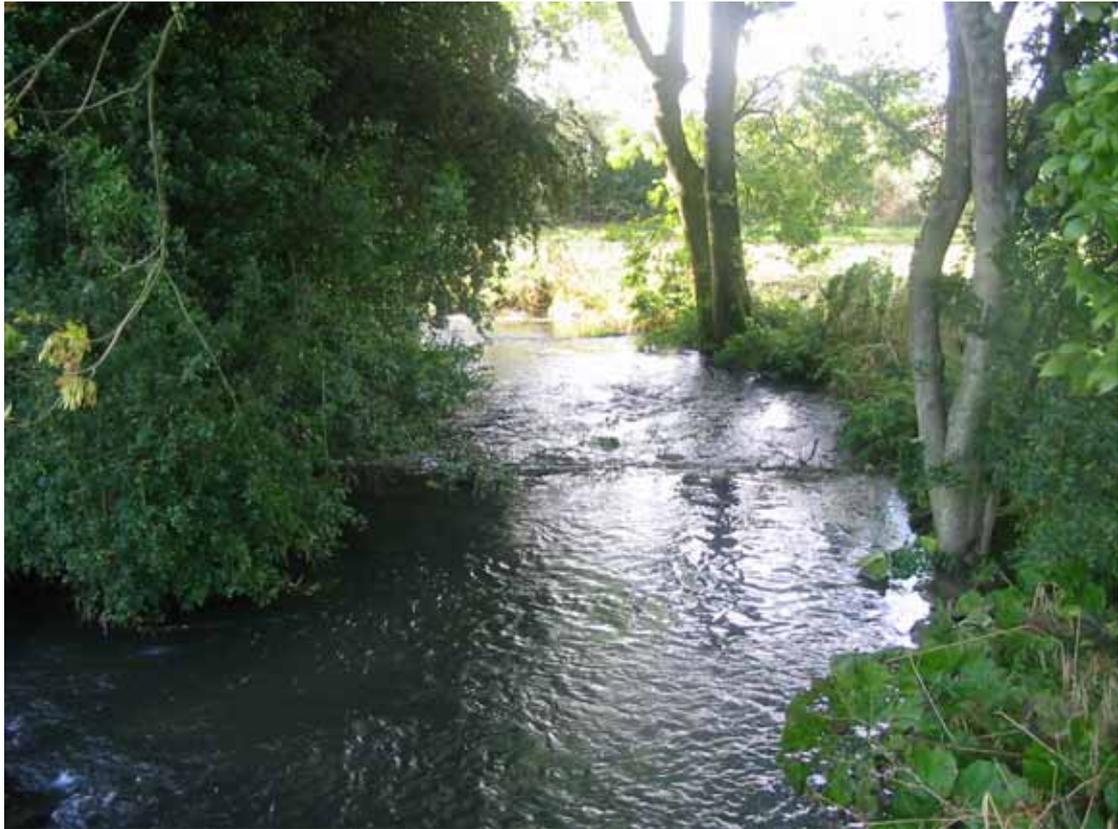
A large spawning weir had been constructed in the low level channel. This remained a key area for spawning on the fishery, with trout cutting redds here annually.

Constructed trout spawning weir

- The benefits of the spawning weir have been established. It is recommended that its annual maintenance should be continued.
- The installed groynes have had some local impact. However, they are generally too small to create any wider benefits. It is therefore recommended that a larger scale project should be considered for the construction of larger, more numerous deflectors. These should be constructed from local stone or timber, and should ideally consist of upstream facing groynes or triangular shaped groynes. Indicative designs are provided in the attached Wild Trout Trust guide. Significant work of this nature should be planned carefully in consultation with the EA.

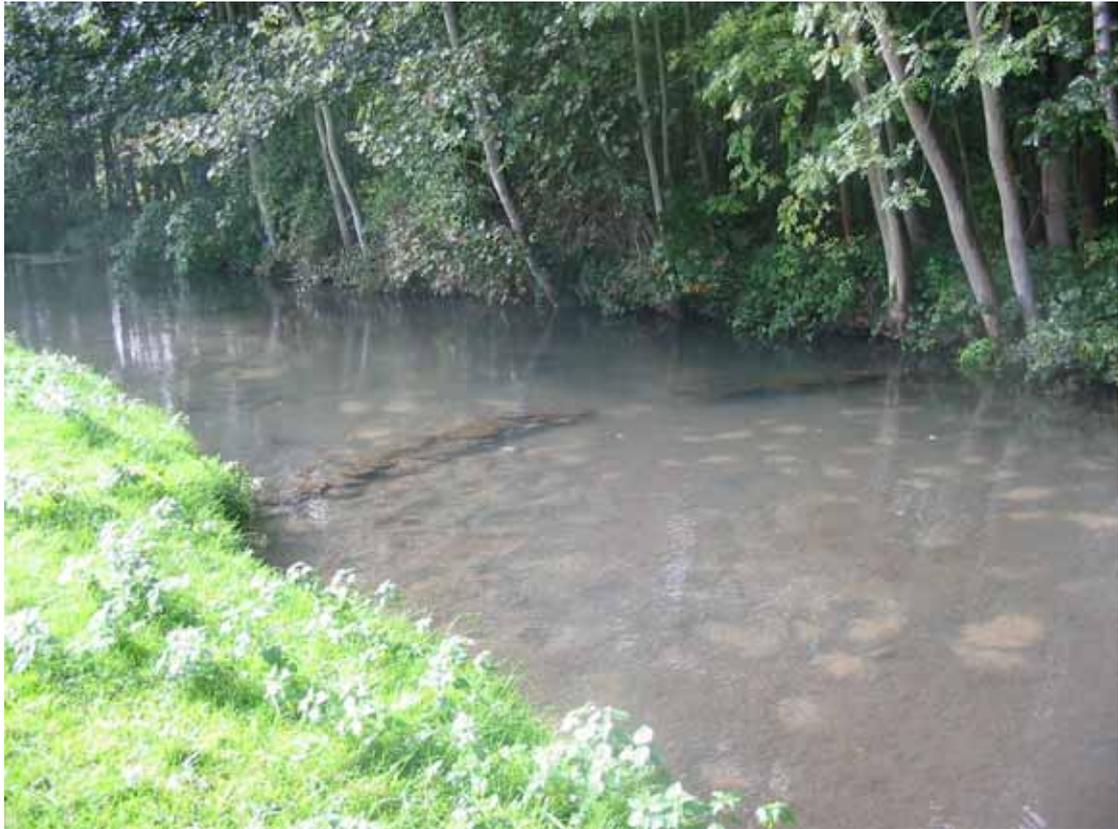
The bed profile of this reach was relatively uniform, with the continued absence of water crowfoot and other submerged weeds limiting the availability of instream cover. Numbers of small stone weirs and groynes had been placed in this reach in order to create more diversity in flow velocity and bed profile.

Water clarity was very poor, with a noticeable grey colouration present.

Installed stone flow deflector. Note grey colouration to the water

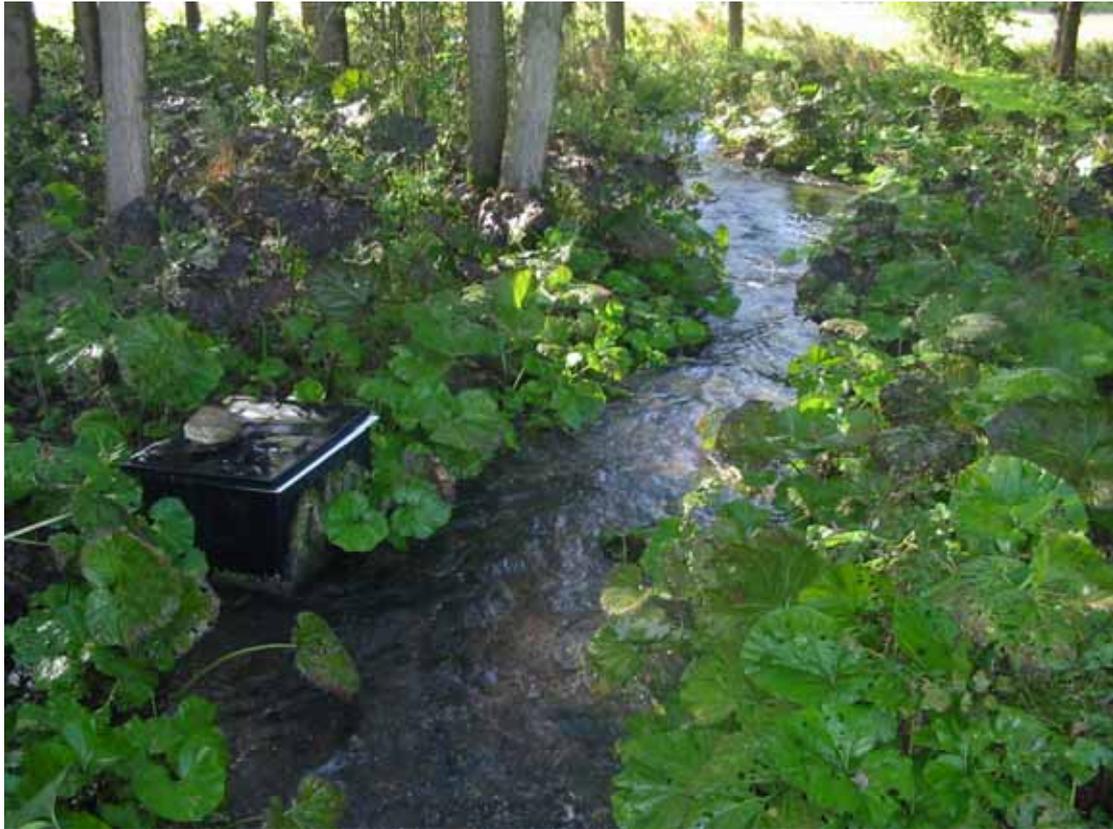
Regular fishery surveys have been undertaken at Williamstrip by the EA. These have revealed a moderate stock of brown trout, with some recruitment. A deep substrate incubation box has been operated on the estate for several years. Hatch rate of eggs and emergence of alevins from the box has been good, although at present no measure of the contribution of these fish to the river system has been possible. In addition, the constructed spawning weir continues to be operated, with annual cleaning taking place prior to the spawning season. In addition to running the incubation box, the estate stocks 500 12”+ brown trout annually. Small but significant numbers of rainbow trout are also present in the fishery, probably originating from upstream fisheries or from escaped fish from Bibury Fish Farm.

Deep substrate incubation box located in side channel

- The incubation box has proved successful at producing large numbers of alevins that have self-stocked to the system. It is likely that the number of fry produced far exceeds the carrying capacity of the downstream juvenile habitat, with consequent density dependent mortality likely. In order to optimise recruitment of fry, it is recommended that a simple catch trap is installed on the incubation box, and retained fry distributed into suitable habitat elsewhere in the fishery. This is best carried out using a watering can.
