Habitat Advisory visit to the River  
Great Ouse, Rectory Farm, Tingewick,  
undertaken on behalf of George Eaton  
by Vaughan Lewis, Windrush AEC Ltd  
December 2004

## **1.0 Introduction**

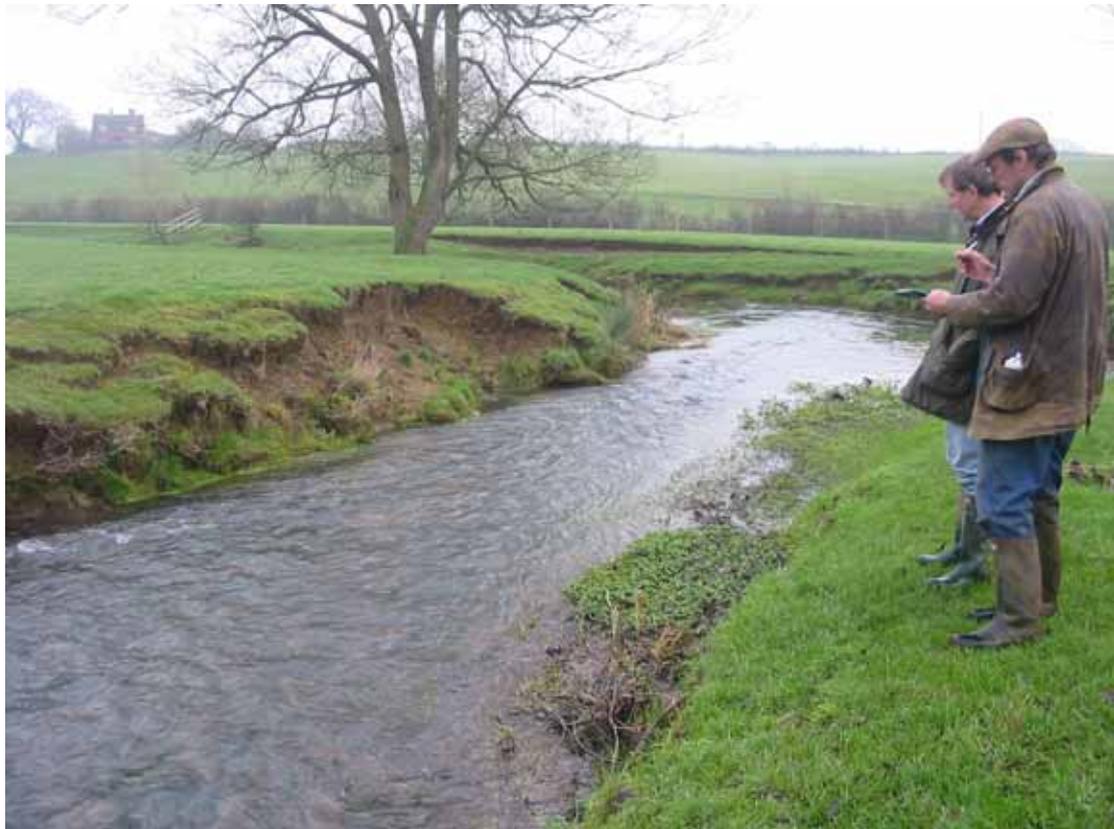
Downstream of the Tingewick roadbridge, both banks of the river were overgrazed by agricultural stock, with a consequent paucity of overhanging bankside vegetation and significant sections of eroded bank. At the upper end of the stretch, there was a short section of gravel dominated riffle, with a steep gradient. Below this, the river had a meandering planform with an abundance of deeper water, suitable for adult brown trout and some shorter lengths of riffle spawning habitat. A small number of freshly cut trout redds were visible on the riffles.

**Over-grazed banks adjacent to riffle downstream of Tingewick road bridge**

- There are sections of the fishery in which the banks have been over-grazed and poached by agricultural stock, resulting in loss of valuable marginal cover and mobilisation of fine sediment into the water. In order to reduce the damaging impacts of stock grazing, these sections should be securely fenced, in order to create a marginal buffer strip. Maximum benefits are obtained when these strips are at least 10m wide. However, significant improvement to riparian habitat can still occur with narrower buffer strips.

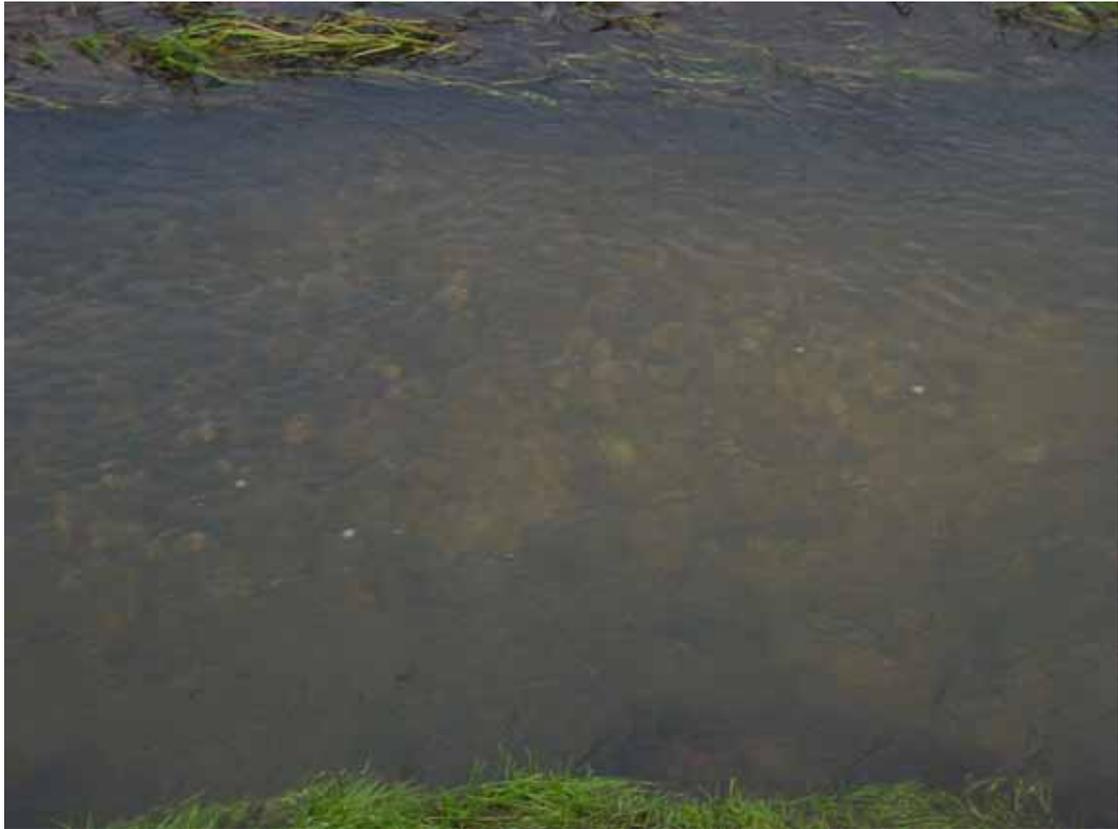
### **Freshly disturbed gravel (redd) at site of trout spawning activity**

- The quality of the short sections of suitable spawning gravel could be improved by establishing a regime of cleaning spawning gravels each September. This can be achieved by either manual raking, or by the use of high-pressure water jets. Care must be taken to clean riffles rotationally, with only short sections being treated annually. It is important that the EA are contacted prior to any cleaning of gravel, due to the possible discoloration of water in the river resulting from the operation. The same concerns dictate that downstream neighbours should also be forewarned of the operation.

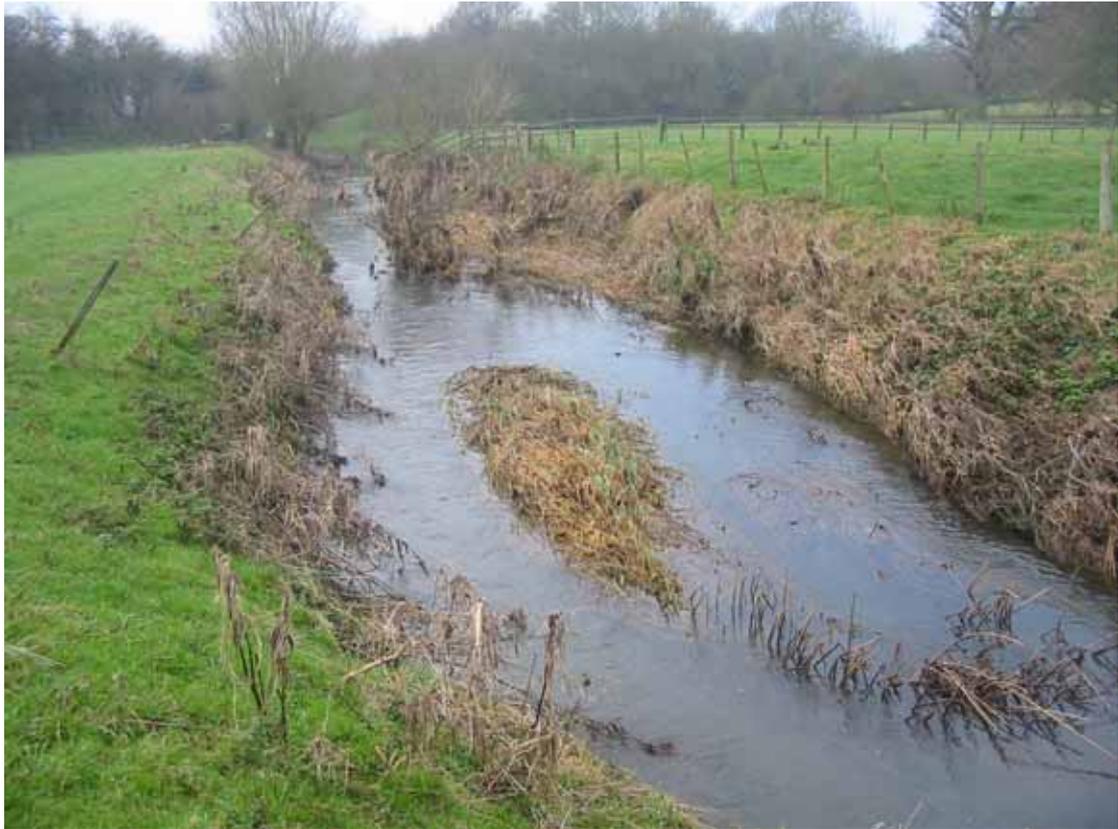
Over much of its length, the river channel was heavily incised ( $>1.5\text{m}$ ), with a spoil bank visible on the RB, evidence of past dredging activity. The resulting channel was over-wide and over-deep. As a consequence, flow velocity in the summer has often been low, allowing the extensive growth of emergent vegetation including reed canary grass *Phalaris arundinacea* and common club-rush *Schoenoplectus lacustris*, which in some cases, totally occluded the channel. This had at times, significantly reduced the available open water area, diminishing angling opportunity during the summer months. At some locations, the emergent vegetation growth had begun to consolidate marginal areas of silt. In addition, there were short sections where mid-channel growth had spilt the flow, with the result that small islands had begun to appear.

**Heavy growth of emergent vegetation with part formed 'island'**

- The growth of the emergent weed is very extensive during the summer months, largely as result of the previous heavy dredging undertaken, that has resulted in an over-deepened channel and an associated reduction in water velocity. Removal of all of the weed is not practical or desirable. However, it is possible to manage the weed in order to maintain sections of open water. This can be achieved by either manual cutting (chain scythes), mechanical cutting (hydraulic powered cutter mounted on 360 excavator) or by the use of herbicide. Of these options, the best in terms of its cost, lack of environmental disturbance and practicality is probably the herbicide.

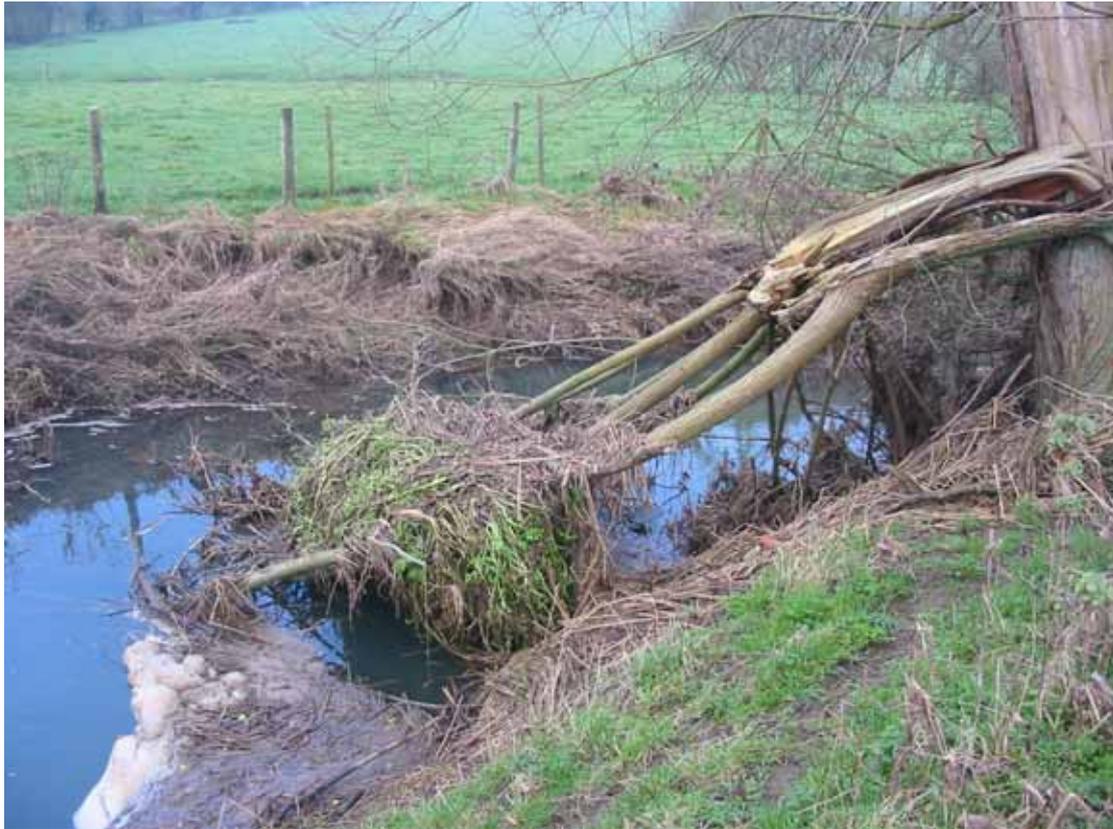
Significant amounts of Large Woody Debris was present throughout the fishery in the form of fallen trees and branches. This was creating valuable cover and was assisting in the scouring of the bed and sorting of the substrate.

**Woody debris dam deflecting current on the inside of a bend and encouraging the creation of a marginal silt shelf**

The report also provides recommendations for the management of LWD, the most important of which is "although there are certain situations that may require wood removal to eliminate stream blockage, the wisest management is no management". Building on this simple truism, it is recommended that before any future work to remove LWD from river channels is undertaken, the wider implications of the proposal on the whole river system are considered, rather than just the potential (in many cases unproven) benefits to salmonid populations. In addition, the impact of planned riparian tree work on the supply of LWD to the river should be considered.

In order to manage LWD effectively on the Rectory Farm fishery, it is important that a balance is struck between the benefits of retention of timber within the river channel, and access for angling. It is also important that the Environment Agency is made aware of an adopted policy to retain LWD in the channel, in order to prevent its removal during routine management operations undertaken by the Agency.
