Habitat Advisory visit to the Rosses
Fishery, Co.Donegal, Eire
Undertaken on behalf of the Rosses
Anglers' Association by Vaughan
Lewis, Windrush AEC Ltd
August 2004

1.0 Introduction

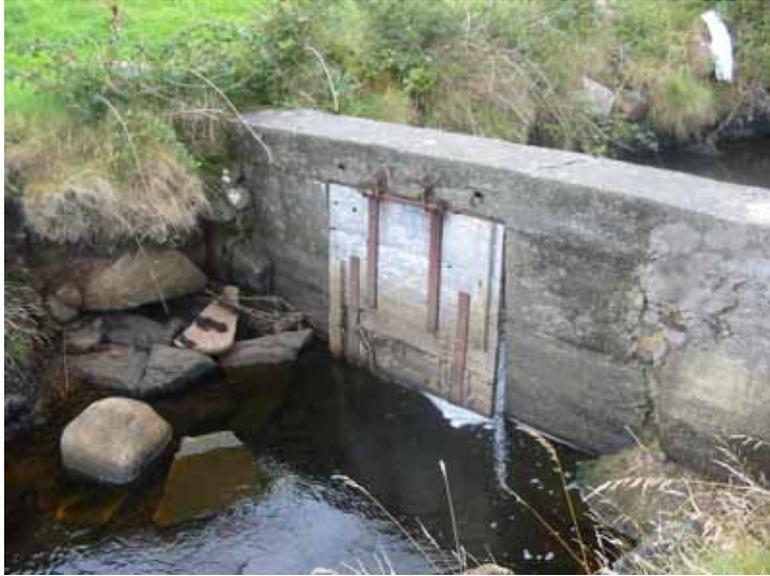
Lough Meela is the primary fishery on this system. It lies within 400m of the sea, with its outlet stream controlled via a tidal flap. This was installed some years ago in order to control ingress of saline water to the lake and surrounding agricultural land.

Tidal flap on outlet from Lough Meela

The tidal flap at the lower end of the Meela river prevents access to migrating fish except during spate flows. Provided that there are no unknown and over-riding reasons for retaining the flap in its present closed state, then it is recommended that it should be fixed in an open position for a trial period. This will allow access for fish up and down the river at all states of tide and river flow. It will however allow tidal back up into the river and possibly the lough during higher spring tides.

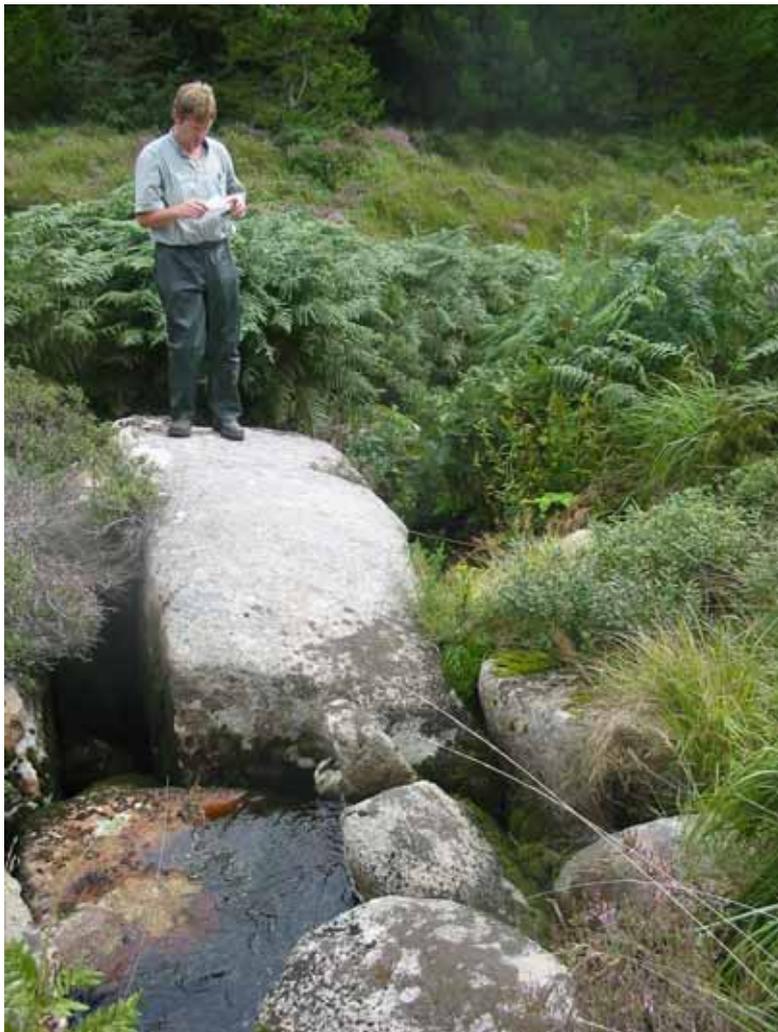
Of the sites visited during the advisory visit, that on the stream between upper and lower Lough Craghy had the highest density of trout. Unfortunately, only some 400m of this channel was accessible from the lower lake due to the presence of at least two boulder dams, that effectively blocked the channel to migrating fish. Similar obstructions and associated issues have been identified on other streams in the system. In addition, the stream was heavily shaded by gorse and other shrubs, particularly below the roadbridge.

Boulder obstruction to migrating fish above Lough Craghy

The presence of boulder dams on the streams above Lough Craghy is limiting access for migratory fish to extensive sections of potential spawning. Consideration should be given to removal/modification of these dams, both on the stream visited during the advisory visit and on those identified in the Central Fisheries Report. If the obstructions could be removed, recruitment of juvenile trout to the system would be expected to increase significantly.

The practicalities of removal are difficult, with access a significant problem. The use of blasting could be explored with a professional organisation experienced in the field of mining/mineral extraction. Clearly, the use of such a technique carries significant health and safety risks, and legislative requirements, that should be addressed as part of any project planning.

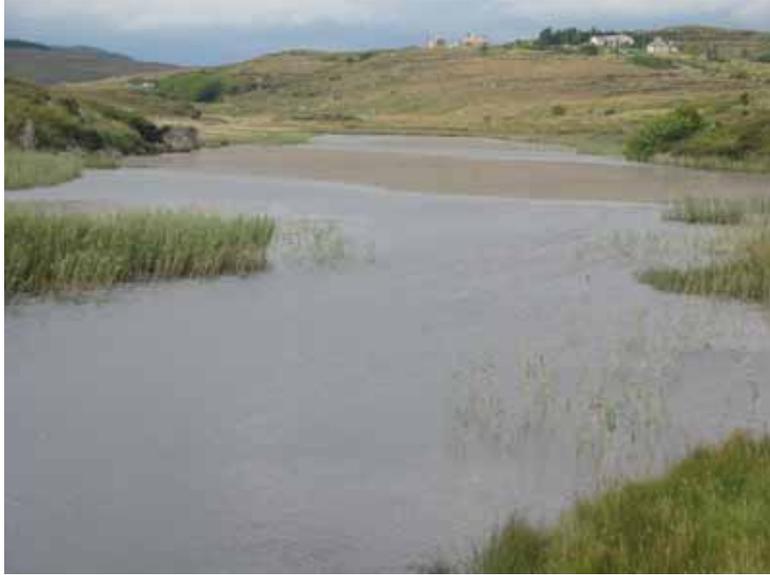
fish numbers but also due to reduce access to fishable water as a result of an dramatic increase in the growth of broad-leaved pondweed *Potamogeton natans*. Stands of this plant covered extensive areas of the lough, effectively preventing angling taking place. Growth of the weed may be linked to a reduction in lake levels due to drainage activity and changes in sluice operation on the system, and increased nutrient levels due to domestic effluent and agricultural fertilisers. The latter point was reinforced by the presence of filamentous algae in the inflowing watercourse.

Lough Sallagh showing extensive growth of broad-leaved pondweed

The key issue identified on this system is the recent growth of broad-leaved pondweed in Lough Sallagh itself. Ideally, this problem would be addressed at source. However, as this would require re-instatement of the former water level in the lake, the removal of agricultural drainage in the area and prevention of the ingress of nutrients into the lough from diffuse sources, this is unlikely to be a realistic option.

Options for treatment of the weed are thus limited to the use of approved herbicides, mechanical cutting or shading material, for instance sheets of black polythene. Whilst the latter technique is attractive with respect to cost and lack of environmental impact, the practicalities of its use are daunting on a waterbody of this size. If however, the club feel that they can lay out sufficient sheeting and anchor it firmly to the bed of the lough, then it may be worth considering a small scale trial that could be extended at a later date if proved to be effective.

Partial chemical treatment of the weed is theoretically possible using 2 approved herbicides, dichlobenil and glyphosate. Dichlobenil is used as a pre-emptive treatment during early spring, whilst glyphosate is used to treat the actively growing plant once its leaves have emerged onto the water's surface. Broad leaved pondweed is categorised as 'moderately susceptible' to both herbicides. Of the two herbicides, glyphosate offers the cheapest and least environmentally damaging option being inactivated on contact with water and sediment. Dichlobenil has significant residual effects, with control sometimes lasting into the following season. Given the ecological importance of the Rosses fisheries, careful consideration must be given before contemplating the use of any herbicide. Detailed advice on the use of herbicides can be obtained from the Centre for Aquatic Plant Management capm.org.uk. In addition the legal position on the usage of herbicides in Ireland should be confirmed with the fisheries board, and all necessary legal consents obtained.

Physical cutting of the weed provides perhaps the best option for the club. Hydraulically powered weed cutting boats are used routinely in Ireland, particularly on the canal systems (see Central Fisheries Board Website for details www.cfb.ie) They have the potential to cut large amounts of weed in a day and their use would therefore need to be carefully monitored in order to avoid ecological damage. In addition, the rate of growth of submerged weed is likely to be such that repeat cutting during the angling season is required, significantly increasing potential costs.

Rather cheaper but more labour intensive are the various hand operated chain scythes. These consist of linked sets of blades or knives that are stretched out across the bed of the lake and 'sawed' backwards and forwards by operatives on each end of the chain. The cut weed floats to the surface and can be removed when it floats into the edge. The scythes can be obtained in the UK from Aquatic Services (0044 1387 850580 or email: sales@aquatic-services.co.uk)

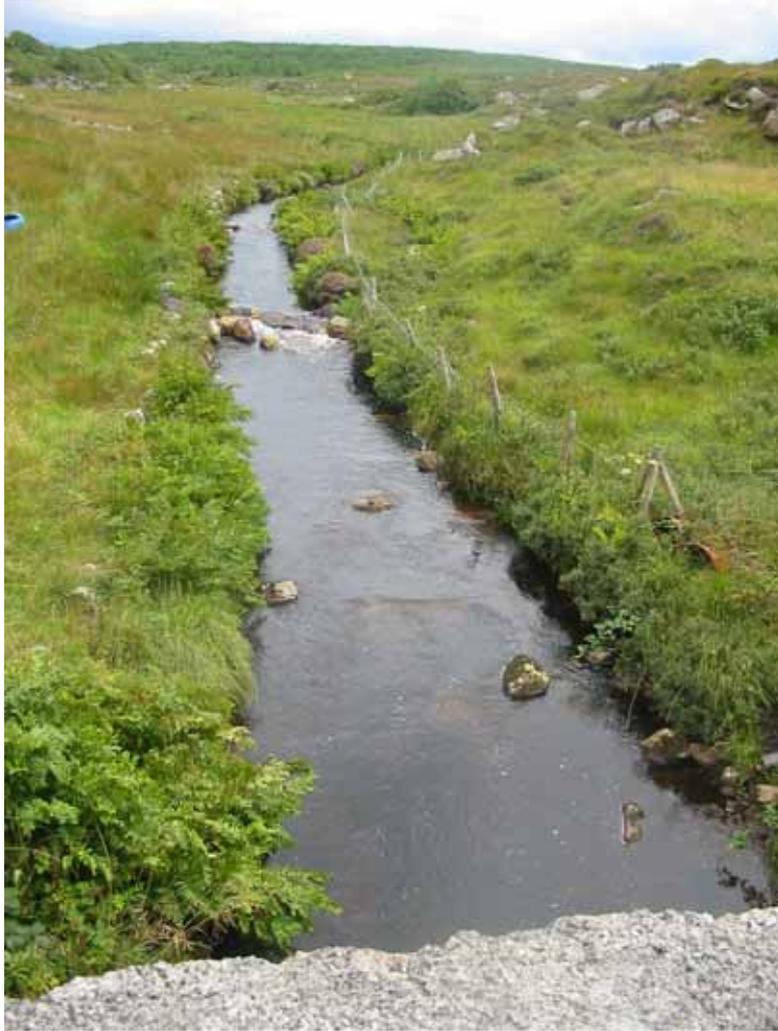
This stream to Sallagh was surveyed in 2002, with moderate densities (0.32 fish/m^2) of 0+ trout and very poor densities (0.02 fish/m^2) of >0+ fish recorded. Lack of deeper water for adult fish was identified as a possible reason for low numbers of >0+ fish, along with the close geographic proximity of Lough Sallagh that provided good habitat for large fish.

Inflow stream to Lough Sallagh immediately upstream of the lough

With respect to the stream flowing into Lough Sallagh, the Central Fisheries Board report recommends the creation of deeper pools by the selective placement of larger boulders. This recommendation is endorsed, with the caveat that the boulder placement should be carefully considered in order to minimise the risk of significant bank erosion.

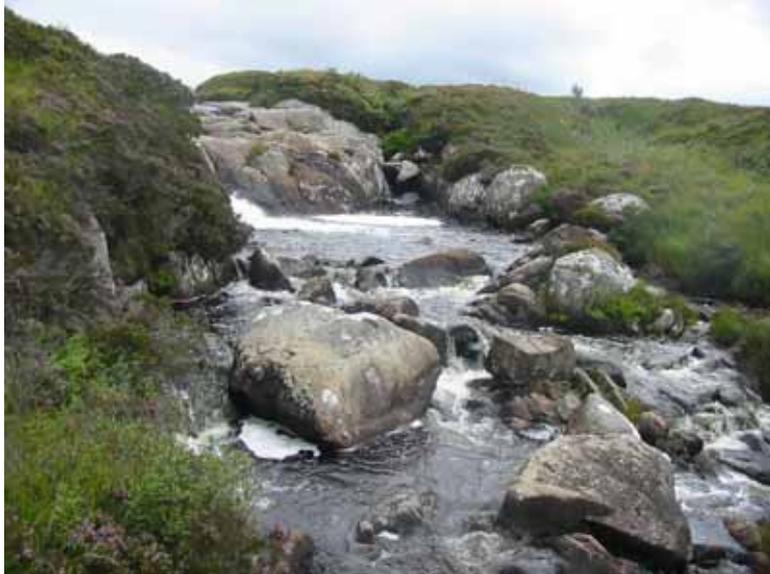
This is the only system examined during the advisory visit that has a self-sustaining stock of Atlantic salmon. There was a significant set of falls on the Owenamarve river just upstream of the N56 that formed a barrier to migratory fish over a wide range of discharges. Low densities of trout fry, parr and salmon parr were recorded below the falls during the 2002 survey, with the absence of salmon fry and poor trout fry density attributed in part to the lack of suitable gravel substrate. Advice regarding possible changes to the falls to improve passage were provided in the Central Fisheries Survey Report¹.

Waterfall on the Owenamarve river

The key issue on the Owenamarve system is the impact on upstream migration of the falls as described above. The head loss at the downstream end of the falls is currently too great for fish to negotiate over a large range of discharges. In addition, the depth of the downstream stilling pool is insufficient for optimum ascent. In order to address

this, boulders should be re-arranged downstream of the fall in order to increase the depth of the stilling pool, reducing the effective head loss for fish to negotiate.

Within the falls themselves there is scope for the creation of a series of resting pools that would aid fish passage. These should be constructed on a temporary basis by moving large boulders within the falls. If these temporary structures are found to be effective, more permanent features could be put in place using a combination of boulders, rebar and concrete.
