Habitat Advisory visit to the River  
Avon at Amesbury, Wilts.  
Undertaken on behalf of Salisbury and  
District Angling Club by Vaughan  
Lewis, Windrush AEC Ltd  
November 2005

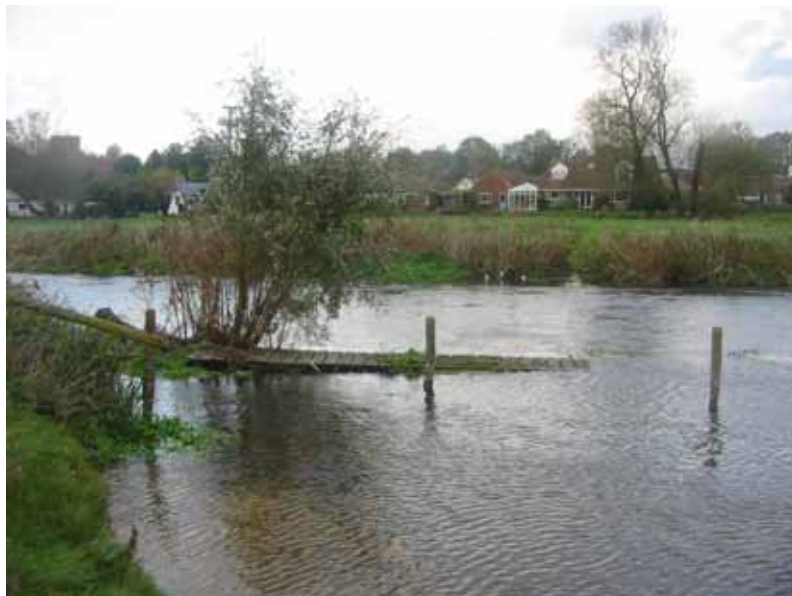
The River Avon at Amesbury was subject to a major enhancement scheme some 8-9 years ago. The work was undertaken by a fishery contractor, in conjunction with the club. It entailed significant narrowing of the channel using faggot bundles and chalk infill to create a walkway for anglers. The wetted channel behind the walkway provided habitat for a range of wetland species and a valuable low velocity refuge area for fish during high flows.

Unfortunately, high flows soon after construction resulted in the partial failure of much of the work. As a consequence, the club has sought the advice of the Wild Trout Trust as to possible future management options for the reach.

### **Remains of previous river narrowing**

Considerable lengths of the previously installed enhancements had been lost, with only short sections still visible in the form of access bridges and lines of exposed stakes and logs. Some sections of deeper water were present alongside the bank as a result of erosion due to the collapsed revetment.

- The installation of faggot bundles along the fenced sections would both encourage the rapid development of a vegetated margin and the narrowing of the channel. It is recommended that faggot revetment should only be installed where the bed profile adjacent to the bank is shallow. In some sections, the vertical driven poles remained from the original enhancements. It would be a simple and desirable process to reweave a mix of deadwood faggots and live willow wands (from on-site coppicing) between the stakes, reforming the previous line of the revetment. Subject to ensuring that nesting birds are not disturbed, it is recommended that the installation of faggot/willow revetment and construction of islands is undertaken during the late spring period, in order to allow adequate time for vegetative growth to stabilise these structures before they are subject to high winter flows. Some of the wooden bridges remaining from the original enhancements posed a possible Health and Safety risk and should be removed from the water.

- Areas of deeper water alongside the bank resulting from the historic enhancements should be allowed to remain unchanged.
- An alternative to narrowing from the banks is the construction of small, mid-stream islands. Benefits include the creation of refuge areas for animals and plants. Remote from human disturbance and grazing, they may support different plant communities compared to more accessible banks. Some criticism of the construction of islands in small chalk streams has been received from geomorphologists, who note that the occurrence of such features naturally is unusual in these low energy environments.

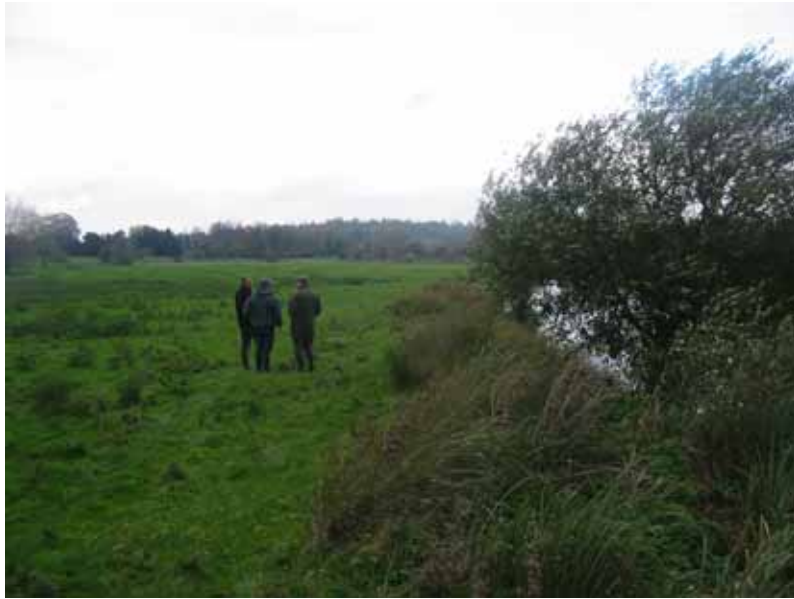
A raised bund was present on the RB. It is very likely that this bund was formed from material previously dredged from the river.

**Elevated bund on the RB of the river**

- The deeper, downstream section of the reach could be improved by the introduction of gravel riffles. Gravel could potentially be obtained by the excavation and screening of the RB raised bund. Trial pits would need to be dug into the bunds in order to ascertain the percentage of gravel present within them and a cost-benefit balance undertaken regarding the value of their on-site screening. Alternatively, gravel could be imported to site from a local mineral quarry. The lowering of the bund would not only provide an opportunity for local sourcing of gravel but would, in

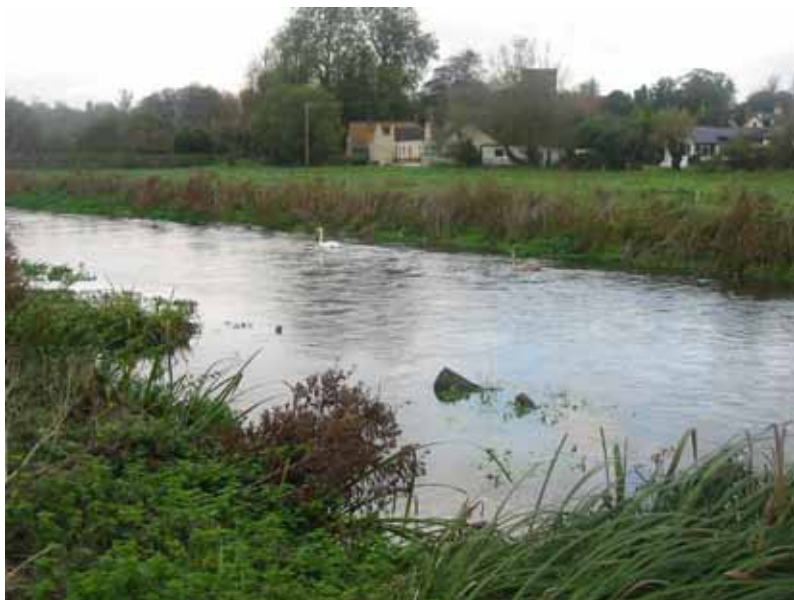
The sections of RB fenced as part of the previous scheme had developed excellent stands of emergent marginal vegetation and young willow trees. Consequent narrowing of the channel had increased flow velocity and diversity, helping to sort bed material and increase bed heterogeneity.

**Strong growth of marginal vegetation in fenced areas. Note line of former enhancement (delineated by logs in water)**
