**SLAMANNAN ANGLING & RIVER PROTECTION ASSOCIATION**

**RIVER AVON  
WEST LOTHIAN, SCOTLAND**

**ADVISORY VISIT REPORT**

**THE WILD TROUT TRUST**  
20<sup>th</sup> March 2005

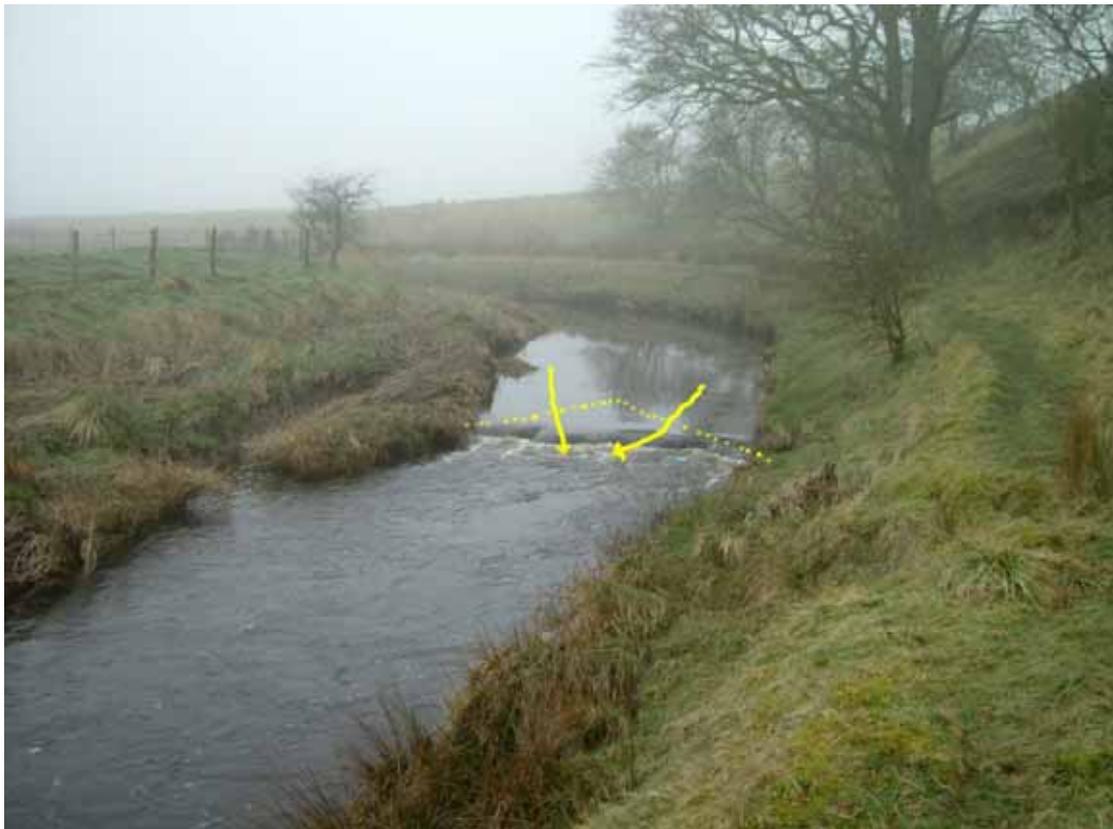
**PIC 2 Upstream pointing weirs**

The club has installed several low rock weirs to create deeper areas and to liven up the flows. Where these have been constructed they are doing a good job. However it is suggested that in future any weirs should be constructed in a more advantageous shape i.e. in an upstream pointing fashion (see picture 2 below). This shape will at all levels of low flows direct the water towards the centre of the stream, which will protect the downstream banks from erosion.

Furthermore by diverting the flow towards the centre of the stream this will encourage the flow to scour out a deeper area behind each weir, which in low flows will afford better holding areas for fish. These weirs will improve the oxygenation of the water during summer flow regimes. Where ever new weirs are constructed it is essential to ensure that the rocks used are let well into the river banks at the margins as this will prevent high flows from eroding away the river bank during high flows.

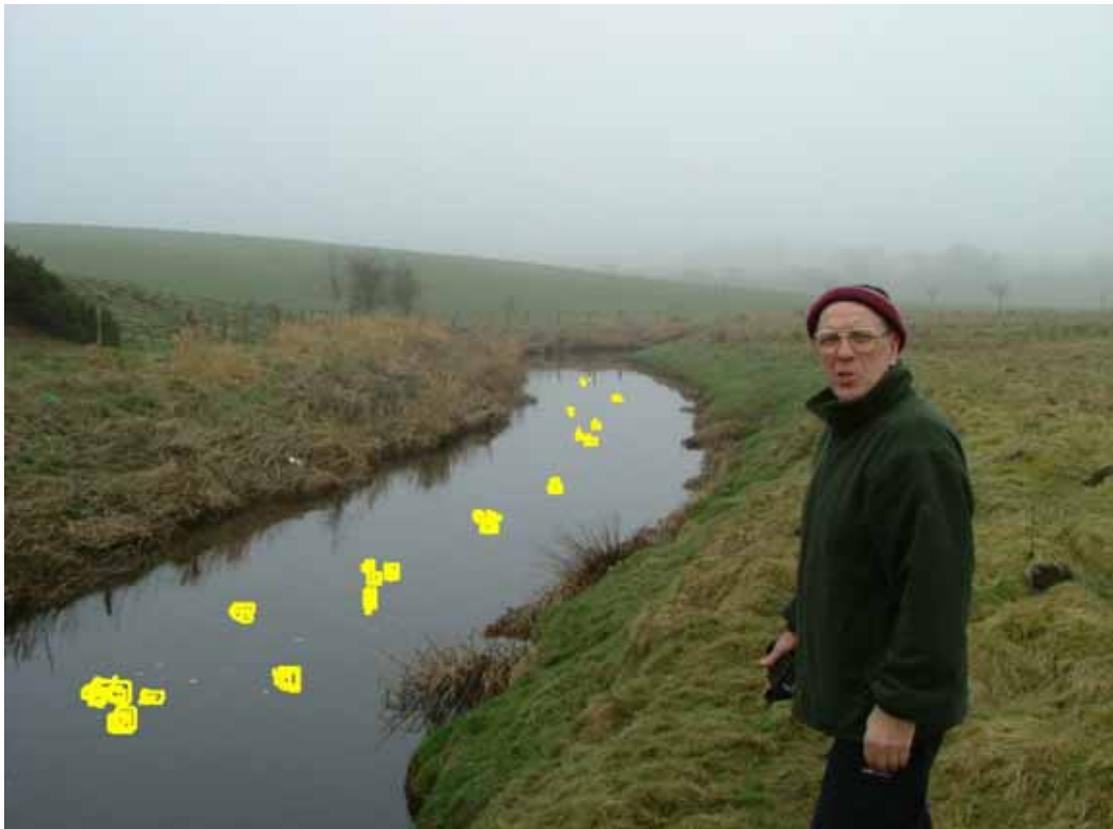
**Pic 3 Random placed rocks**

Further upstream there is a long sluggish stretch with little or no features on the riverbed to attract trout or provide cover or safe feeding stations. There are options here that should be considered. With large amounts of natural rocks available along the riverbanks, which were originally dredged out of the riverbed, it is sensible to put some back into the river channel. It is suggested that some larger rocks are randomly placed along the river bed all placed singly or in clusters within the middle third of the stream channel. Once in place these will provide cover for trout and afford feeding stations as well as creating and instilling some life back into a dead stretch of river. Another consideration would be to construct a series of **alternating triangular rock structures** along the banks that are set to be no more than 25% of the channel width and set alternately along both banks thus encouraging the river to meander side to side along this straight stretch. With randomly placed rock in-between these structures this would liven up the flows and afford better holding habitat and feeding stations for adult trout. (see **pic 3 below Random placed rocks. And pic 4 for Triangular structures**

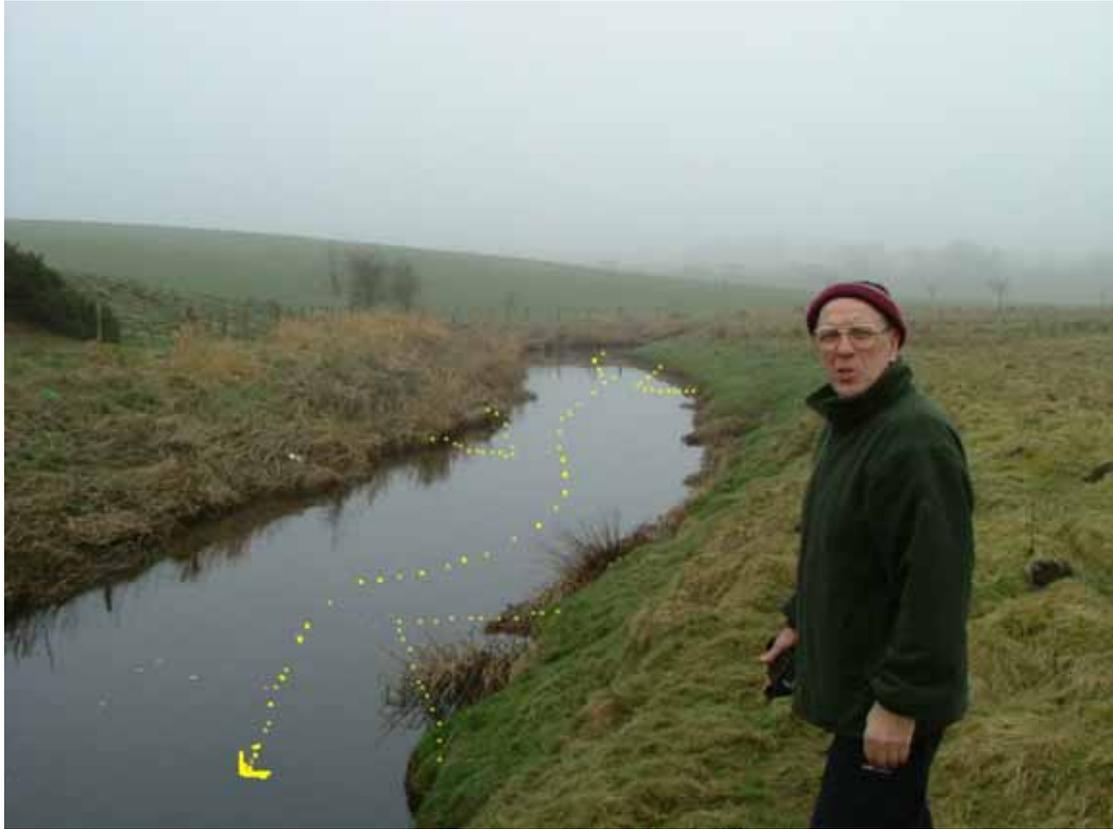
**Pic 4 Rock Triangle deflectors.**

The triangles are constructed with substantial rocks that will remain in place during high spate flows and set to be 6” out of the water at summer levels and be under water for higher flows these will deflect the flow and create the required meander effect at all levels.

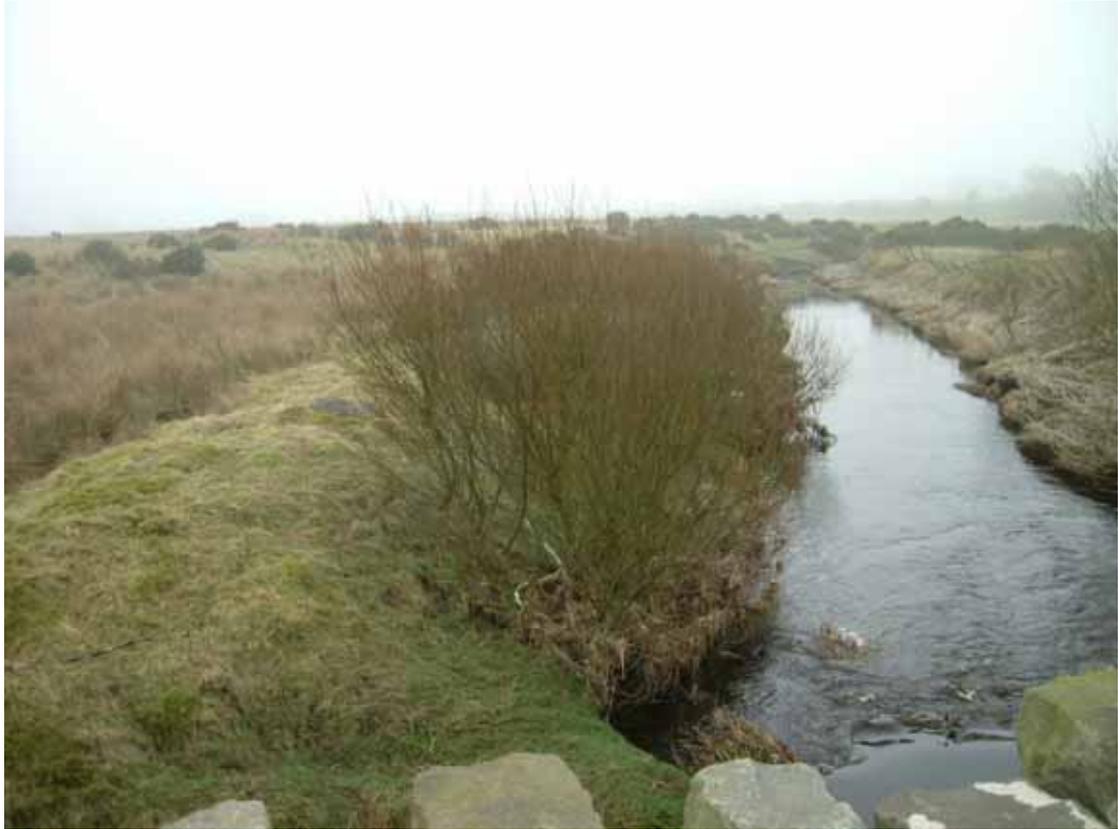
**Pic 5 More of the same**

The work already completed is excellent so continue the good work. Keep it simple and wherever construction is undertaken make sure you over engineer the work as a precaution to losing the work in high flows. It is suggested that all the small tributaries are also looked at and any obstructions that might restrict fish movement up into these potential spawning areas should be removed.

More of the same should be the policy. What ever construction work is planned it is essential to consult with SEPA to gain their support and advice and consent before you put your plans into operation they will guide through the red tape!. Keep the Forth Foundation and all your riparian owners fully informed at all times.

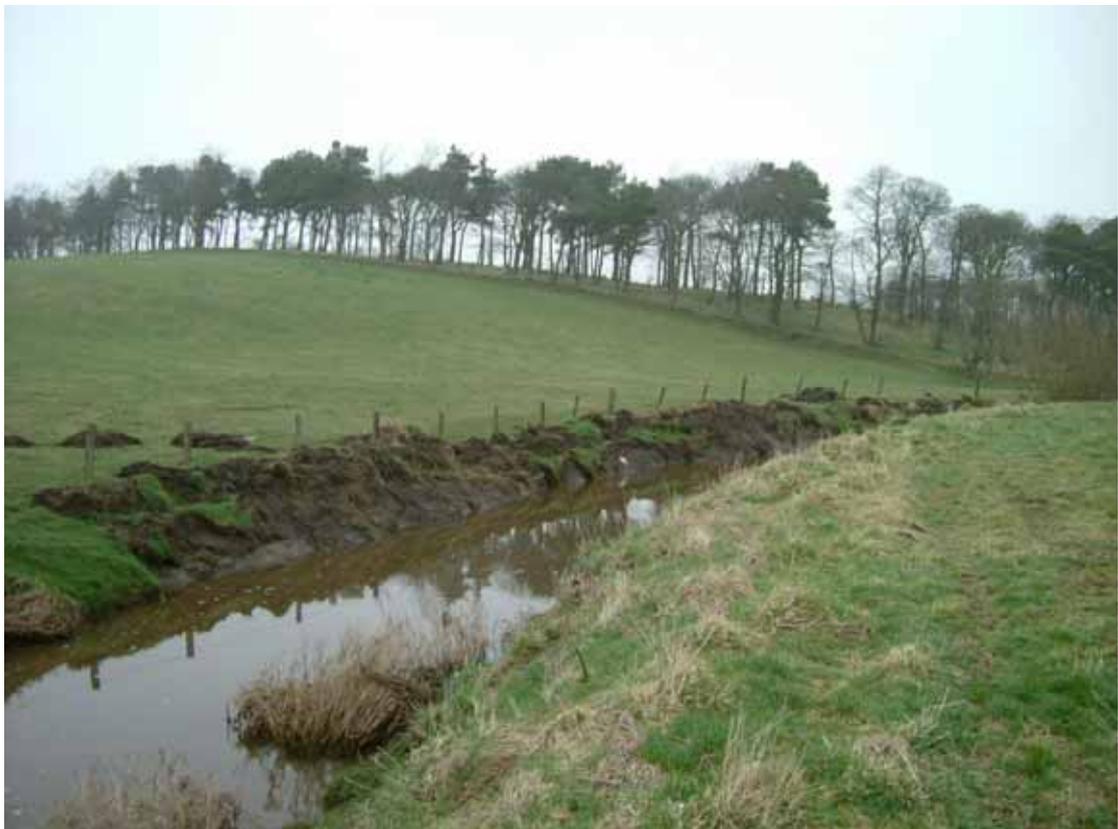
**Pic 6 Damage**

The damage to the riverbanks by the mis-guided actions of the farmer has to be reported to SEPA and it's for them to take action with the farmer. Unfortunately the damage has been done and little can be done to rectify the problem.
