**HABITAT ADVISORY VISIT TO THE RIVER
BABINGLEY, HILLINGTON, NORFOLK.**

**UNDERTAKEN BY VAUGHAN LEWIS,
WINDRUSH AEC LTD ON BEHALF OF THE
HILLINGTON SYNDICATE**

OCTOBER 2005

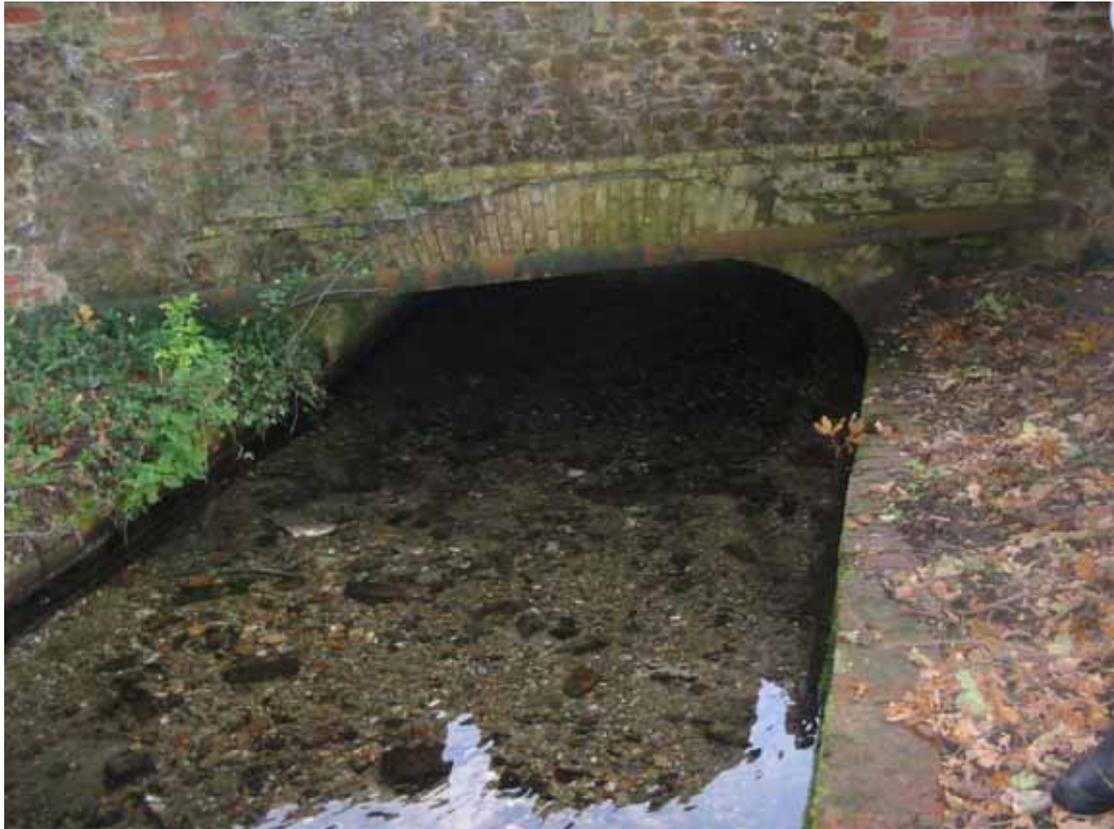
The upper limit of the Hillington fishery was marked by the crossing of the river by the B1153. A short section of mixed gravel riffle, suitable for brown trout *Salmo trutta* spawning was present downstream of the bridge, with the river then dropping some 1m over a weir. Brown trout have been noted migrating upstream over this weir by syndicate members.

Upper limit of the fishery, showing mixed gravel substrate

- The third, preferred option would be to excavate a completely new channel for the Babingley in the LB field adjacent to the Broadwater. This channel would be cut from above the weir at the upper limit of the fishery, discharging into the existing channel downstream of the LB sluices. This would fully utilise the available gradient within the new channel. Careful planning would be required to ensure correct sizing of the channel with respect to the available flow, with a meandering profile increasing habitat diversity. This option would be neutral with respect to flood risk, with an increase in capacity over the length of the new channel, with unchanged conveyance upstream and downstream during peak flood events. Financially, this option is likely to prove the cheapest of those discussed, with all excavation undertaken in the dry and minimal additional materials required.

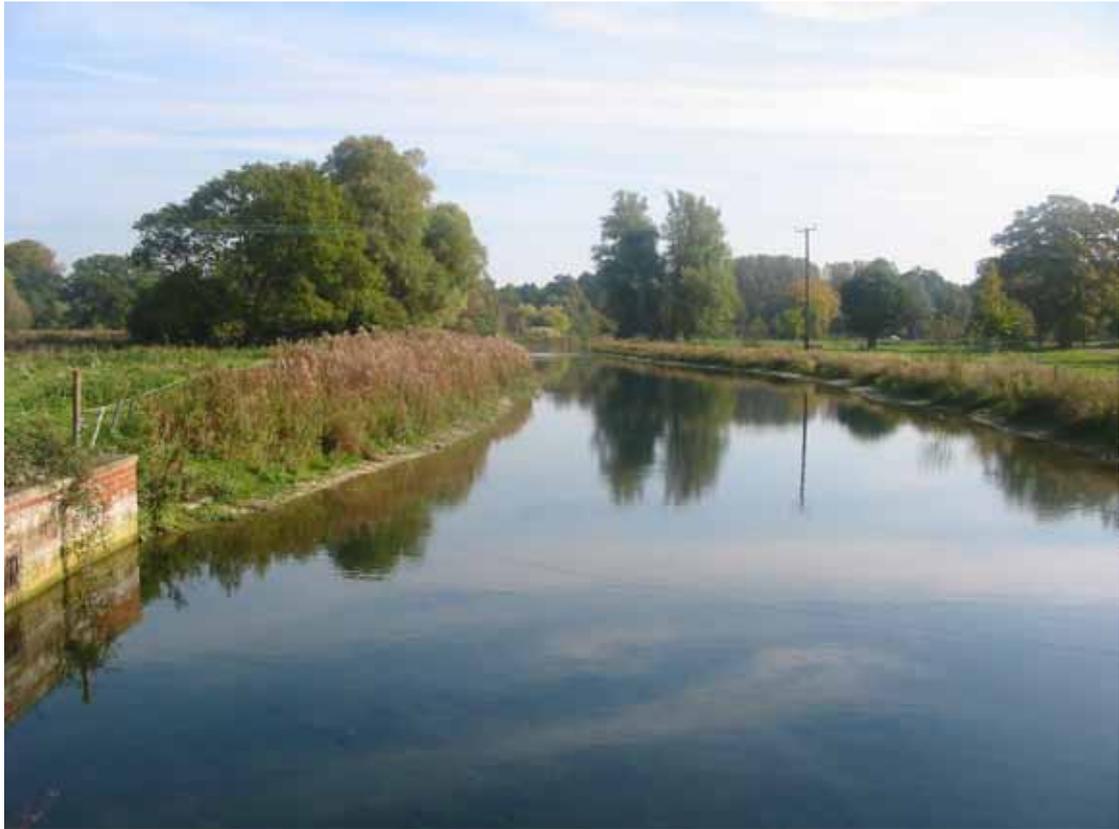
Below the weir, the river gradually widened to form a large Broadwater, created by the historic impoundment of the river. The Broadwater had a main channel, bifurcating into two arms at its downstream end. Moderate numbers of brown trout were observed in the Broadwater, ranging in size from 10cm in length (0+ fish) to over 2kg in weight. Syndicate members suggested that recruitment of trout appeared to have declined in the recent past, with numbers of small to medium sized fish much reduced. One suggestion for this decline was the increased presence of cormorants *Phalacrocorax carbo* at the fishery.

View of Broadwater looking upstream from LB arm

- Options for useful remedial action to the Broadwater include:
 - Undertake de-silting, either using hydraulic excavators, or by suction dredging. Both options would be expensive, with large volumes of wet sediment needing to be stored, de-watered and spread locally. In the absence of further remedial action, infilling of the Broadwater with fine sediment would continue, with a further dredging operation inevitably required in the near future.

- Construct a discrete channel for the Babingley within the existing Broadwater, exiting at the sluices at the downstream limit of the LB arm. This is a practical option, with the banks of new channel being defined using locally excavated granular soil retained by a palisade of coir fibre and/or faggots. Correctly sized, the new channel would erode deposited sediment within it, eventually exposing clean gravel substrate. This option would isolate the Broadwater from the flow of the Babingley, reducing the input of damaging fine sediment and nutrient. The existing water level in the Broadwater would be retained by the existing sluices, with additional water bled into the system periodically or as required via an additional sluice installed from the upstream limit of the new channel. This would allow the Broadwater to continue to function as a stillwater fishery, until natural succession precluded this.

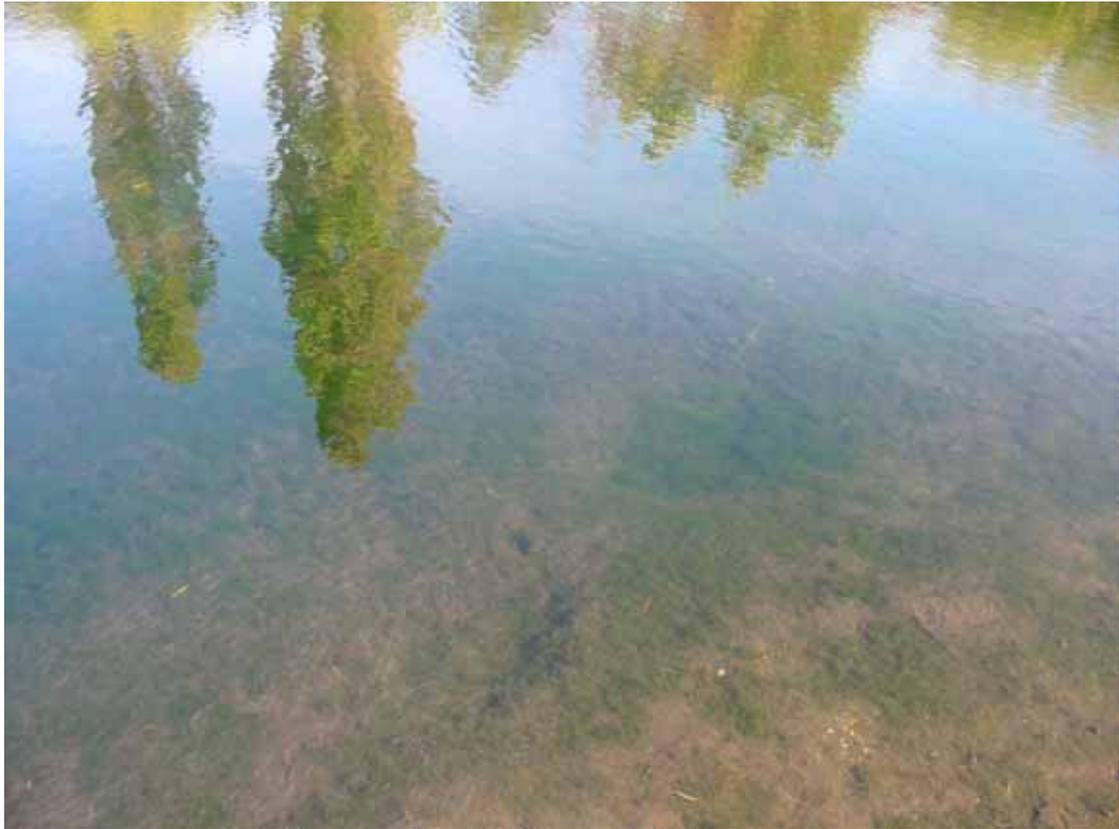
The habitat within the Broadwater was generally poor. The bed was heavily coated by fine sediment to a depth of (apparently) up to 1m. As a consequence, the depth of the water remaining was generally less than 0.5m and in some cases, considerably less. A mix of filamentous algae and diatomaceous algae covered much of the bed of the Broadwater, with rooted macrophytes limited to small stands of starwort *Callitriche* Spp.

Bed of Broadwater showing thick layer of sediment and associated filamentous algae

- The life of the Broadwater as a fishery is limited if no remedial action is taken. A combination of high nutrient loading (from upstream and local agriculture, and the large numbers of ducks/geese present) and the detention of fine sediment will result inexorably in succession to alder/willow carr or reedbed. Estimates of how long this process will take are difficult, but it likely that the fishery value of the Broadwater will be very low in twenty years time.
- The previous practice of periodic flushing of the Broadwater is likely to be illegal under section 90 (1) (a) and (b) of the Water Resources Act 1991 (this specifically prohibits the 'removal from any part of the bottom, channel, or bed of

any freshwaters a deposit accumulated by reason of any dam, weir or sluice holding back the waters ...and does so by causing the deposit to be carried away in suspension in the waters'. In addition, the practice is likely to be counter productive during the winter period, with mobilised sediment deposited on areas used by trout to spawn or by juvenile fish.

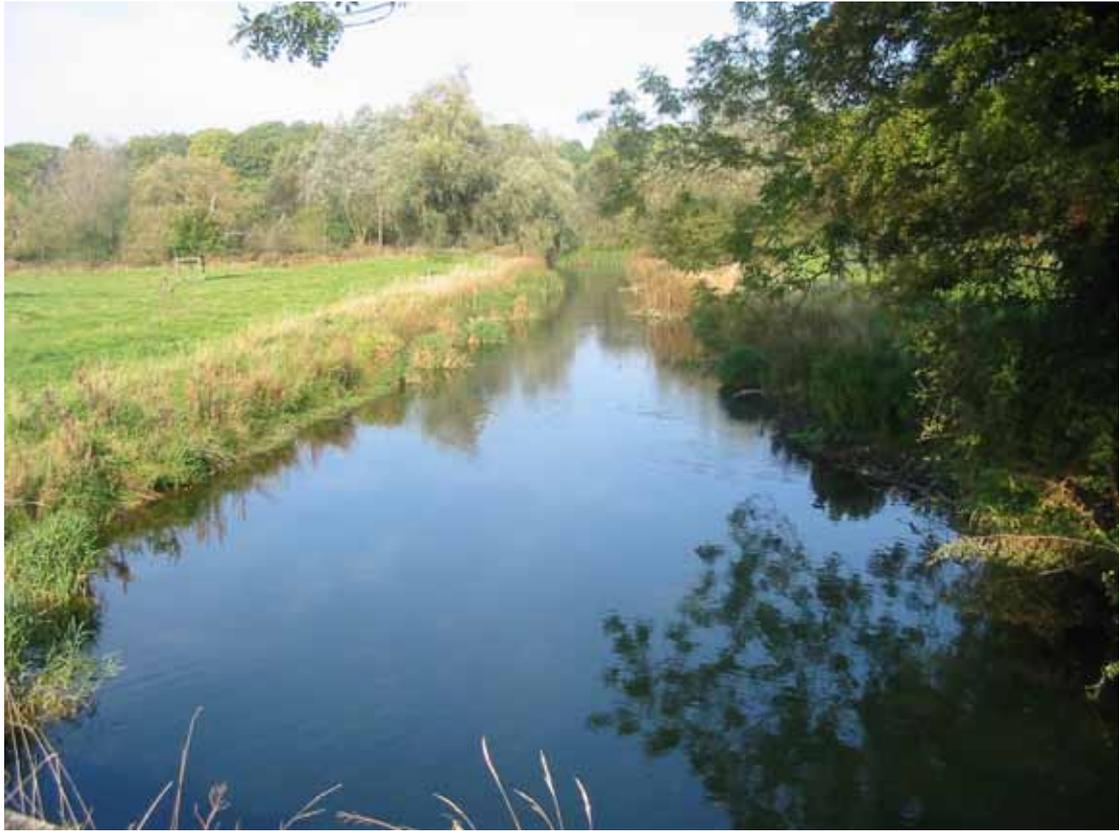
Water exited the Broadwater via the RB arm. As a consequence, instream enhancements undertaken by the Environment Agency on the LB arm downstream of the Broadwater were rendered redundant.

LB channel downstream of the Broadwater, now largely deprived of flow

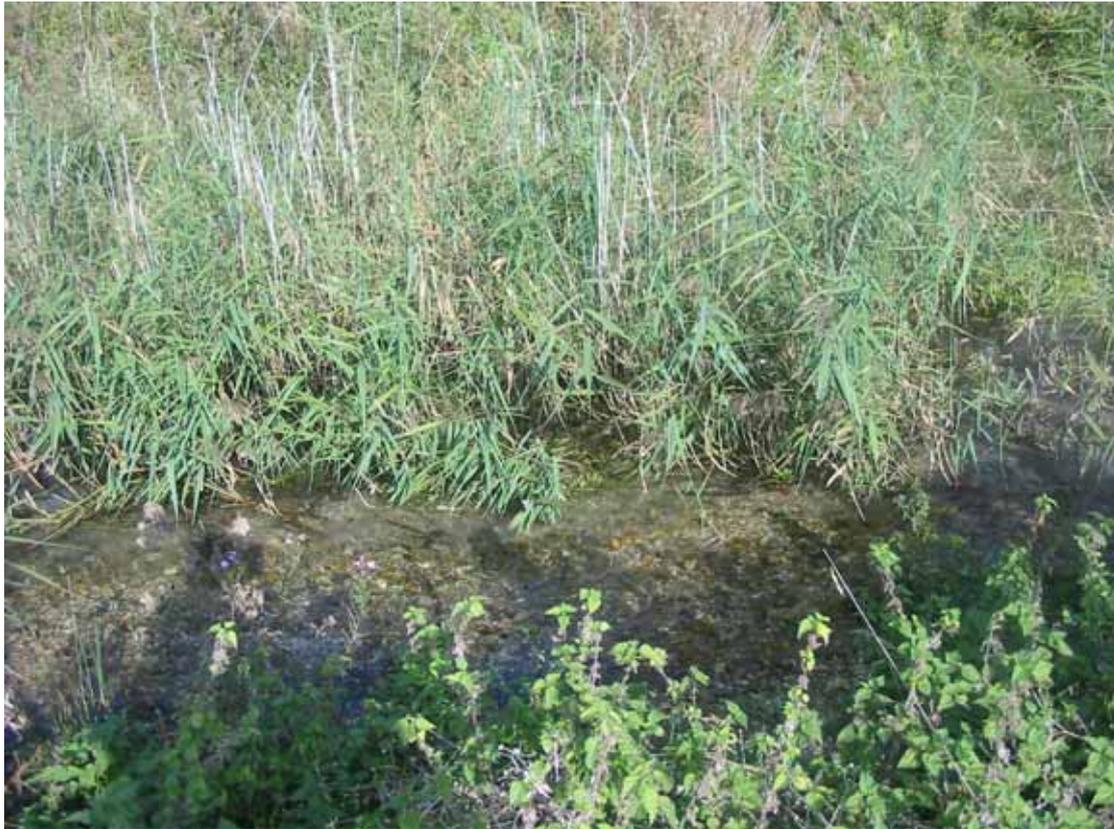
The RB channel downstream of the Broadwater was overgrown with emergent vegetation in places, although there were some small sections of gravel potentially valuable for spawning and juvenile brown trout.

Section of reasonable quality gravel on RB arm downstream of the Broadwater

- Establish a regime of cleaning spawning gravels each September. This can be achieved by either manual raking, or by the use of high-pressure water jets. Care must be taken to clean riffles rotationally, with only short sections being treated annually. It must also be recognised that this option may well favour increased spawning success of the earlier breeding native brown trout to the detriment of the later breeding, introduced rainbow trout. It is important that the EA are contacted prior to any cleaning of gravel, due to the possible discoloration of water in the river resulting from the operation. The same concerns dictate that downstream neighbours should also be forewarned of the operation.

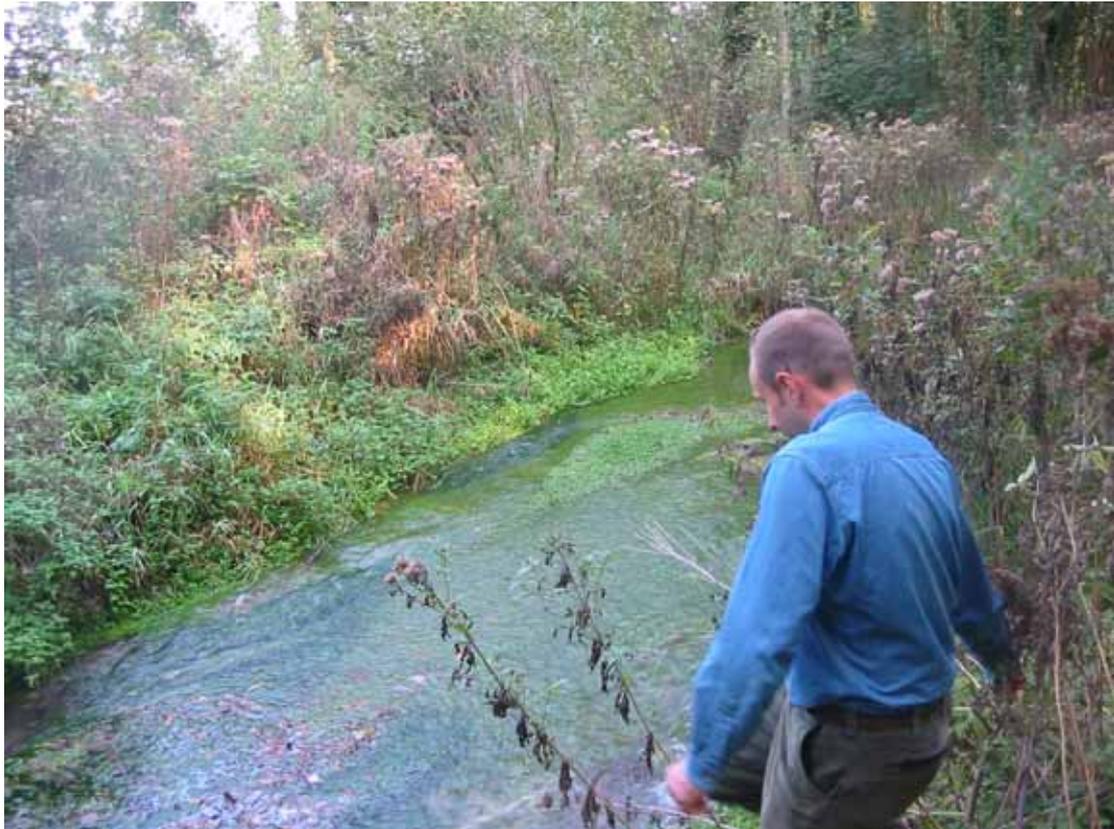
Near to the downstream limit of the fishery, shade had been reduced along a short section of bank by coppicing of riparian trees. In concert with the removal of all of the boards from the downstream sluice, this had created a length of excellent habitat. The growth of marginal vegetation was strong, narrowing the channel, resulting in clean, well sorted gravel interspersed with stands of submerged vegetation including water crowfoot *Ranunculus* spp, and horned pondweed *Zannichellia palustris*.

Section of excellent habitat resulting from reduction in shade, and removal of downstream sluice boards

- Coppicing or 'singling' of riparian trees in sections of heavily shaded channel can be of great benefit. Coppicing and pollarding of trees are traditional and potentially valuable methods of managing trees. Wildlife associated with coppiced trees depends on

- Where the club has control of the in channel sluices, it is recommended that all boards should be removed permanently from these structures. This will allow the free flow of water, gradually reducing channel width and siltation and, in combination with a reduction in shading, the promotion of instream weeds. These processes will combine to improve the abundance and quality of habitat suitable for spawning and juvenile trout.
